Aquatic Plant Point-Intercept Surveys for Sea Lake, Scandia, Minnesota, 20165

[Plant Surveys Conducted: June 2 and August 23, 2016]

Prepared for:
Comfort Lake - Forest Lake
Watershed District

Prepared by:
Steve McComas
Jo Stuckert
Blue Water Science

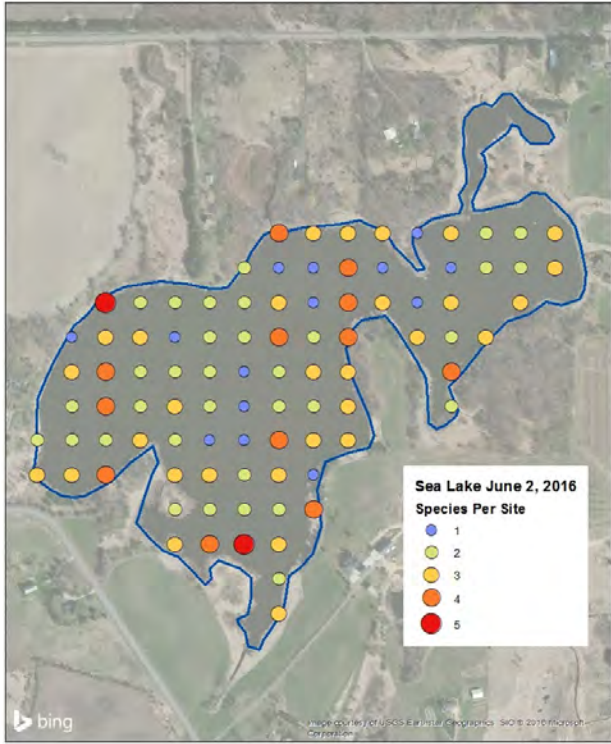
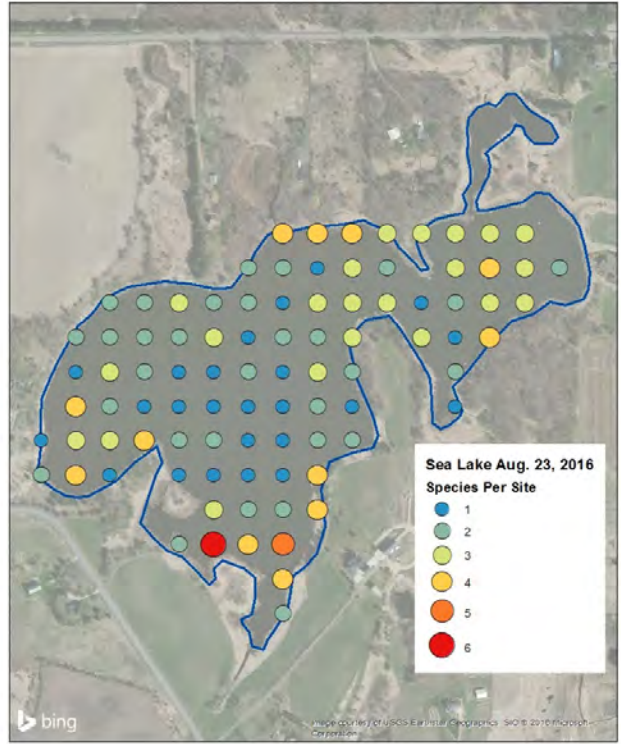
Figure S1. Species richness for Sea Lake on June 2, 2016 (left) and on August 23, 2016 (right).

Sea Lake has a moderate early season diversity of aquatic plants, with 7 submerged species, including 1 non-native species, 3 floatingleaf species, and 2 emergent plant species in 2016. Eurasian watermilfoil was not observed in this survey but curlyleaf pondweed was fairly abundant (Figure S1). A summary of plant occurrences and relative densities are listed in Table S1. The most common plant in the lake in June was coontail followed by curlyleaf pondweed. Curlyleaf pondweed is a non-native species and had a total coverage of 21 acres with heavy growth covering about 7 acres.

Later in the summer, Sea Lake had a lower diversity of submerged aquatic plants, with 4 species observed. Submerged plants covered 100% of the lake (Figure S1). Eurasian watermilfoil and curlyleaf pondweed were not observed in the August survey. A summary of plant occurrences and relative densities are listed in Table S1. The most common plant in the lake in August was coontail followed by elodea.

Sea Lake Species Richness
June 2, 2016

Sea Lake Species Richness
August 23, 2016

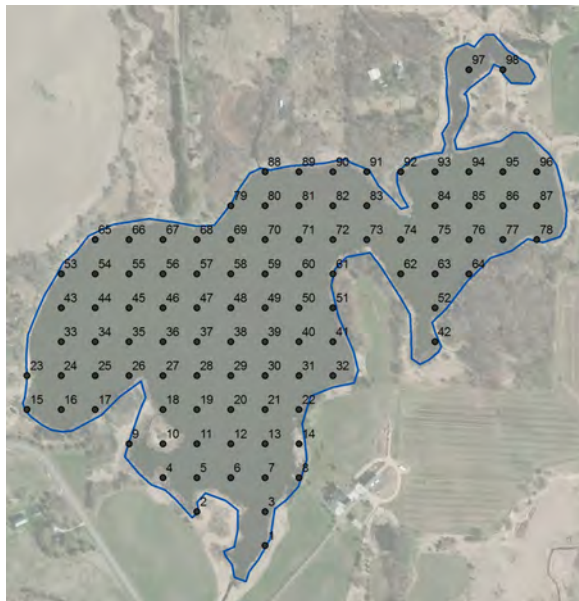
Figure 1. Points used for the aquatic plant survey conducted on Sea Lake. Points were placed 50 meters apart.

A point-intercept survey with ninety-five locations were sampled on Sea Lake with 50 meter spacing between points (Figure 1). The amount of plants on the rake determined the density of each species at that location. The plant species were recorded and the density of each species

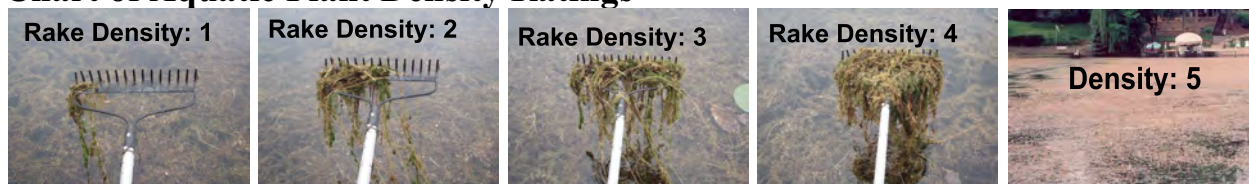
Figure 2. Aquatic plant density ratings from 1 to 5. A density rating of 4.5 or 5 is used for plants topping out at the surface.

was assigned. Densities were based on the coverage on the teeth of the rake. Density ratings were from 1 to 5 with 1 being sparse and 5 being matted growth (Figure 2). Based on these sample sites, plant distribution maps were constructed.

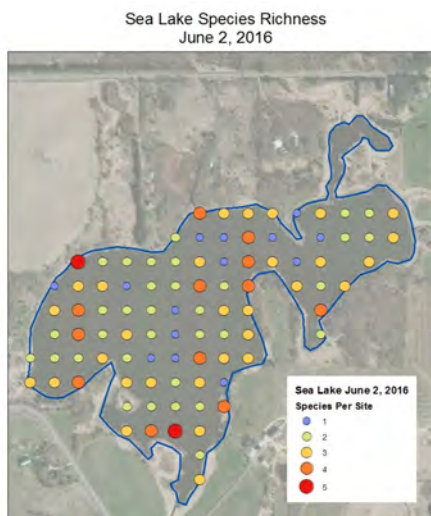
Figure 3. Species richness for Sea Lake on June 2, 2016.

Results of the early summer aquatic plant point intercept survey conducted on June 2, 2016 found there were 7 submerged plants and coontail was the dominant plant in the lake with curlyleaf pondweed second (Table 1). There was 100% coverage of aquatic plants.

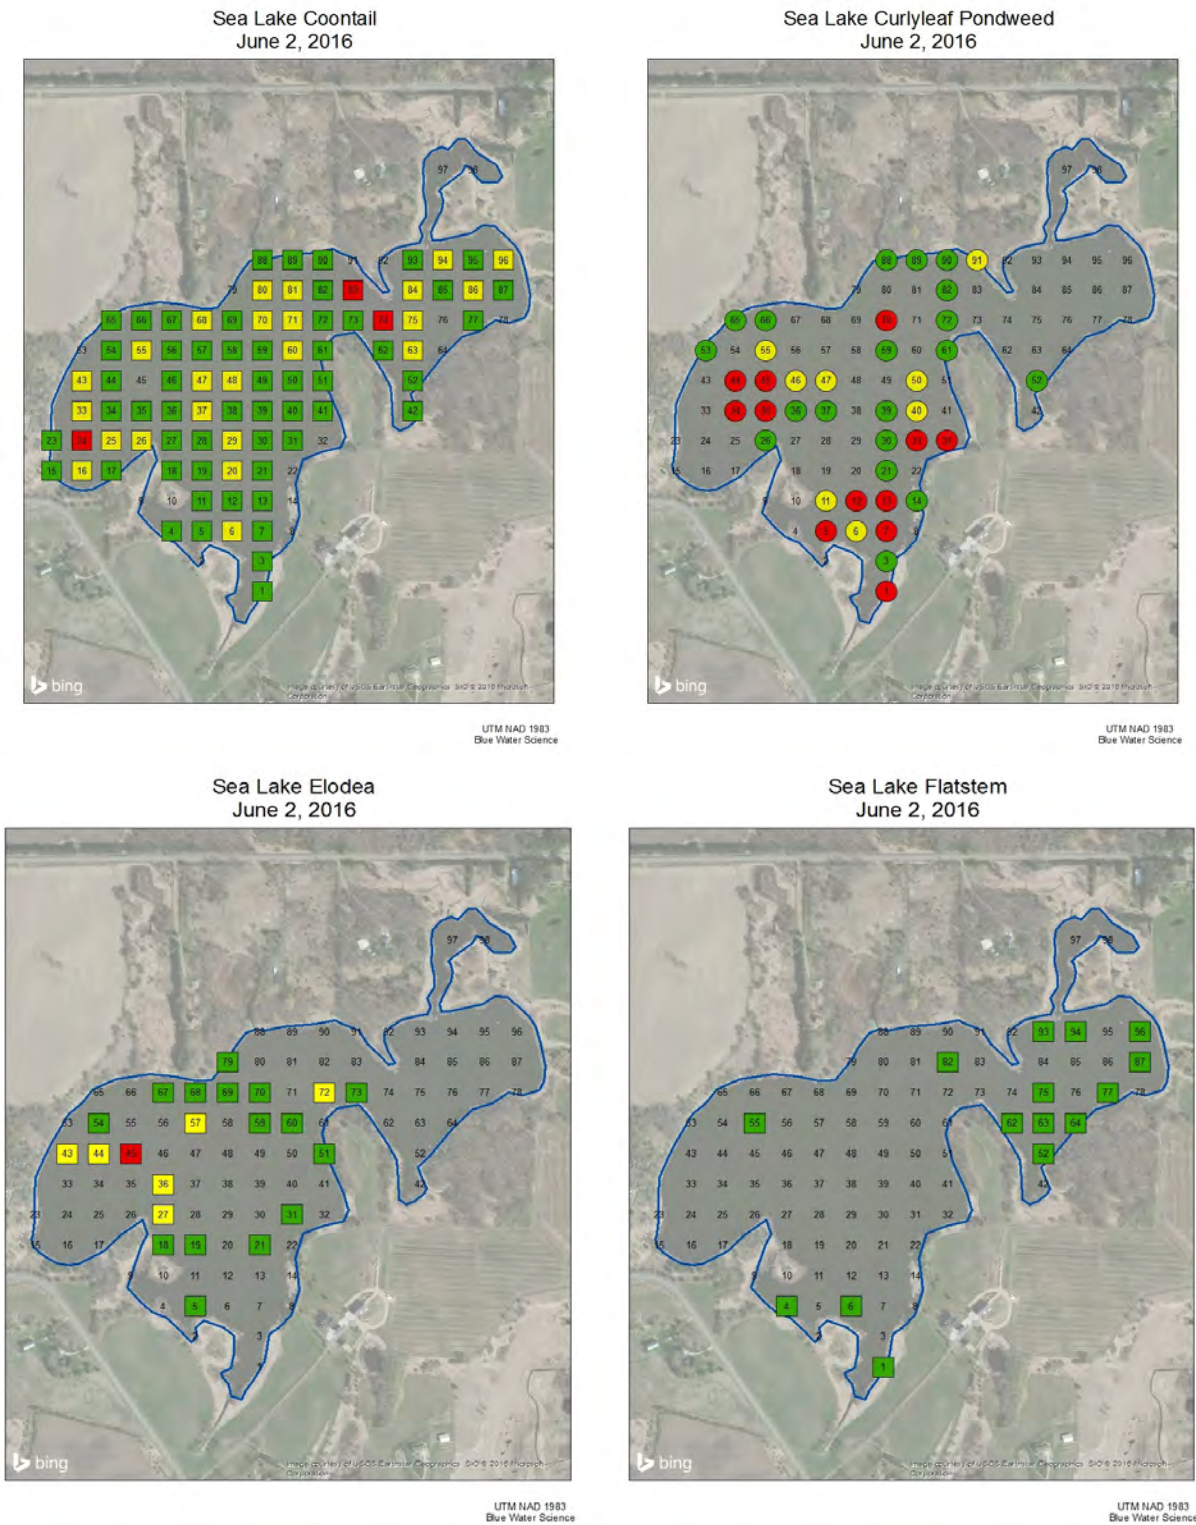
Figure 4. Aquatic plants were found throughout Sea Lake, coontail (top-left), curlyleaf pondweed (top-right), elodea (bottom-left), and flatstem pondweed (bottom-right).

Aquatic plants are distributed throughout Sea Lake on June 2, 2016 (Figure 4).

Key: green = light growth, yellow = moderate growth, and red = heavy growth.

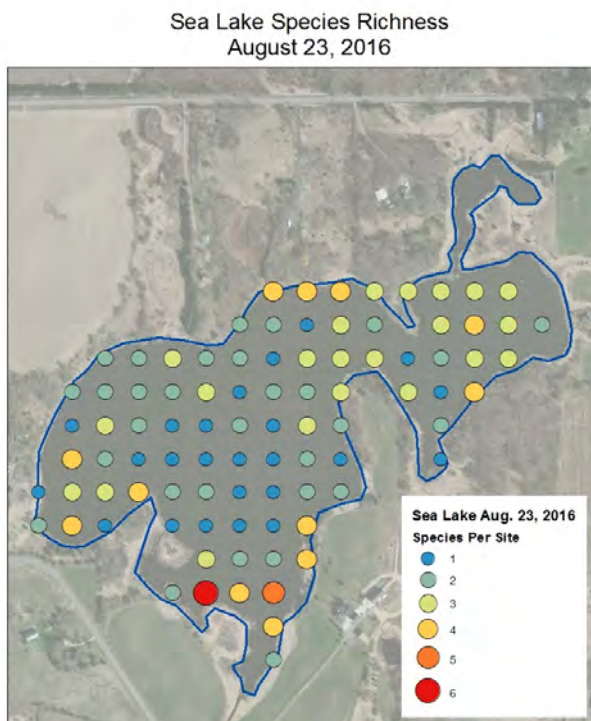
Figure 5. Species richness for Sea Lake on August 23, 2016.

Results of the late summer aquatic plant point intercept survey conducted on August 23, 2016 found several plant species had disappeared and there were 4 submerged plant species present. Coontail was the dominant plant in the lake with elodea second (Table 3). There was 100% coverage of aquatic plants.

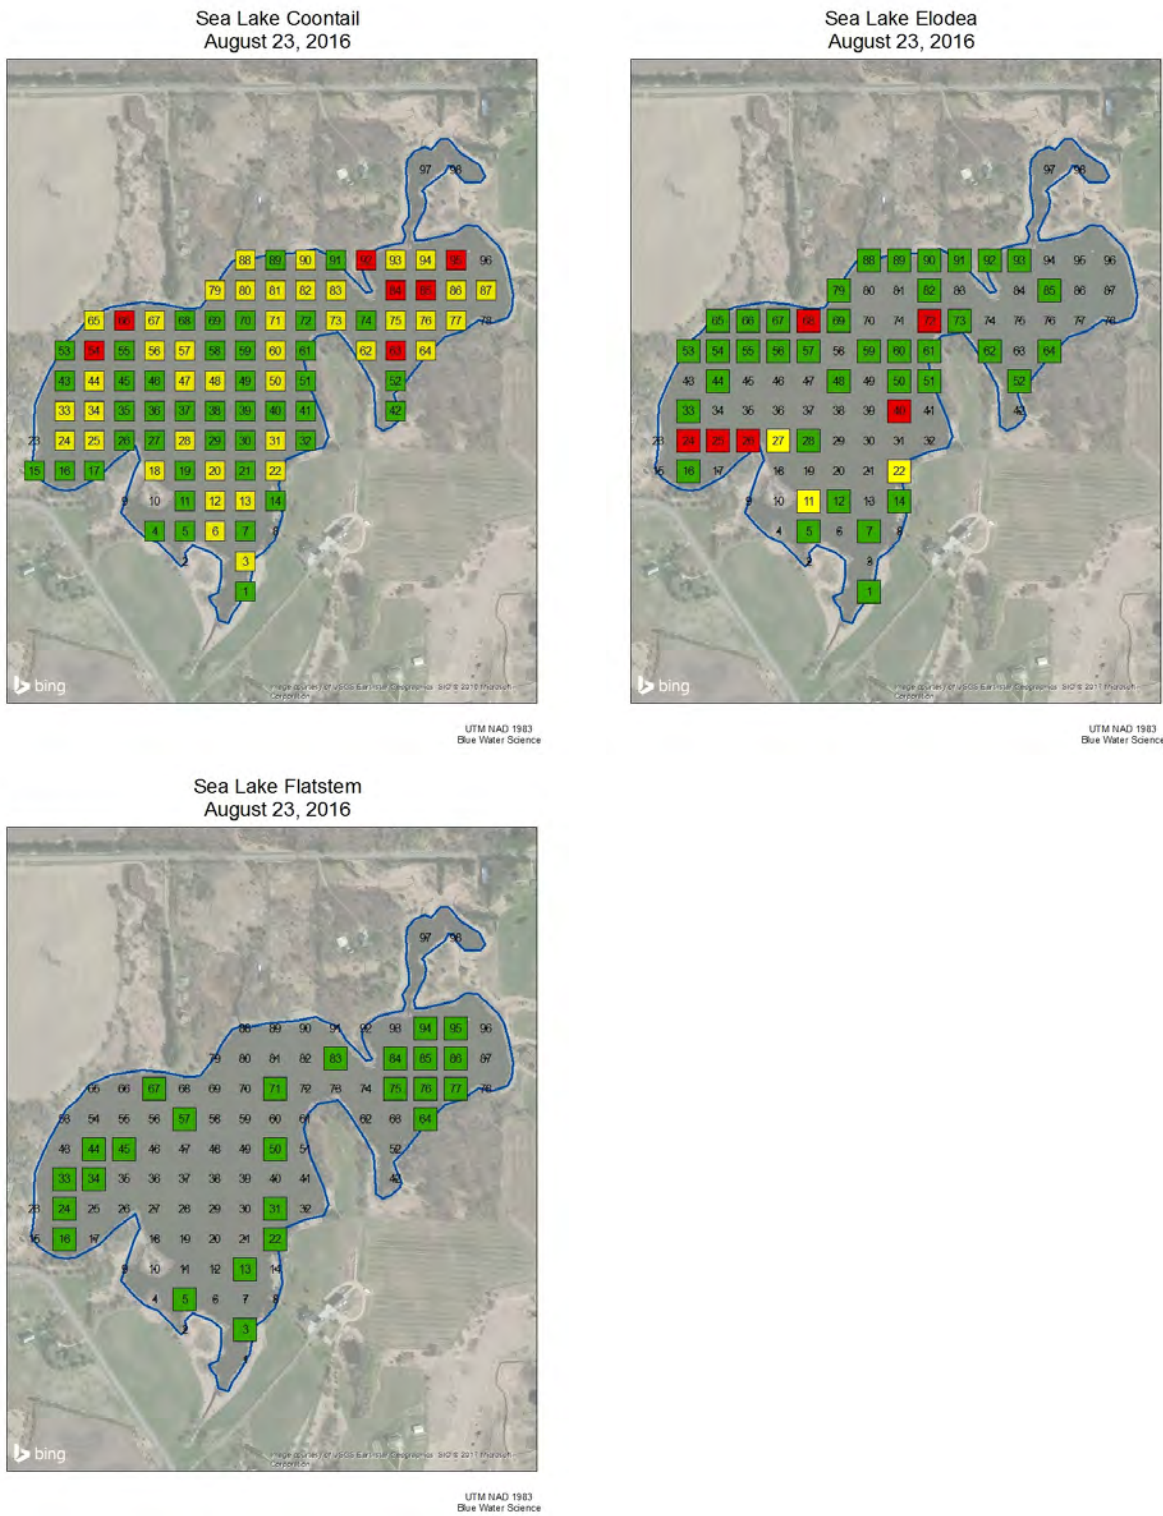
Figure 6. Aquatic plants were found throughout Sea Lake, coontail (top-left), curlyleaf pondweed (top-right), elodea (bottom-left), and flatstem pondweed (bottom-right).

Native aquatic plants are distributed throughout Sea Lake (Figure 6).

Key: green = light growth, yellow = moderate growth, and red = heavy growth.

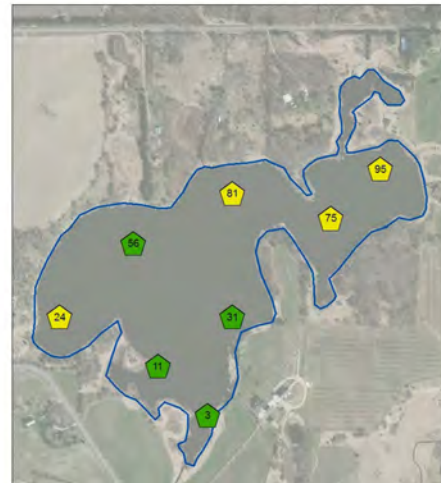
2016 Sea Lake Curlyleaf Pondweed Potential Growth

Curlyleaf Pondweed Growth Potential Based on Lake Sediments: Curlyleaf pondweed is present in Sea Lake. Research has found curlyleaf is limited or enhanced based on lake sediment characteristics. Based on lake sediment characteristics, curlyleaf has the potential to produce mostly moderate growth on an annual basis.

The color indicates the potential growth of curlyleaf pondweed. Key: green = light growth and yellow = moderate growth.

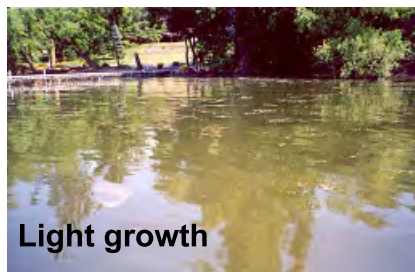
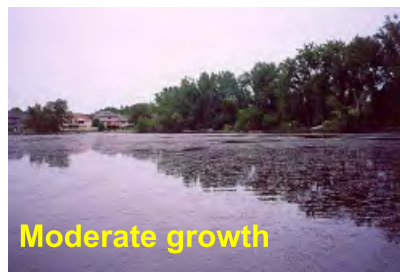
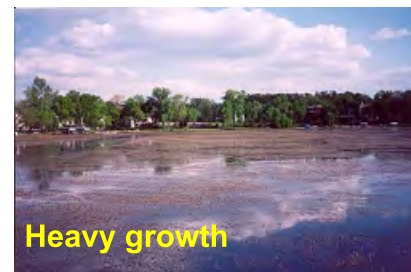
Examples of Curlyleaf Pondweed Growth Characteristics

Light growth (left) refers to non- nuisance growth that is mostly below the surface and is not a recreational or ecological problem. Moderate growth (middle) refers to growth that is just below the water surface. Heavy growth (right) refers to nuisance matting curlyleaf pondweed. This is the kind of nuisance growth predicted by high sediment pH and a sediment bulk density less than 0.51.

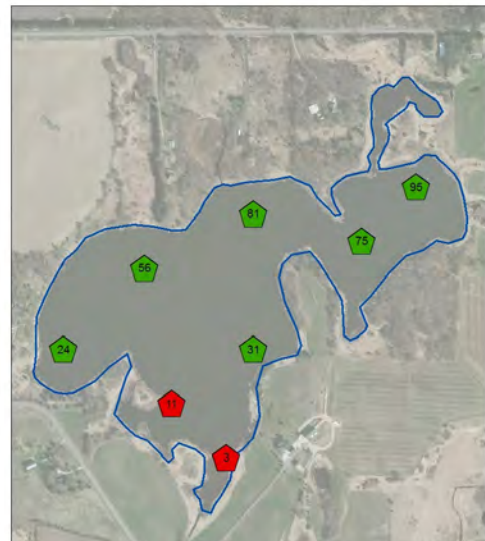
2016 Sea Lake Eurasian Watermilfoil Potential Growth

Eurasian Watermilfoil (EWM) Growth Potential Based on Lake Sediments: Lake sediment sampling results from 2016 have been used to predict lake bottom areas that have the potential to support heavy EWM growth. Eurasian watermilfoil has not been observed in Sea Lake as of August 2016. The potential for milfoil growth, based on lake sediment sampling, would be mostly light growth. Heavy milfoil growth has been correlated with high sediment nitrogen condition and Sea Lake had high sediment nitrogen values at some sites sampled.

The color indicates the potential growth of EWM. Key: green = light growth and red= heavy growth.

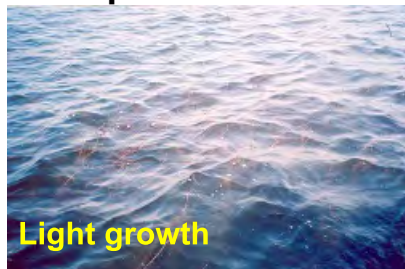
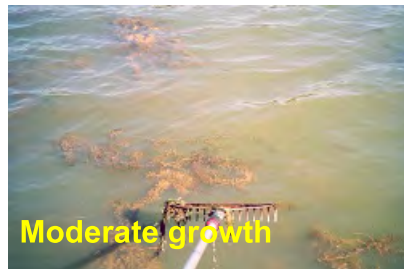
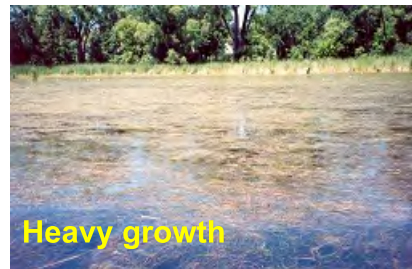
Examples of Eurasian Watermilfoil Growth Characteristics

Light growth (left) refers to non-nuisance growth that is mostly below the surface and is not a recreational or ecological problem. Heavy growth (right) refers to nuisance matting Eurasian watermilfoil. This is the kind of nuisance growth predicted by high sediment nitrogen values and a sediment organic matter content less than 20%.
