## Curlyleaf Pondweed and Eurasian Watermilfoil Delineation, Treatment, and Assessment for Bone Lake, Washington County, Minnesota in 2020

**Prepared for:**  
Comfort Lake/Forest Lake  
Watershed District  
Forest Lake, Minnesota

**Prepared by:**  
Steve McComas  
Jo Stuckert  
Connor McComas  
Blue Water Science

**December 2, 2020**

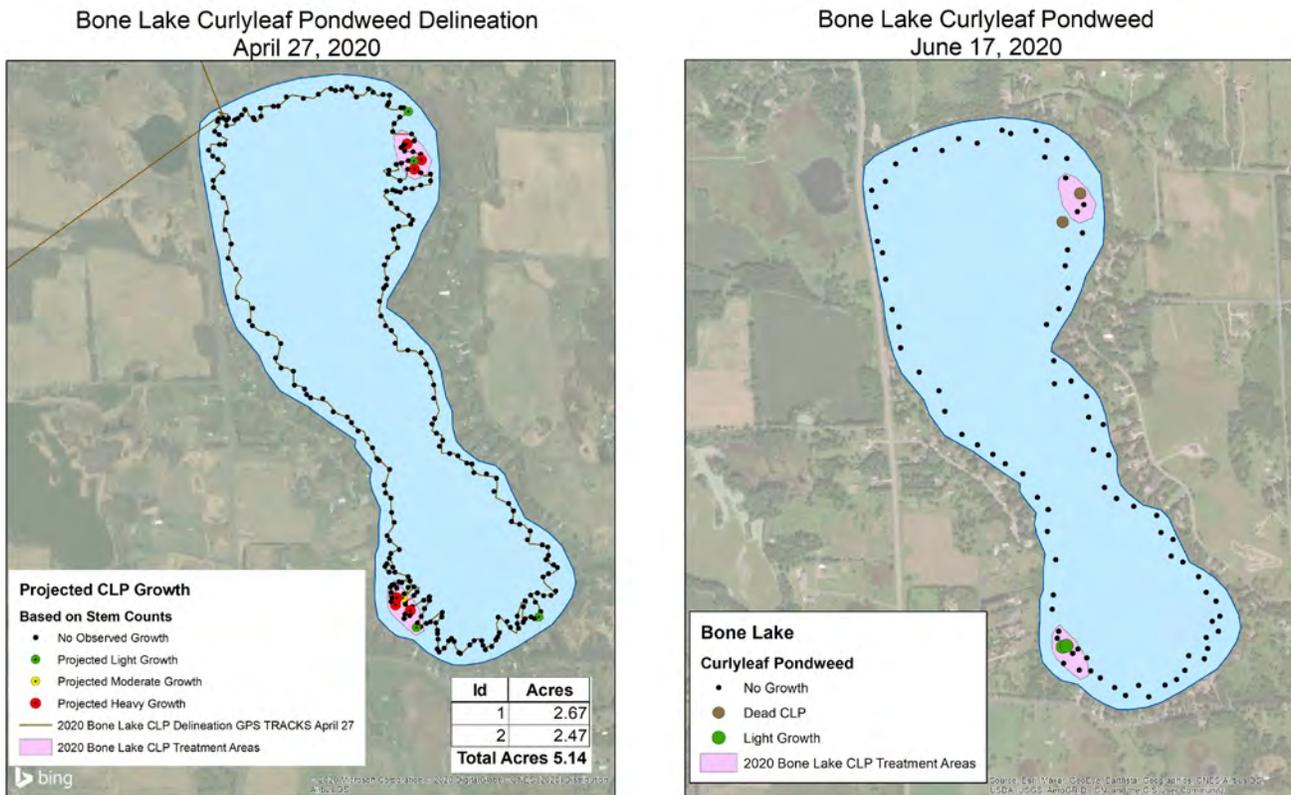
A CLP assessment was conducted on June 17, 2020, which was the time period of peak CLP growth in area lakes. CLP control in the treatment area was good (Figure S1).

Figure S1. [left] CLP was found at 11 out of 249 sample sites in Bone Lake on April 27, 2020. [right] CLP was found at 2 out of 80 sample sites on June 17, 2020. Key: green = light growth, yellow = moderate growth, red = heavy growth.

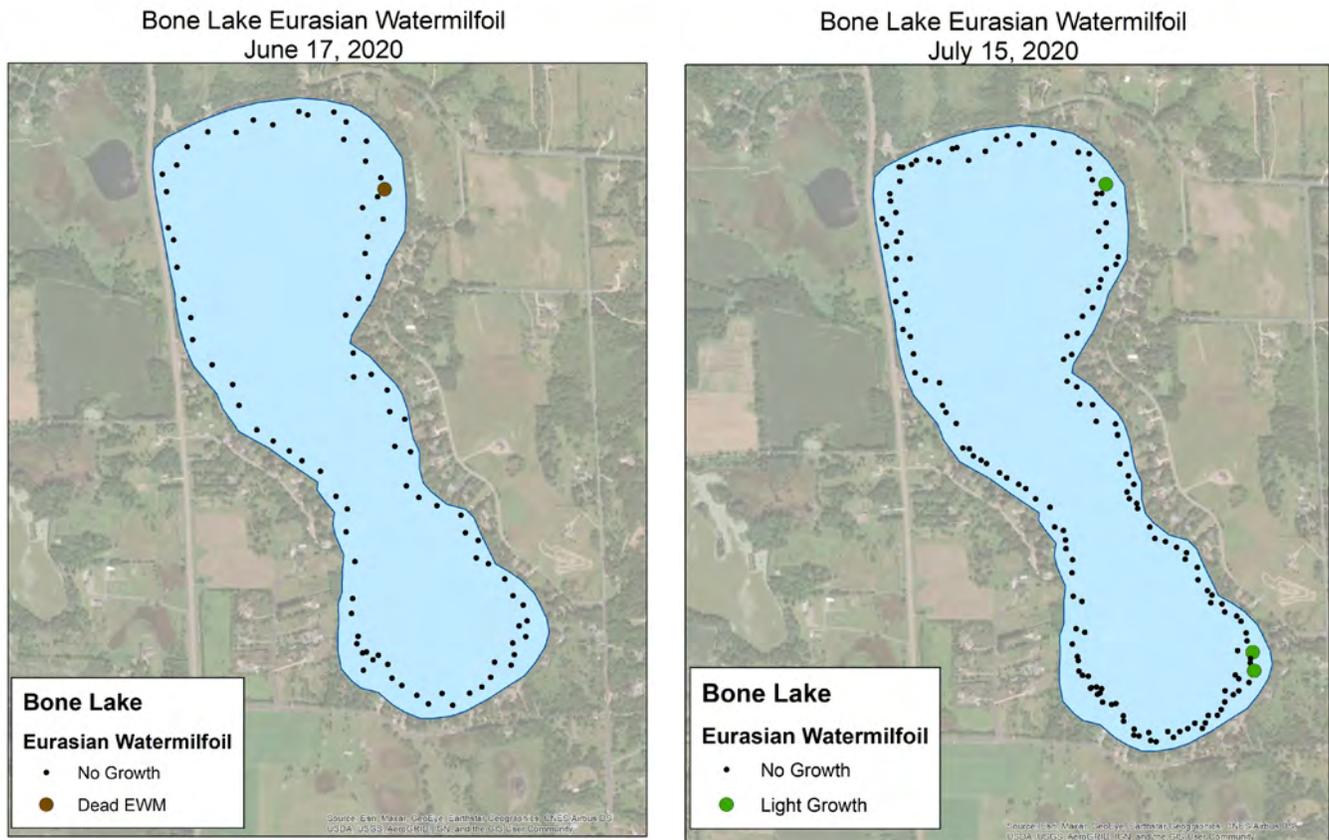
**Eurasian Watermilfoil Delineation, Treatment, and Assessment:** Eurasian watermilfoil (EWM) was verified in Bone Lake in 2006. In 2020, an initial early EWM check was conducted on April 27, 2020 with only light growth observed. Another EWM delineation was conducted on June 17, 2020 and EWM was found at 1 site out of the 80 sites sampled, but the plant sampled was brown and recorded as non-viable (Figure S2). No large areas were delineated for EWM treatment in 2020.

A follow-up assessment was conducted on July 15, 2020. Eurasian watermilfoil was found at 3 locations at light density in Bone Lake (Figure S2).

**Figure S2. [top-left] EWM coverage for Bone Lake on June 17, 2020. [top-right] EWM delineation for Bone Lake on July 15, 2020.**

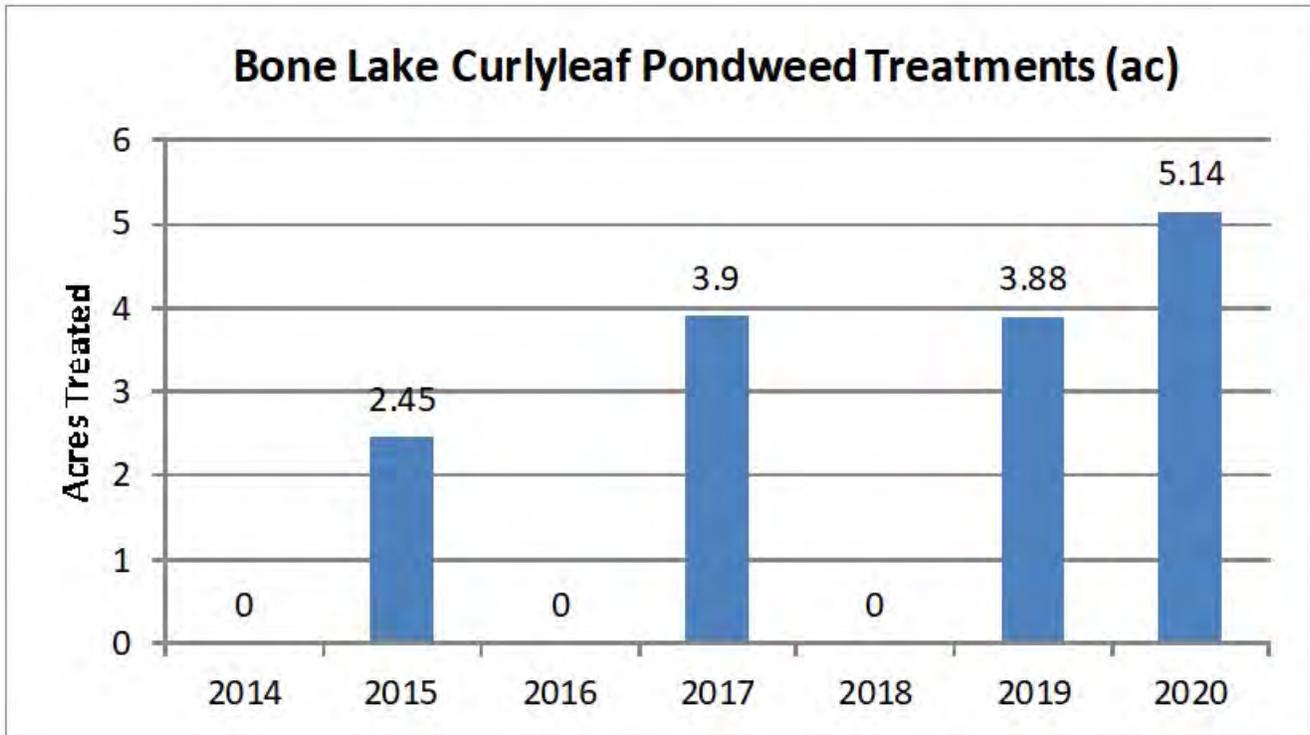
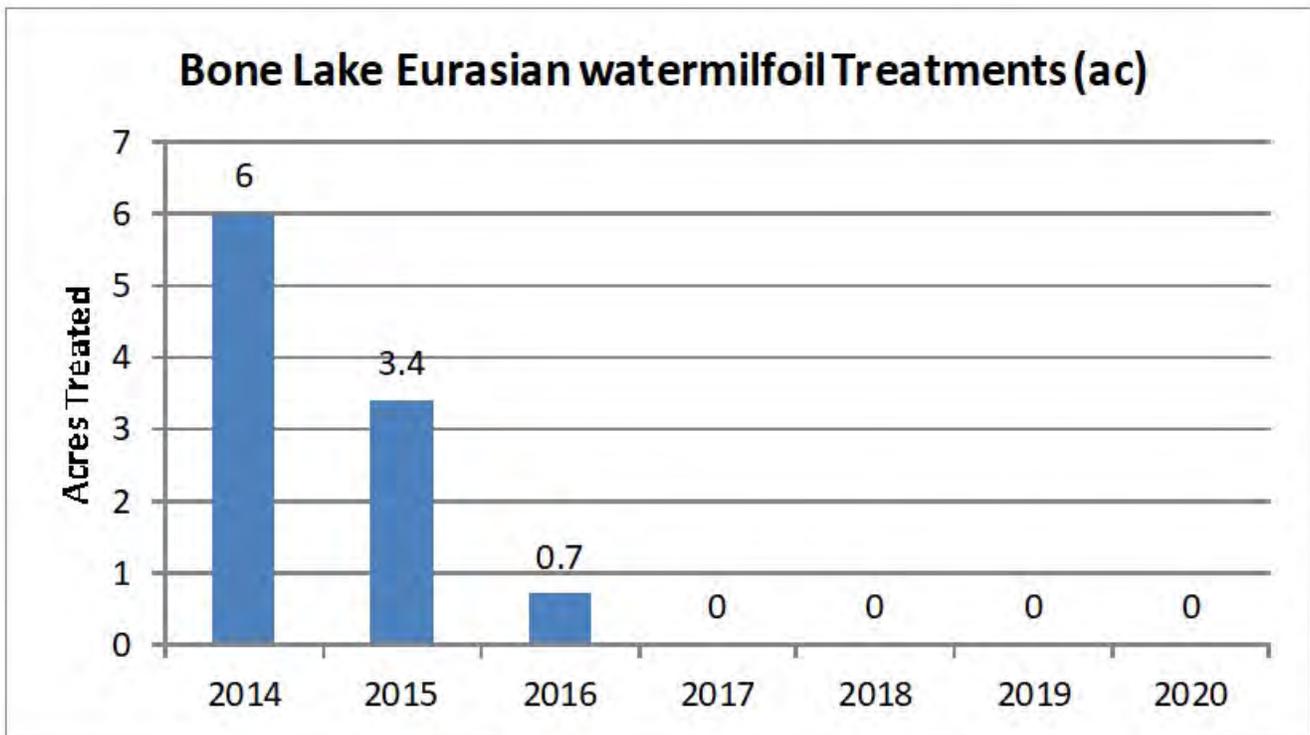
**Summary of CLP and EWM Bone Lake Treatments:** CLP has been treated in 4 out of the last 7 years including the last 2 years. EWM has been treated in 3 out of the last 7 years. However, no EWM has been treated in the last 4 years (Figure S3).

Figure S3. Summary of CLP and EWM treatment acreage for 2014-2020.

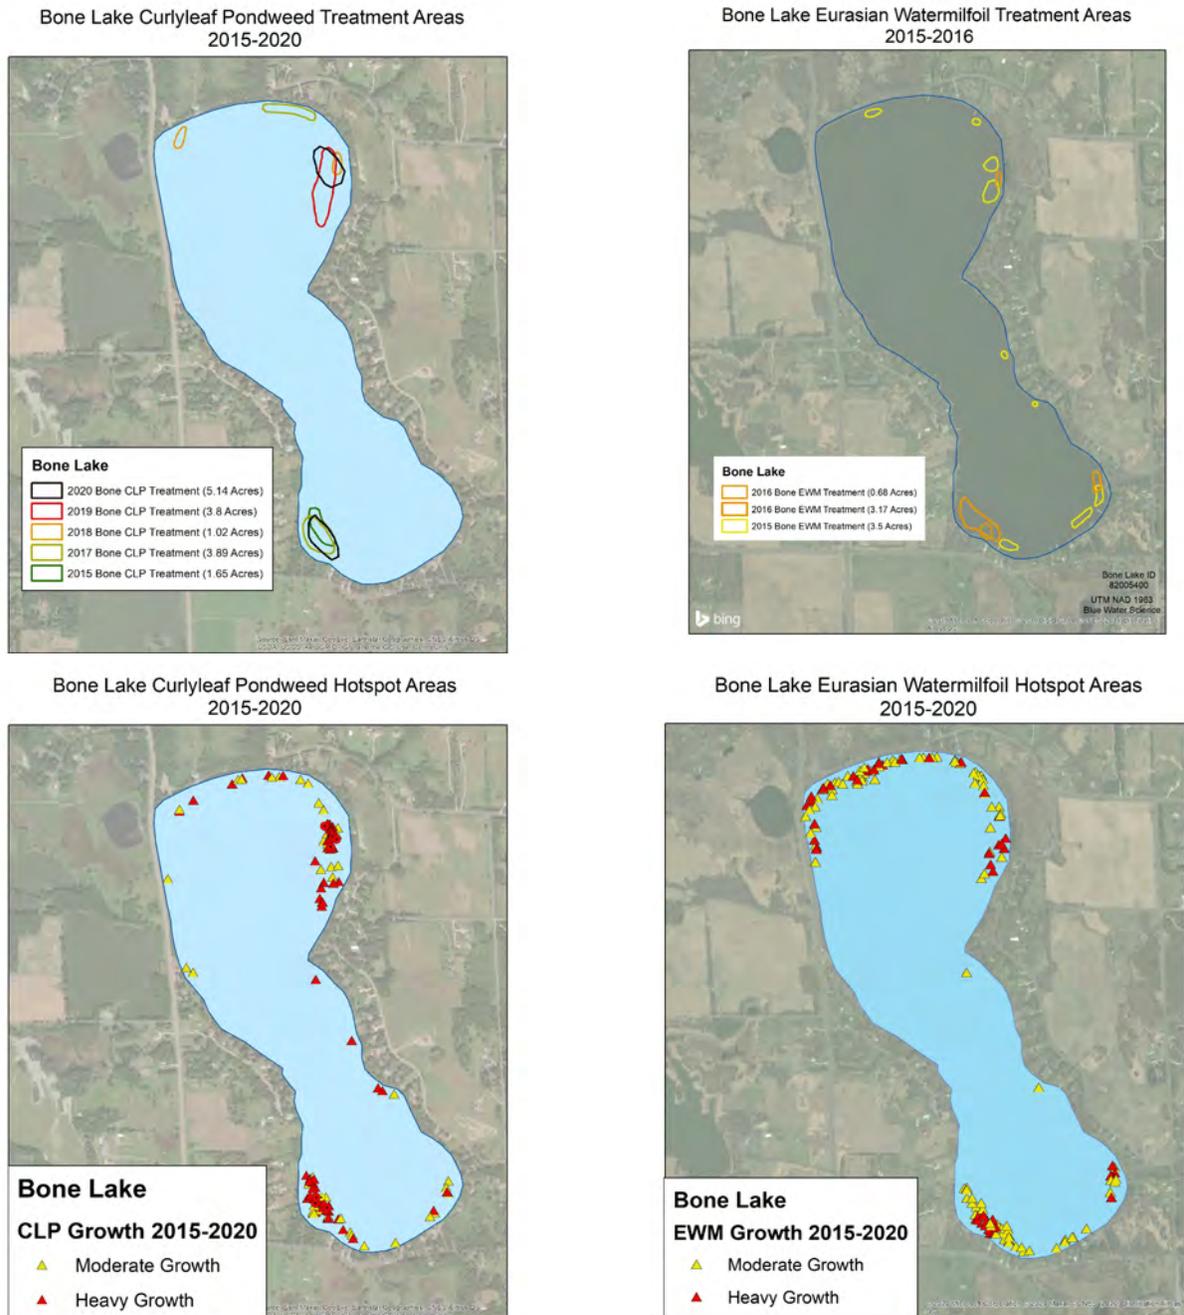
**Curlyleaf and Milfoil Treatments from 2015-2020:** A summary of CLP and EWM treatments from 2015 through 2020 is shown in Figure S4. CLP growth has been variable for the last couple of years. Lake ice, snow cover, and even cloudy days can limit curlyleaf growth. EWM treatment areas have decreased since 2014, but EWM is still present in nearshore areas in Bone Lake.

A hotspot map of sites of EWM moderate and heavy growth for 2015 through 2020 is shown in Figure S3. In the last 5 years EWM growth has been most evident in the northern and southern ends of Bone Lake where growing conditions are conducive to heavy plant growth. EWM has typically grown to a water depth of 6 feet or less.

**Figure S4.** [top-left] Bone Lake CLP treatment map 2015-2020. [top-right] Bone Lake EWM treatment map 2015-2016. [bottom-left] Hotspot map of CLP growth over the years of 2015-2020 placed on a single map. [right] Hotspot map of EWM growth over the years of 2015-2020 placed on a single map  
Key: yellow = moderate growth, and red = heavy growth.

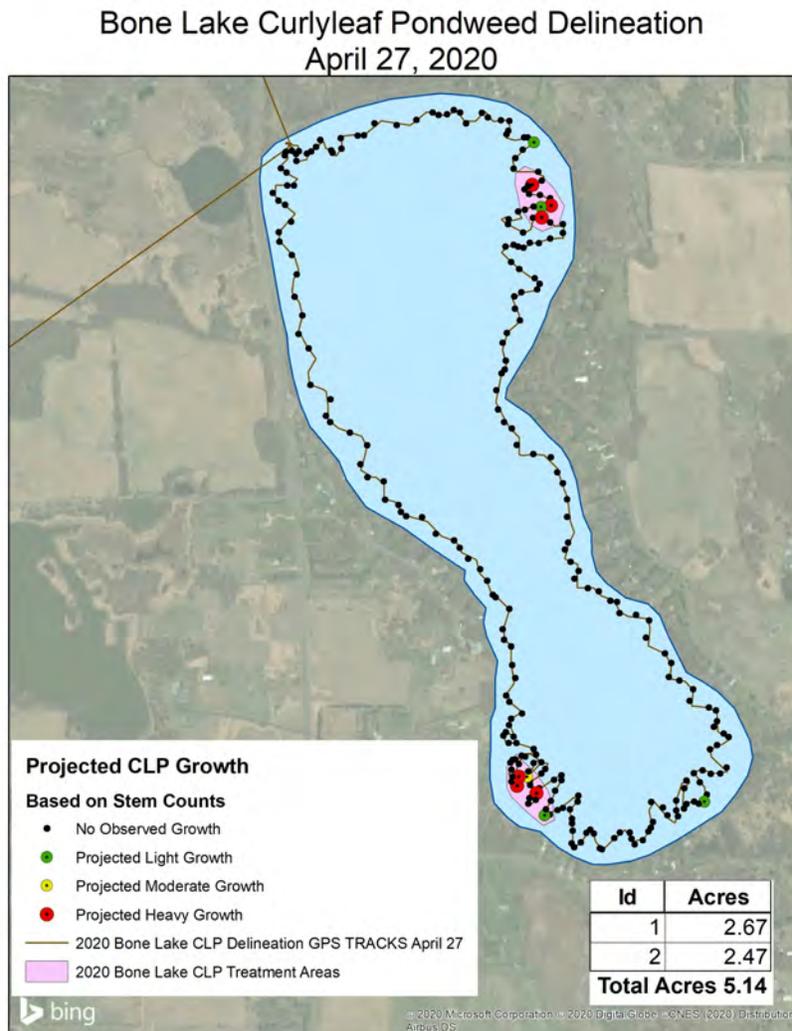
Results of the delineation conducted on April 27, 2020 found CLP present at 11 sample sites. A total of 249 sites were sampled on April 27, 2020. Two areas were delineated for CLP treatment (Figure 3). A CLP treatment of 5.14 acres was conducted May 12, 2020.

**Figure 3. CLP coverage for Bone Lake on April 27, 2020.**

**Key: green dots = light growth, yellow dots = moderate growth, red dots = heavy growth, black dots = no growth, and pink shading = treatment area.**

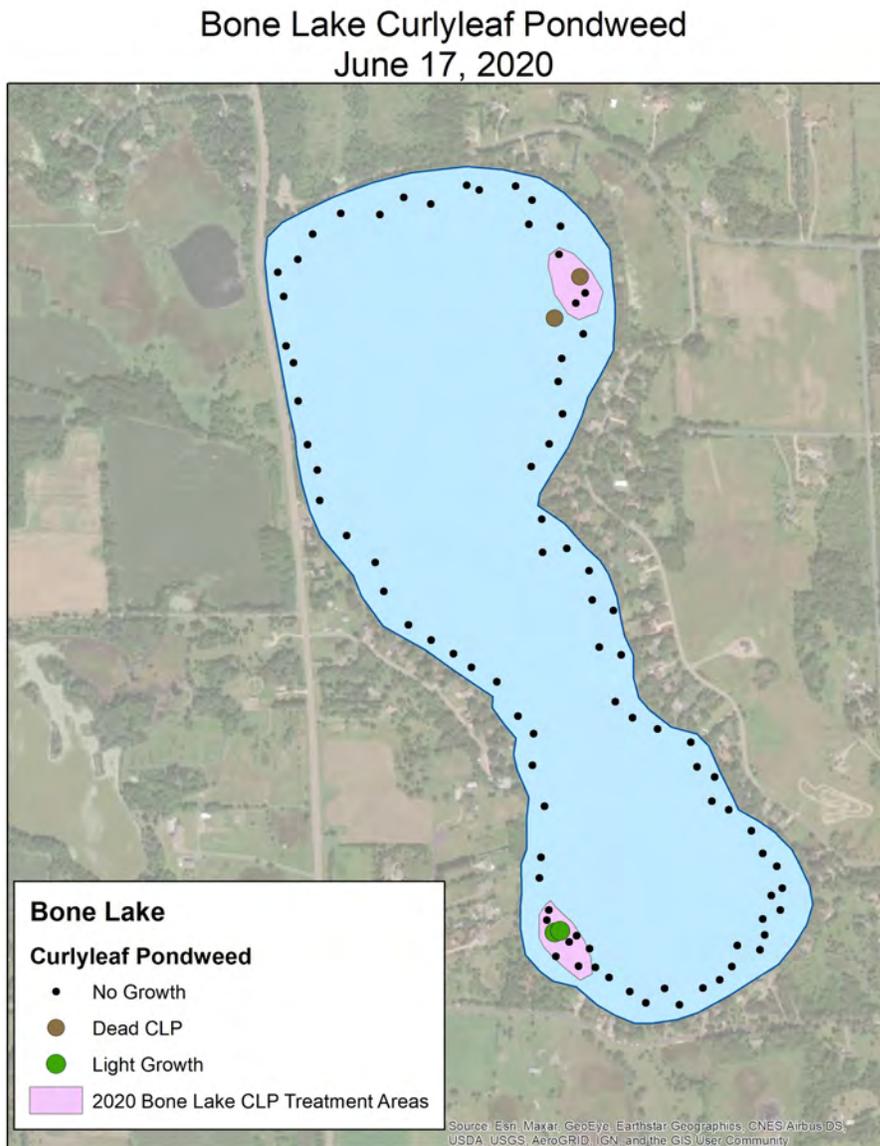
Results of an assessment conducted on June 17, 2020 found that CLP was present at 2 out of 80 locations. The CLP treatment on May 12, 2020 of 5.14 acres had good control results. Very little CLP was present in lake areas outside of the treatment polygons (Figure 4).

**Figure 4. CLP was found at 2 out of 80 sample sites in Bone Lake on June 17, 2020. Key: green dot = light growth, brown dot = dead CLP, black dot = no curlyleaf growth, and pink shaded areas = 2020 CLP treatment areas.**

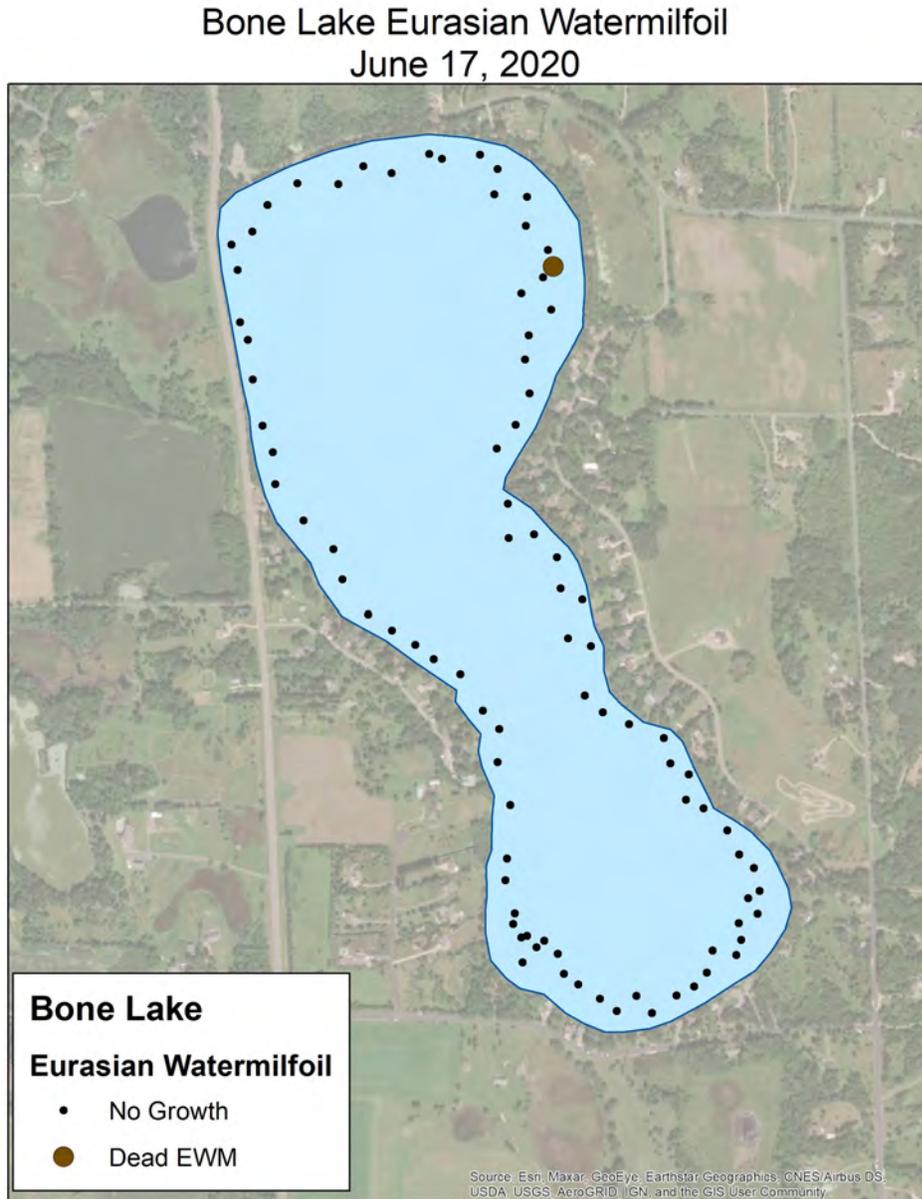
An EWM delineation was conducted on June 17, 2020. EWM was found at 1 sites out of 80 sites sampled but the plant was determined to non-viable (Figure 5). No areas were delineated for treatment (Figure 5).

**Figure 5. EWM coverage for Bone Lake on June 17, 2020.**  
**Key: black = no growth and brown = dead growth.**

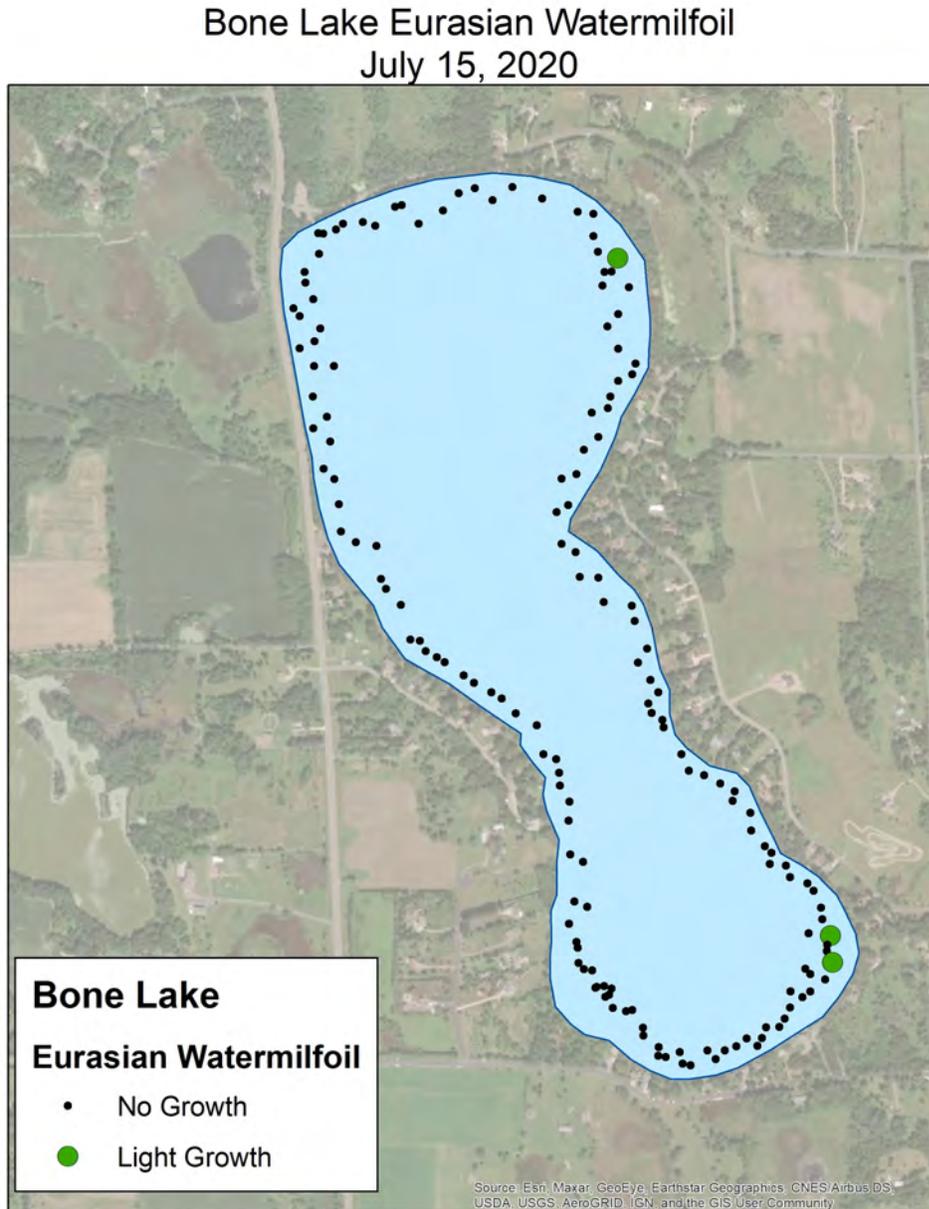
No large scale treatment (greater than 1 acre) of EWM was conducted in 2020. EWM growth was assessed on July 15, 2020 and 3 occurrences of EWM were observed in Bone Lake (Figure 6). The cause of the the EWM distribution in 2020 was undetermined.

**Figure 6. EWM coverage for Bone Lake on July 15, 2020.**  
**Key: green = light growth and black = no EWM growth.**

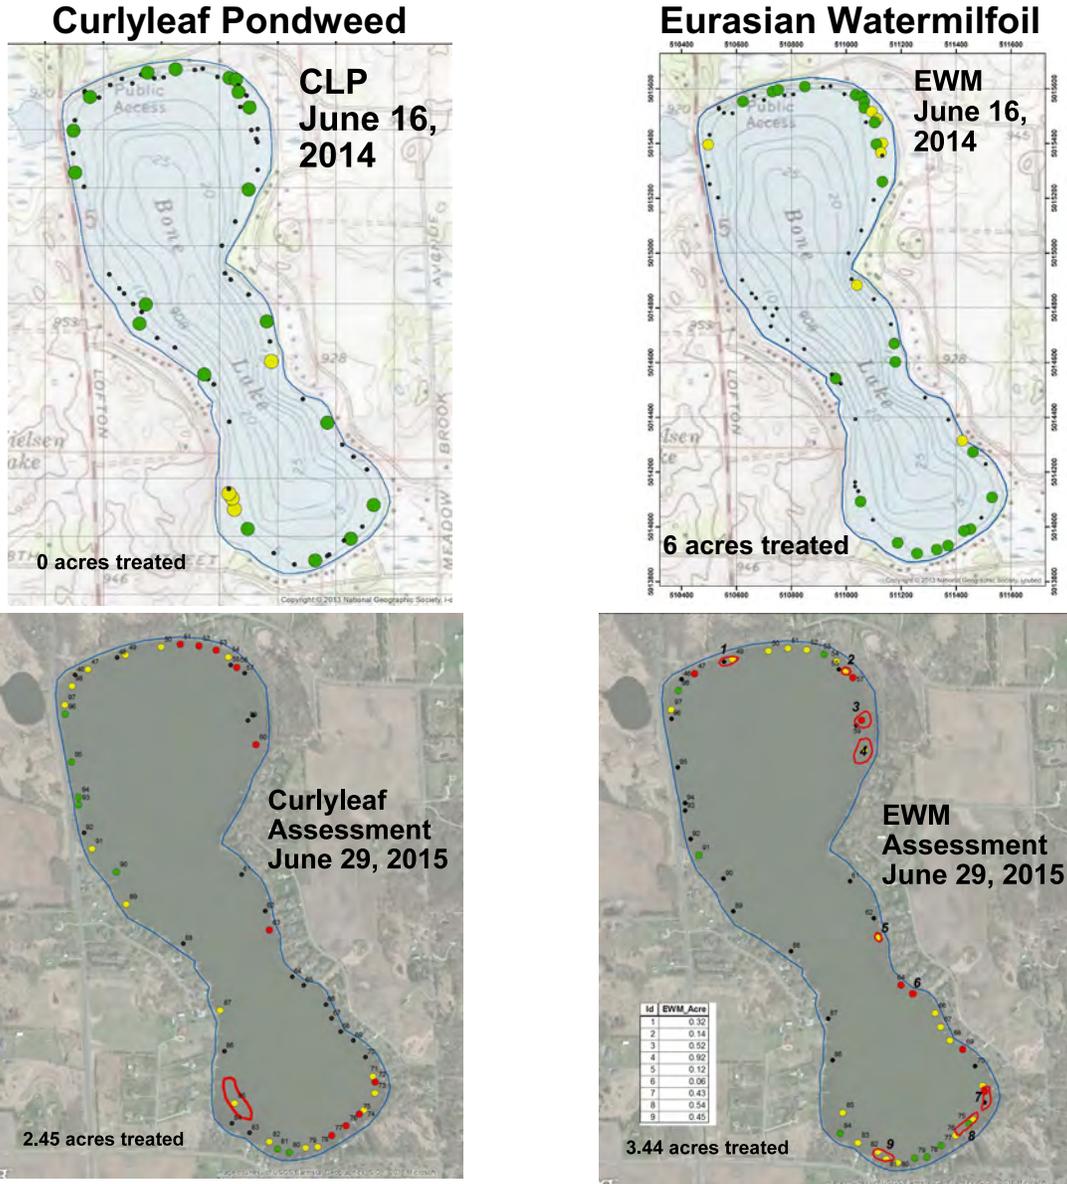
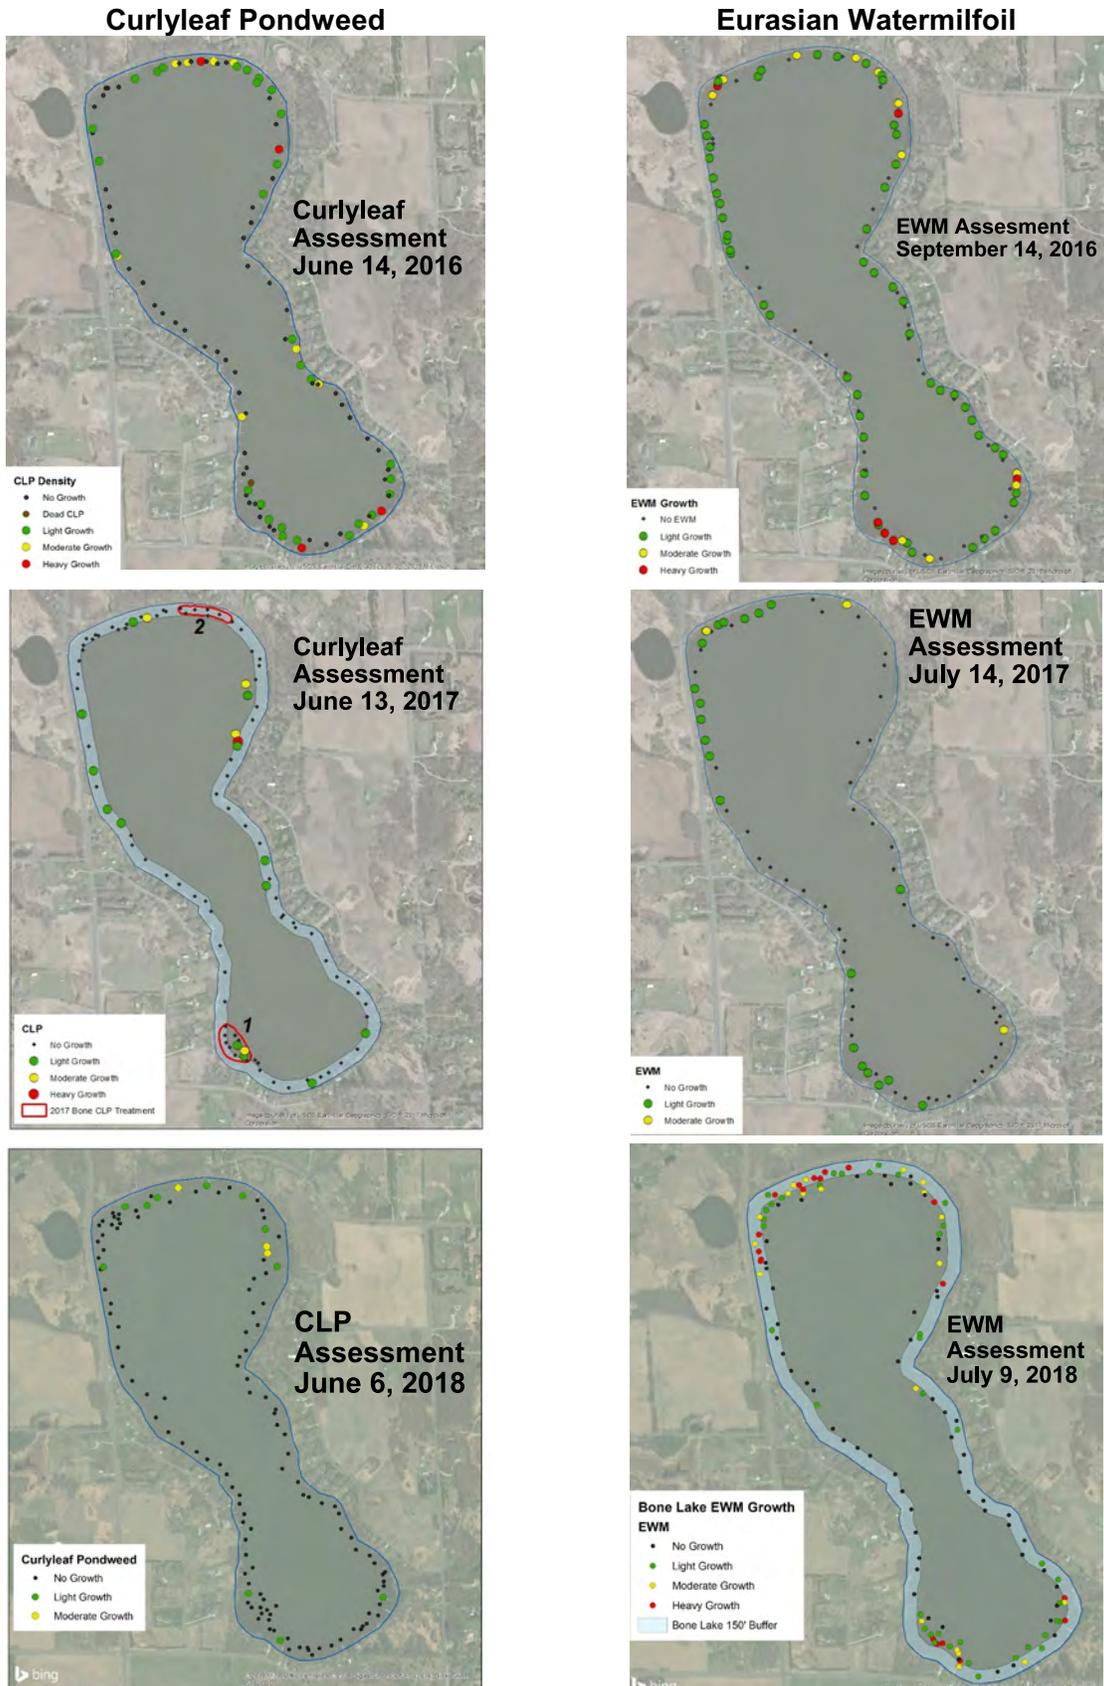
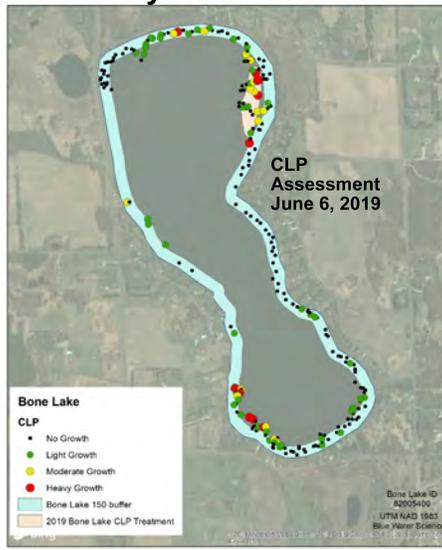
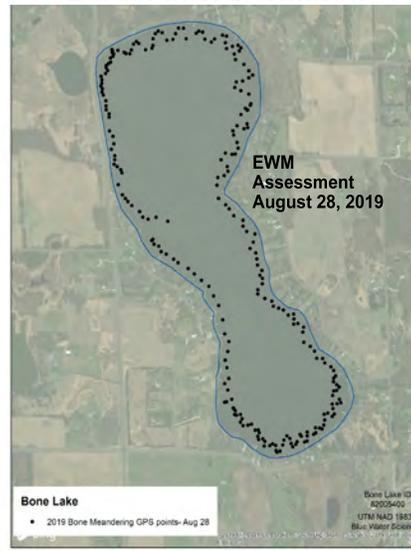
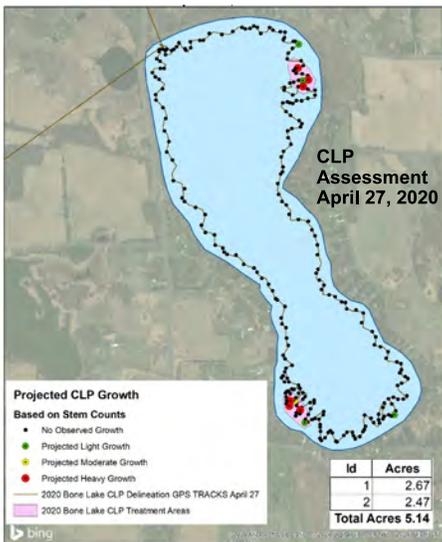
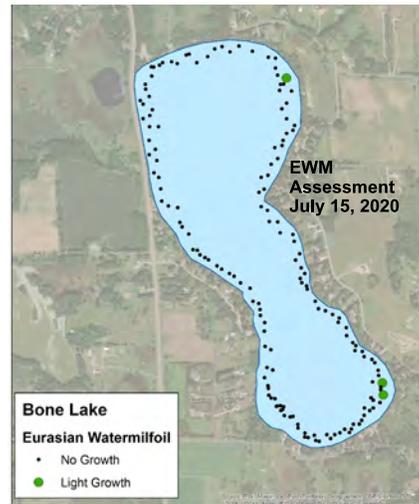
Figure 7. CLP and EWM maps for 2014 through 2020 (continued on the next 2 pages).

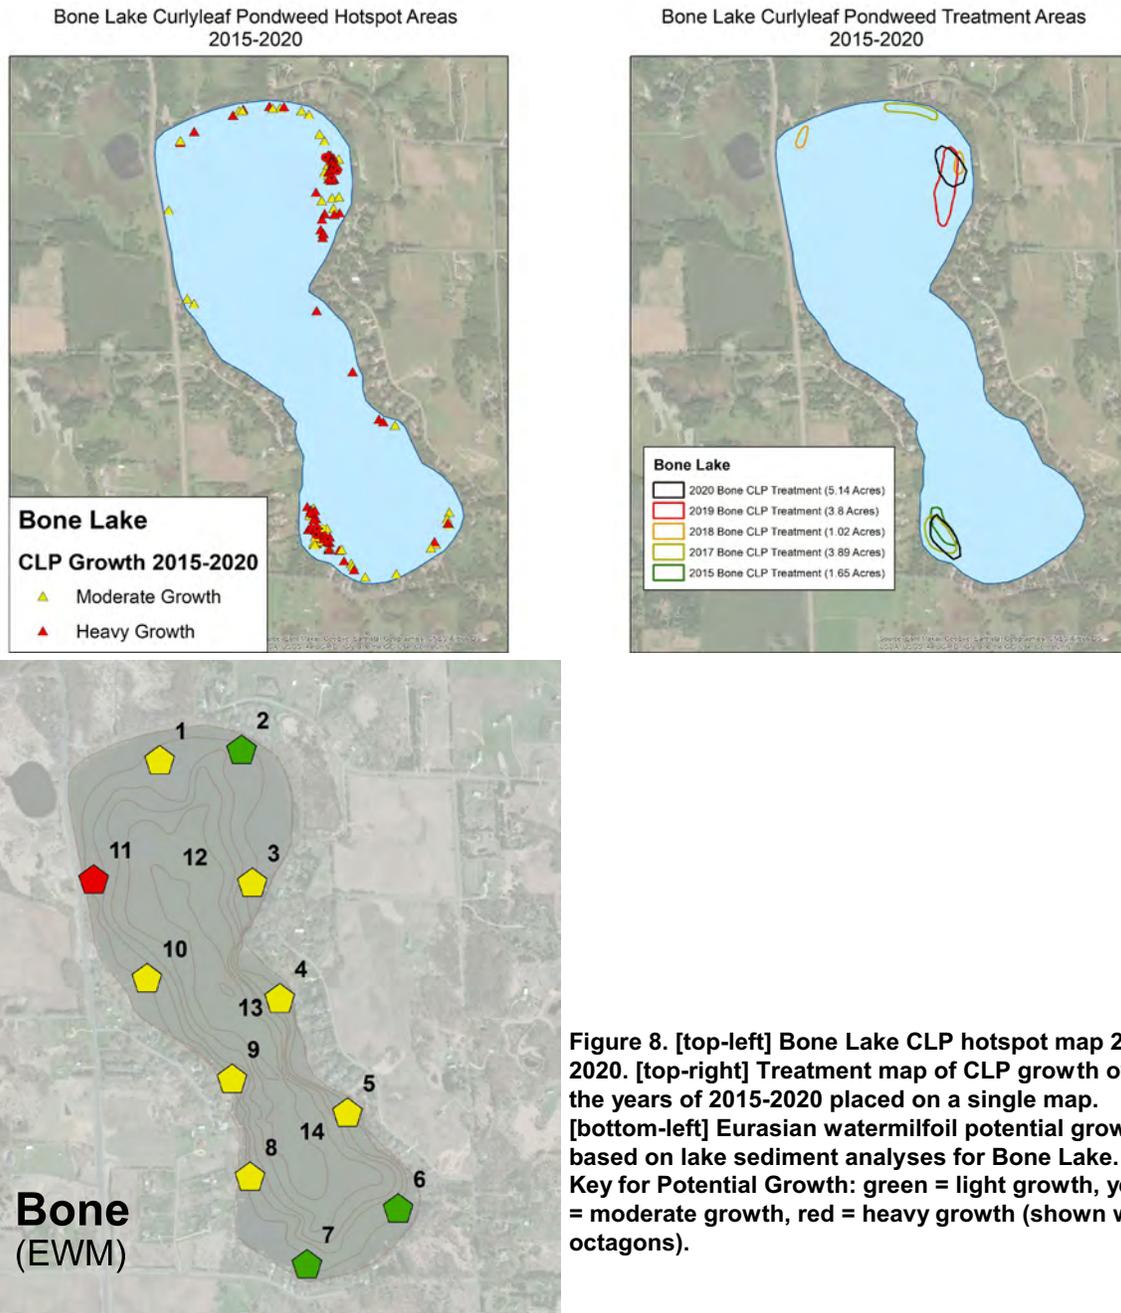
A summary of CLP treatments from 2015 through 2020 is shown in Figure 8. CLP growth has been variable for the last couple of years. Lake ice, snow cover, and even cloudy days can limit curlyleaf growth. A hotspot map of sites of CLP moderate and heavy growth for 2015 through 2020 is shown in Figure 8. In the last 5 years CLP growth has been most evident in the northern and southern ends of Bone Lake where growing conditions are conducive to heavy plant growth. CLP has typically grown to a water depth of 6 feet or less.

Figure 8. [top-left] Bone Lake CLP hotspot map 2015-2020. [top-right] Treatment map of CLP growth over the years of 2015-2020 placed on a single map. [bottom-left] Eurasian watermilfoil potential growth based on lake sediment analyses for Bone Lake. Key for Potential Growth: green = light growth, yellow = moderate growth, red = heavy growth (shown with octagons).

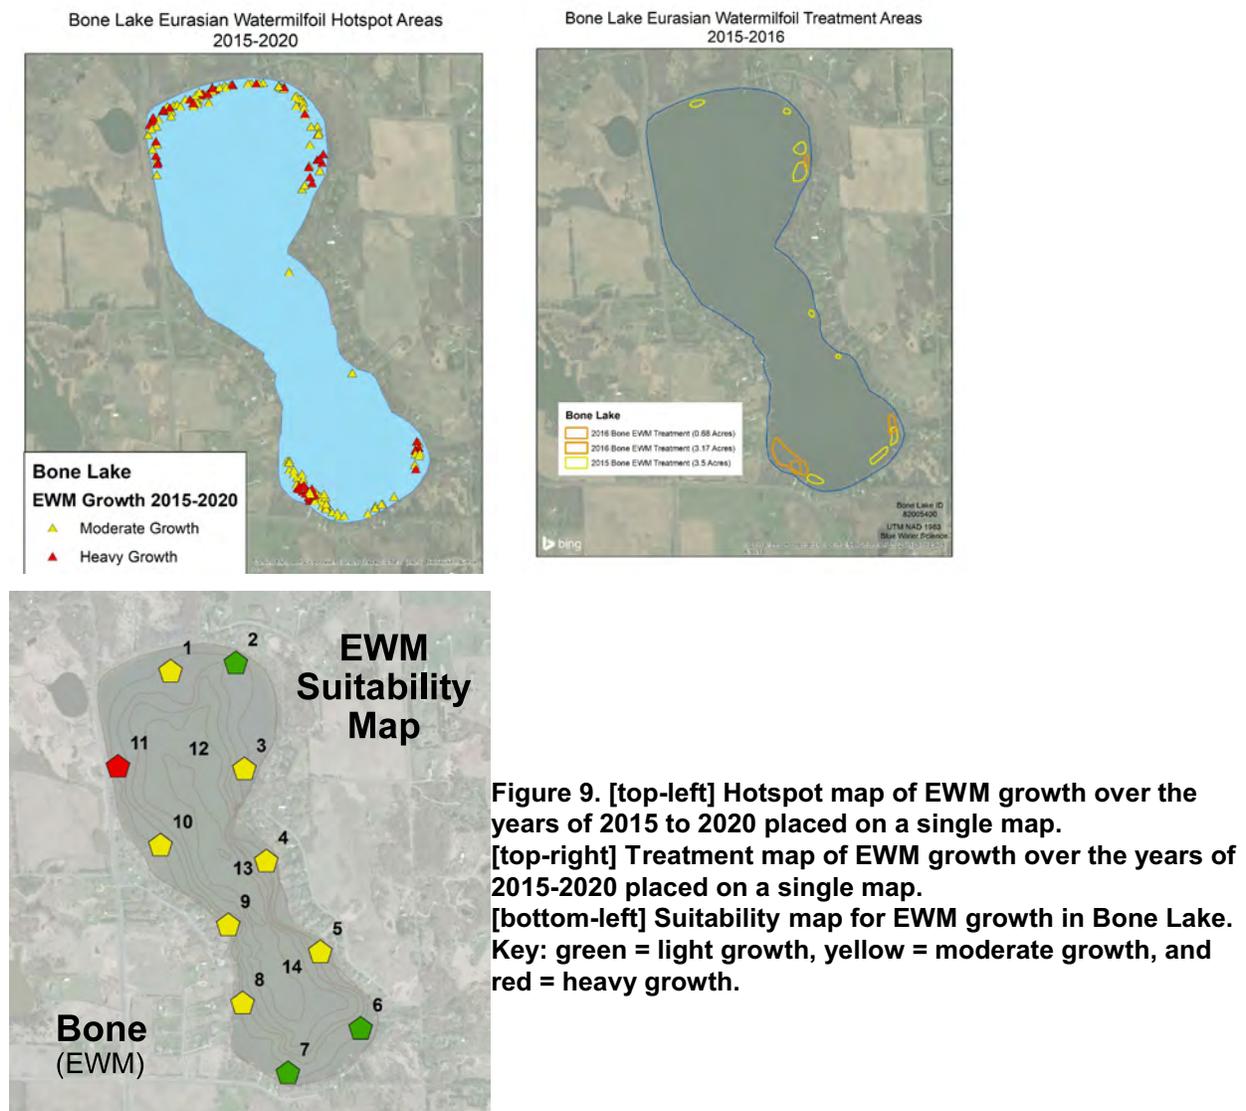
EWM has been in Bone Lake since 2006. Although control of EWM has been ongoing since 2006, EWM continued to expand around the lake. A map showing the occurrence of moderate to heavy growth of EWM in Bone Lake from 2015 through 2020 is shown in Figure 9. Some nearshore areas in the north and south ends of Bone Lake support consistently significant growth. These “hotspot” areas are shown in Figure 9.

Heavy milfoil growth has been correlated with high sediment nitrogen conditions and from a soils survey conducted in 2014, Bone Lake has at least 1 area with high lake sediment nitrogen conditions. The potential for long term milfoil growth, based on lake sediment sampling, predicts mostly moderate growth with the potential for annual heavy growth limited to the northwest side of Bone Lake.

For Bone Lake, it is estimated the plants have the potential to grow down to at least 7 feet of water depth based on low Secchi transparencies, restricting milfoil growth to nearshore areas. Results of the sediment survey indicate growth would be primarily light on a long term basis.
