Curlyleaf Pondweed and Eurasian Watermilfoil Delineation, Treatment, and Assessment for Bone Lake, Washington County, Minnesota in 2022

Prepared for:
**Comfort Lake/Forest Lake
Watershed District
Forest Lake, Minnesota**

December 5, 2022

Prepared by:
**Steve McComas
Jo Stuckert
Connor McComas
Blue Water Science**

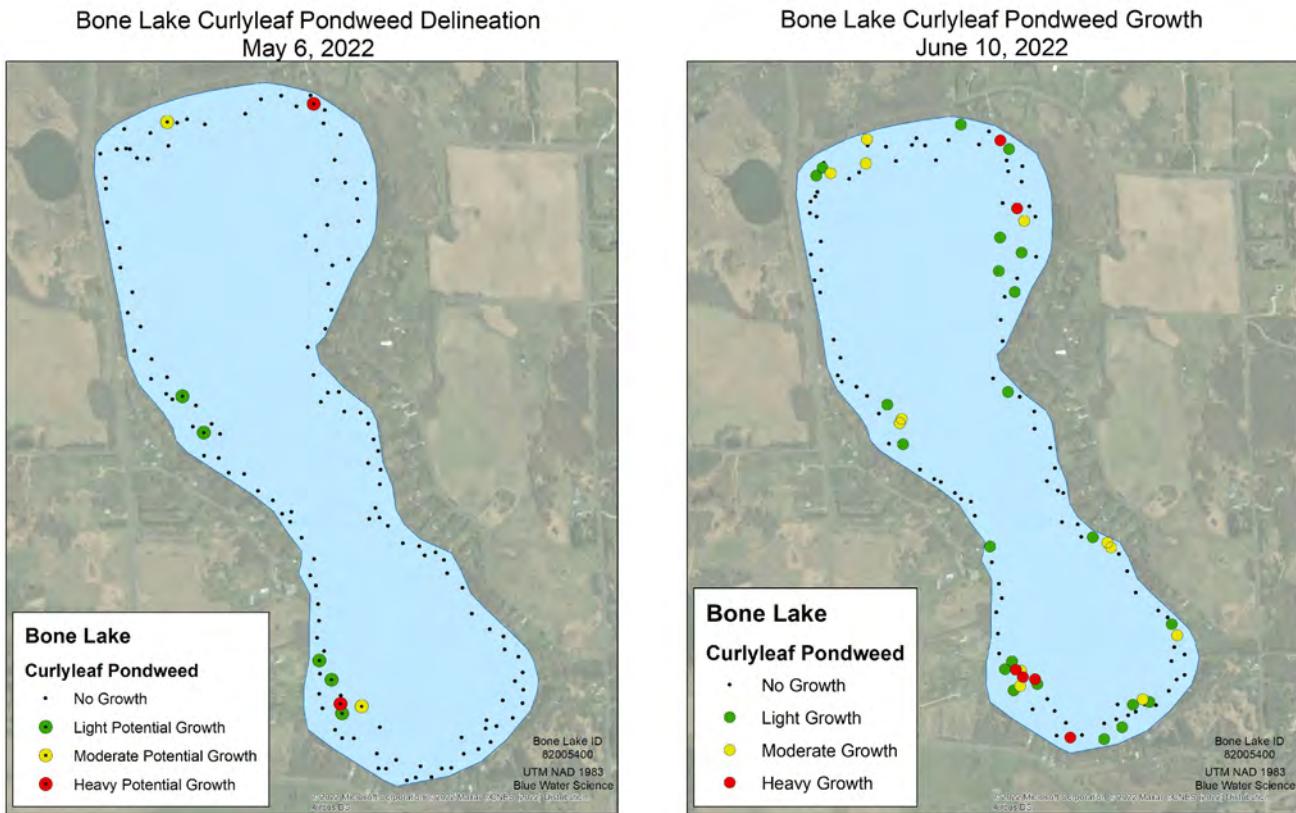
Figure S1. [left] CLP was found at 9 out of 138 sample sites in Bone Lake on May 6, 2022.

[right] CLP was found at 40 out of 132 sample sites on June 10, 2022.

Key: green = light growth potential, yellow = moderate growth potential, red = heavy growth potential.

A CLP assessment was conducted on June 10, 2022, which was the time period of peak CLP growth in area lakes. Curlyleaf was sampled at 40 sites on June 10, 2022 (Figure S1). One area in the southwest corner of the lake had several patches of heavy CLP growth. However, native plant abundance was also heavy in this area. Native plant growth was often more abundant than CLP.

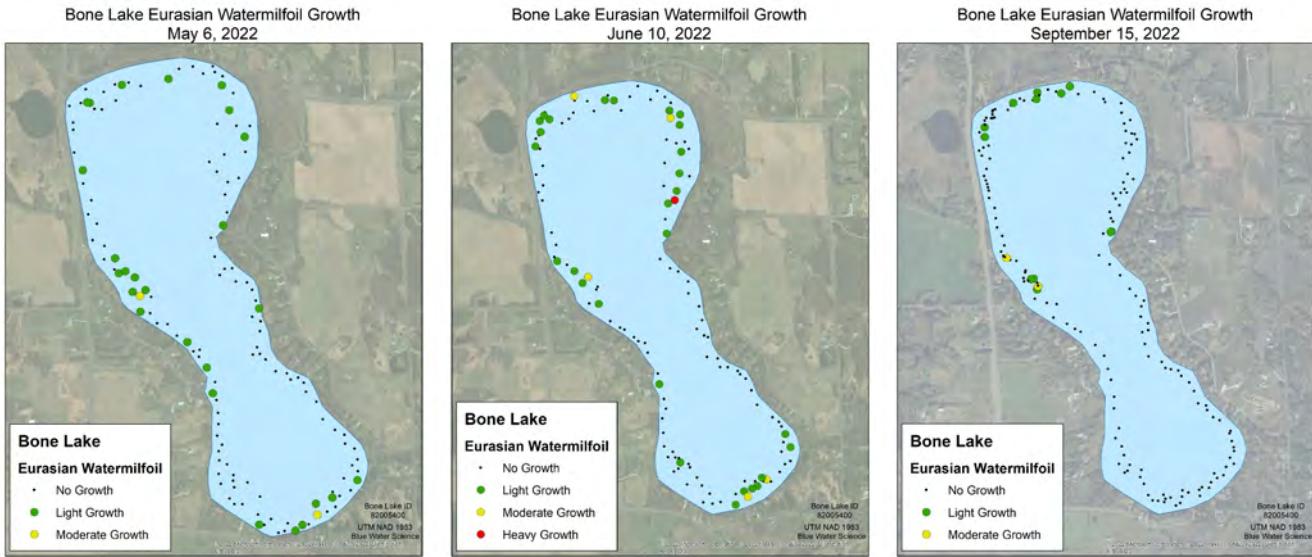
Figure S2. [left] EWM coverage for Bone Lake on May 6, 2022.
[middle] EWM coverage for Bone Lake on June 10, 2022.
[right] EWM coverage for Bone Lake on September 15, 2022.

Eurasian Watermilfoil Delineation, Treatment, and Assessment: Eurasian watermilfoil (EWM) was verified in Bone Lake in 2006. In 2022, an initial early EWM meander survey was conducted on May 6, 2022, and EWM was found at 28 sites out of 138 sites sampled with only light to moderate growth observed. Another EWM delineation meandering survey was conducted on June 10, 2022 and EWM was found at 34 sites out of the 132 sites sampled, with mostly light EWM growth observed (Figure S2). No areas were delineated for EWM treatment in 2022.

A follow-up assessment meander survey was conducted on September 15, 2022. Eurasian watermilfoil had decreased in distribution and was found at 14 sites out of 164 sample locations. EWM density was mostly light in Bone Lake in 2022 (Figure S2).

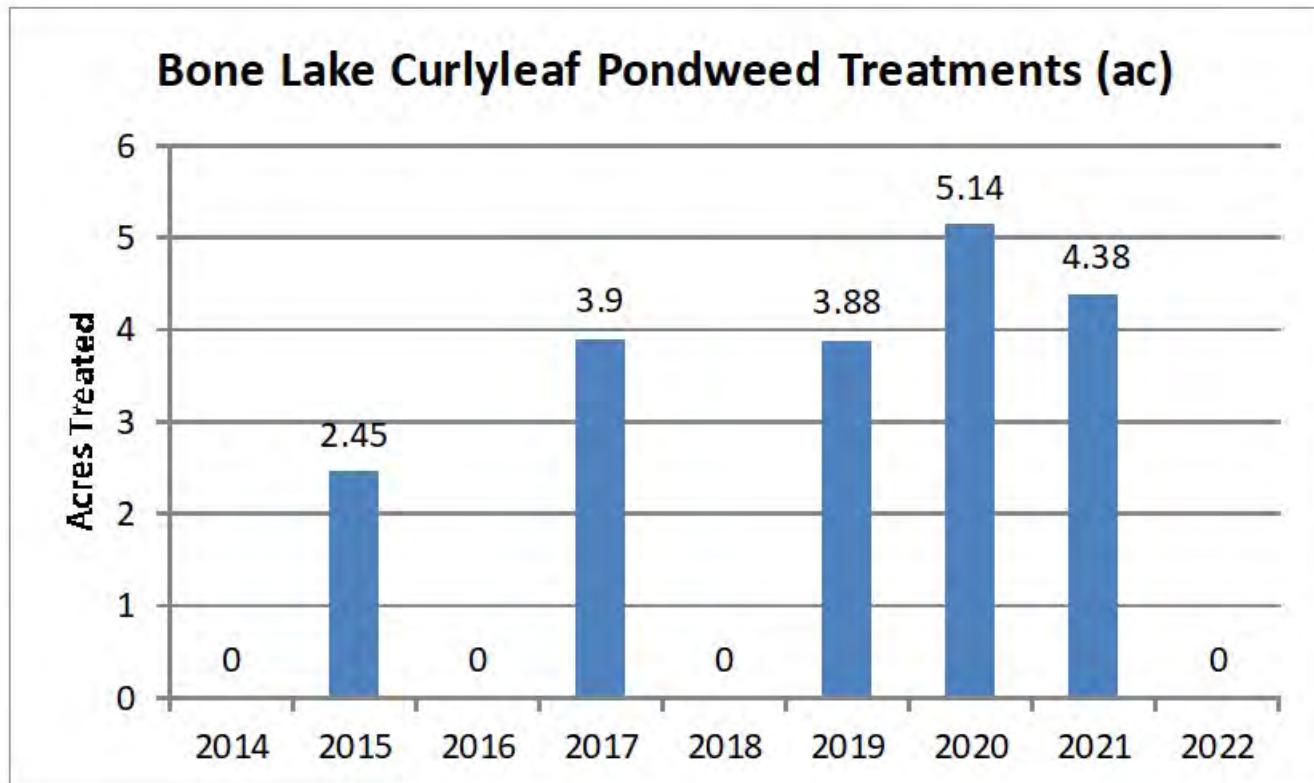
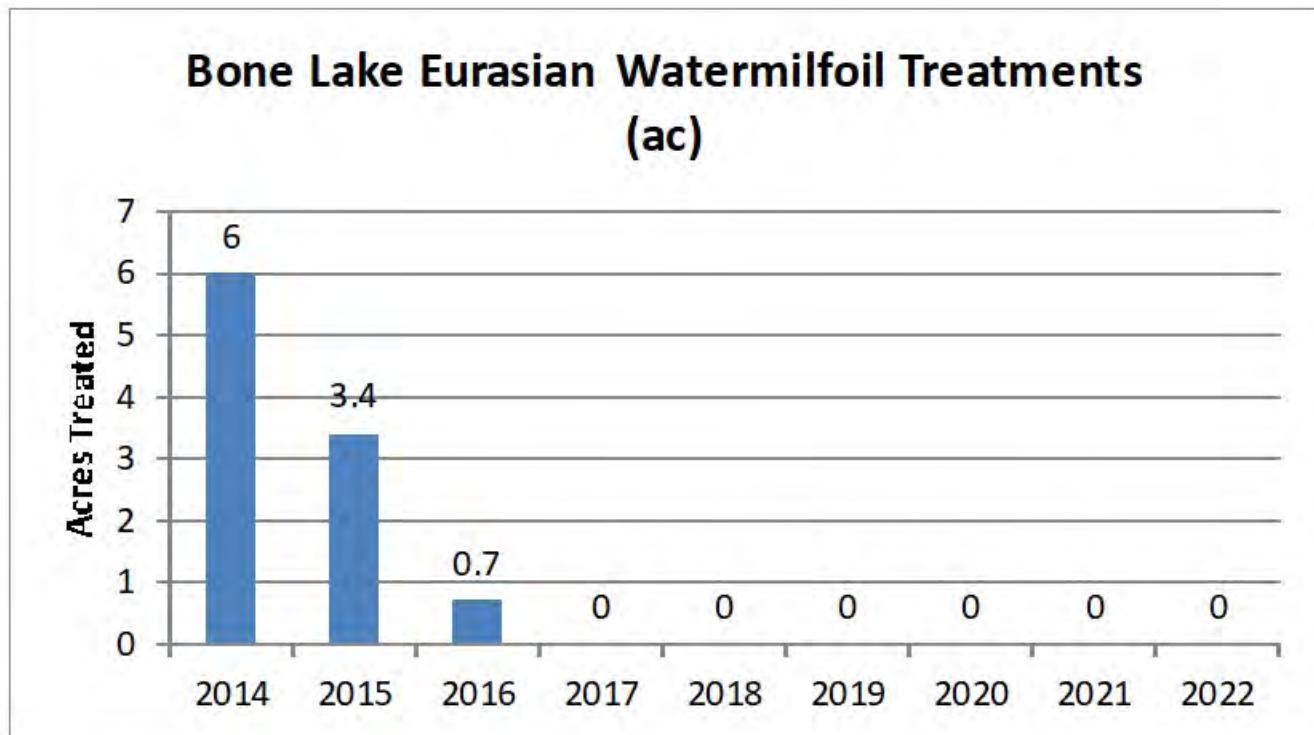
Figure S3. Summary of CLP and EWM treatment acreage for 2014-2022.

Summary of CLP and EWM Bone Lake Treatments: CLP has been treated in 5 out of the last 9 years. EWM has been treated in 3 out of the last 9 years. However, no CLP or EWM was treated in 2022 (Figure S3).

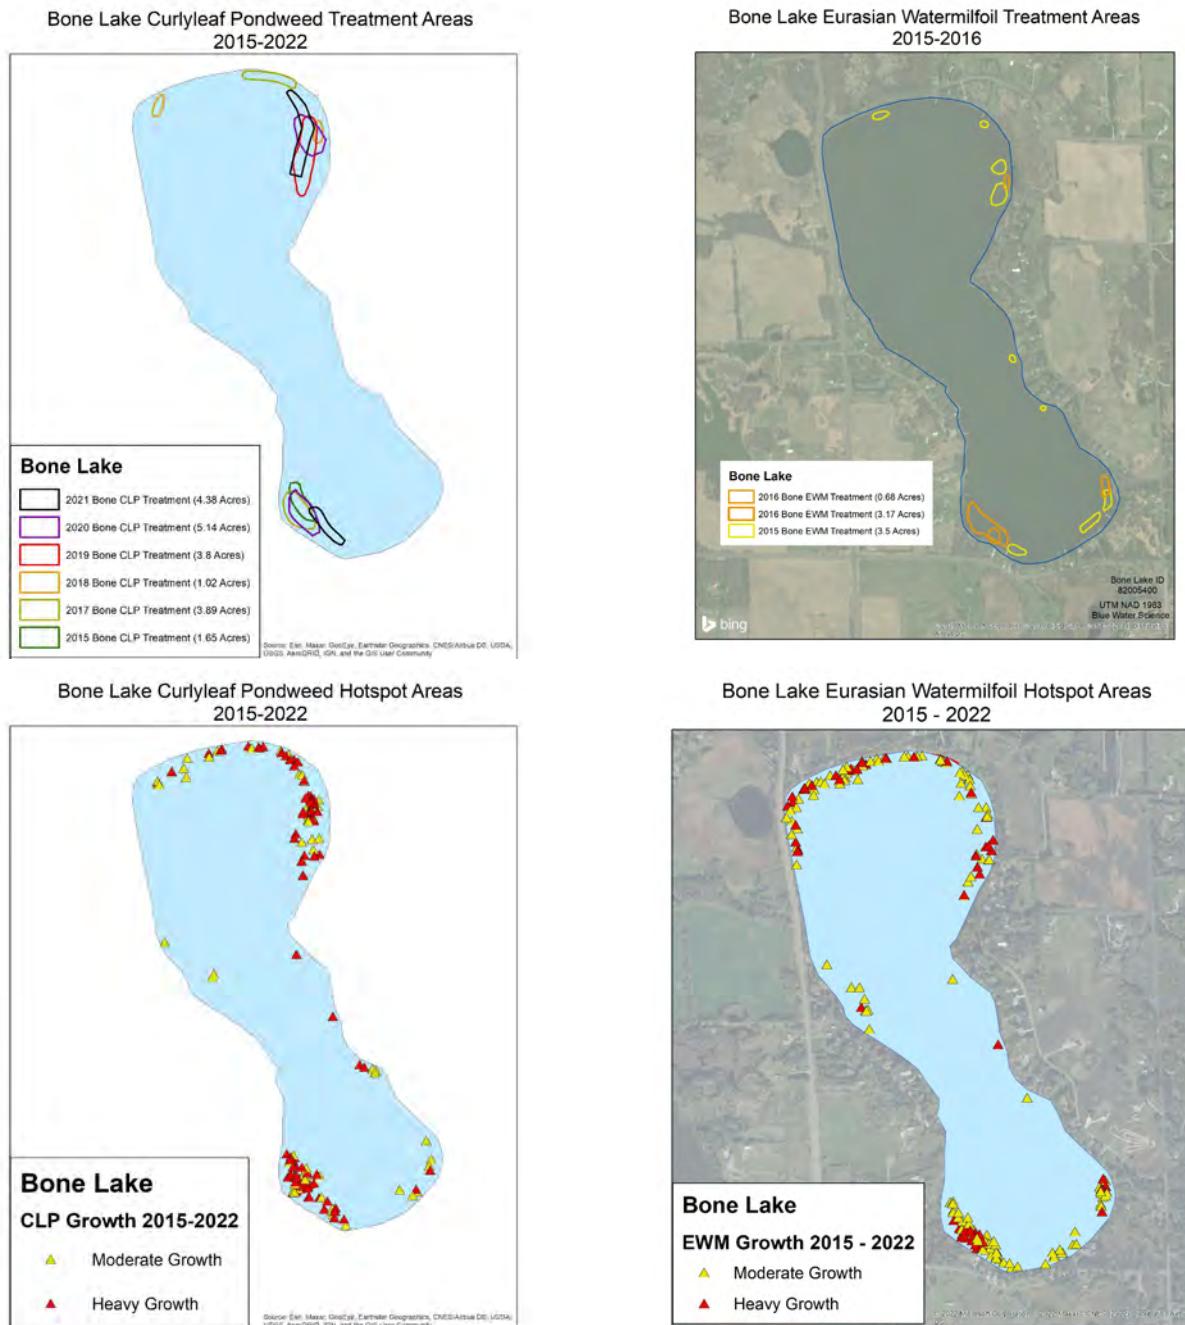
Figure S4. [top-left] Bone Lake CLP treatment map 2015-2022. [top-right] Bone Lake EWM treatment map 2015-2016. [bottom-left] Hotspot map of CLP growth over the years of 2015-2022 placed on a single map. [right] Hotspot map of EWM growth over the years of 2015-2022 placed on a single map
Key: yellow = moderate growth, and red = heavy growth.

Curlyleaf and Milfoil Treatments from 2015-2022: A summary of CLP and EWM treatments from 2015 through 2022 is shown in Figure S4. CLP growth has been variable for the last couple of years. Lake ice, snow cover, and even cloudy days can limit curlyleaf growth. EWM treatment areas have decreased since 2014, but EWM is still present in nearshore areas in Bone Lake.

A hotspot map of sites of CLP and EWM that show moderate and heavy growth for 2015 through 2022 is shown in Figure S4. In the last 5 years CLP and EWM growth has been most evident in the northern and southern ends of Bone Lake where growing conditions are conducive to heavy plant growth. CLP and EWM have typically grown to a water depth of 6 feet or less.

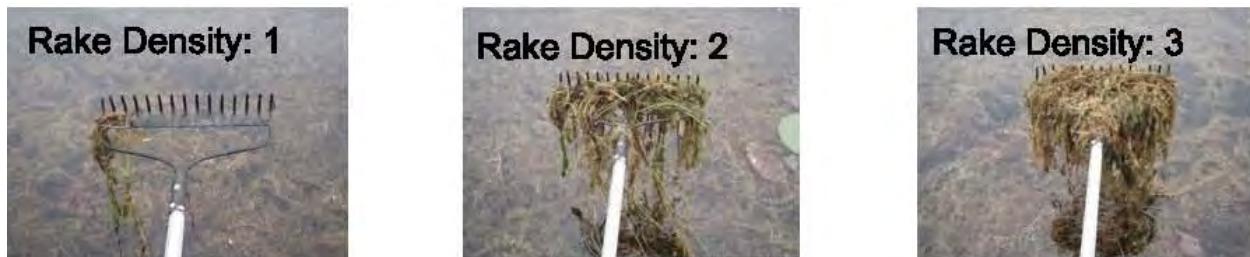
Figure 2. Aquatic plant density ratings from 1 to 3.

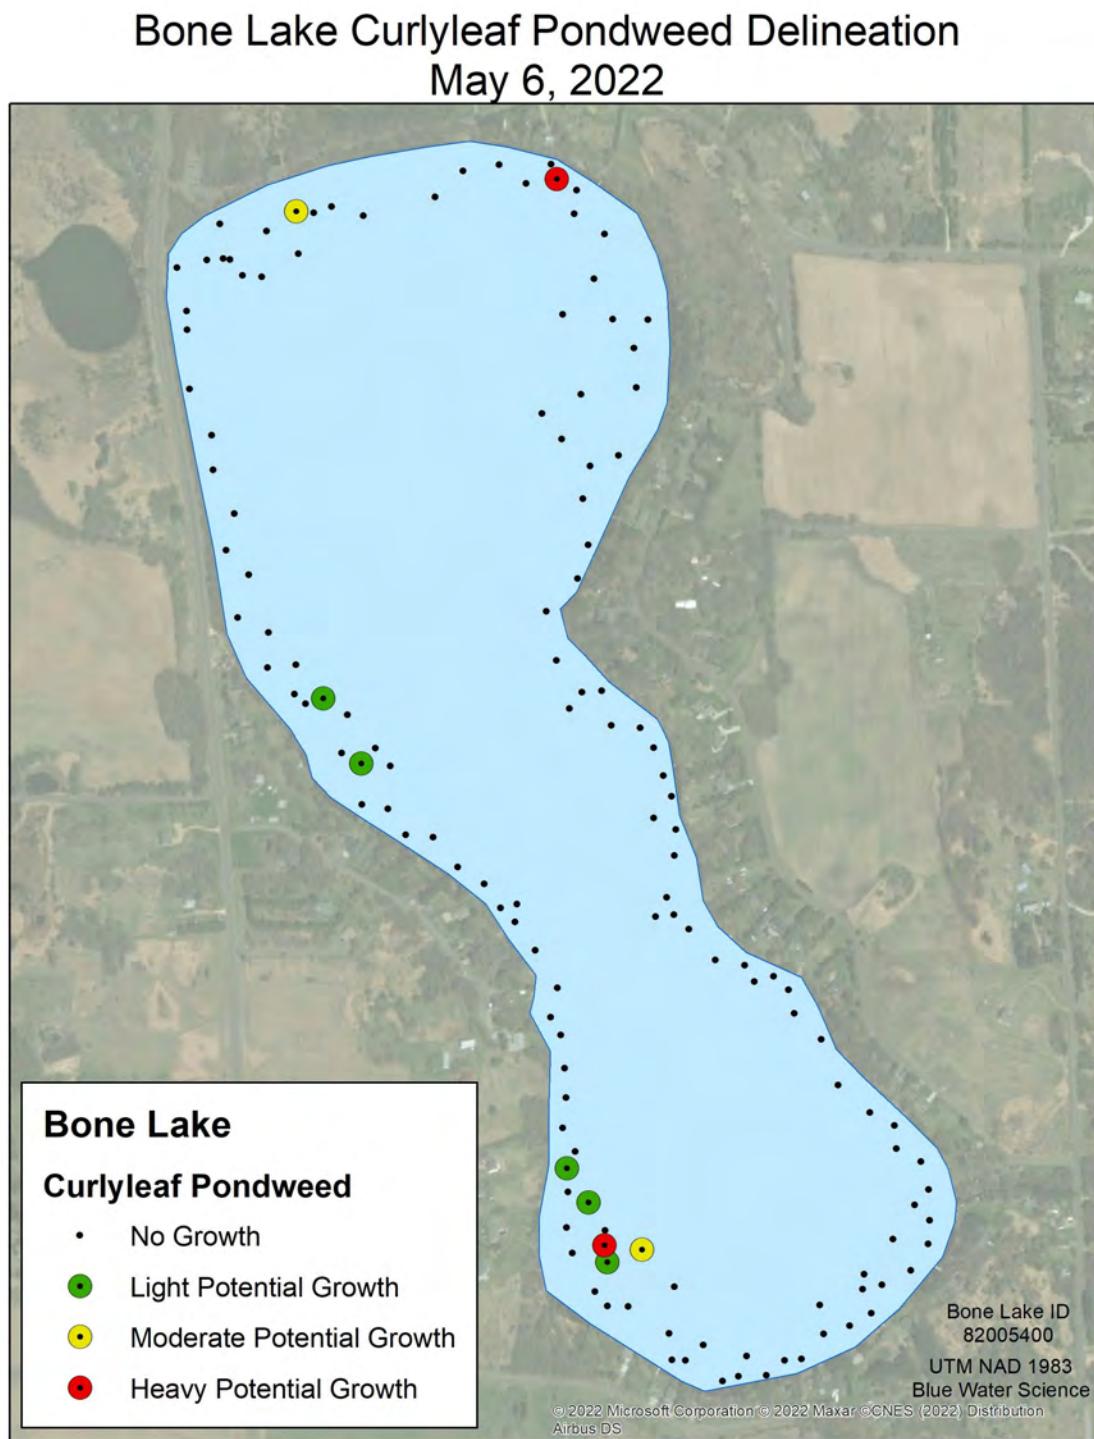
Results of the delineation conducted on May 6, 2022 found CLP present at 9 sample sites out to a total of 138 sites sampled. Curlyleaf was scattered and treatment was not recommended in 2022 (Figure 3).

Figure 3. CLP coverage for Bone Lake on May 6, 2022. Key: black dot = no growth, green dots = light growth, yellow dots = moderate growth, and red dots = heavy growth.

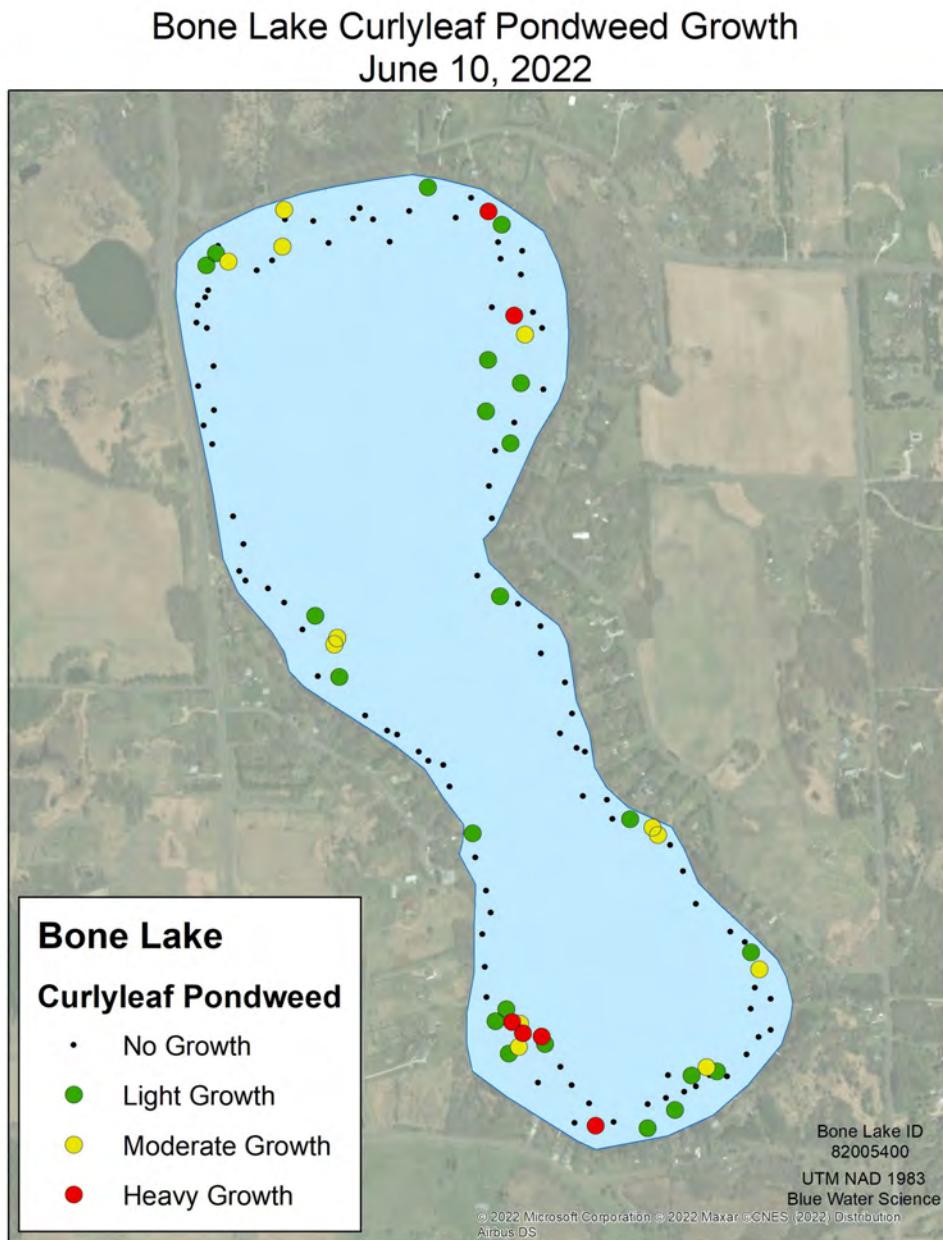
Results of an assessment conducted on June 10, 2022 found that CLP was present at 40 sites out of the 132 locations sampled (Figure 4). CLP had increased in occurrence since April but only several patches in the southwest end of Bone Lake had heavy growth. Native aquatic plant growth was heavy in this area as well.

Figure 4. CLP growth in Bone Lake on June 10, 2022.

Key: black dot = no curlyleaf growth, green dot = light growth, yellow dot = moderate growth, and red dot = heavy growth.

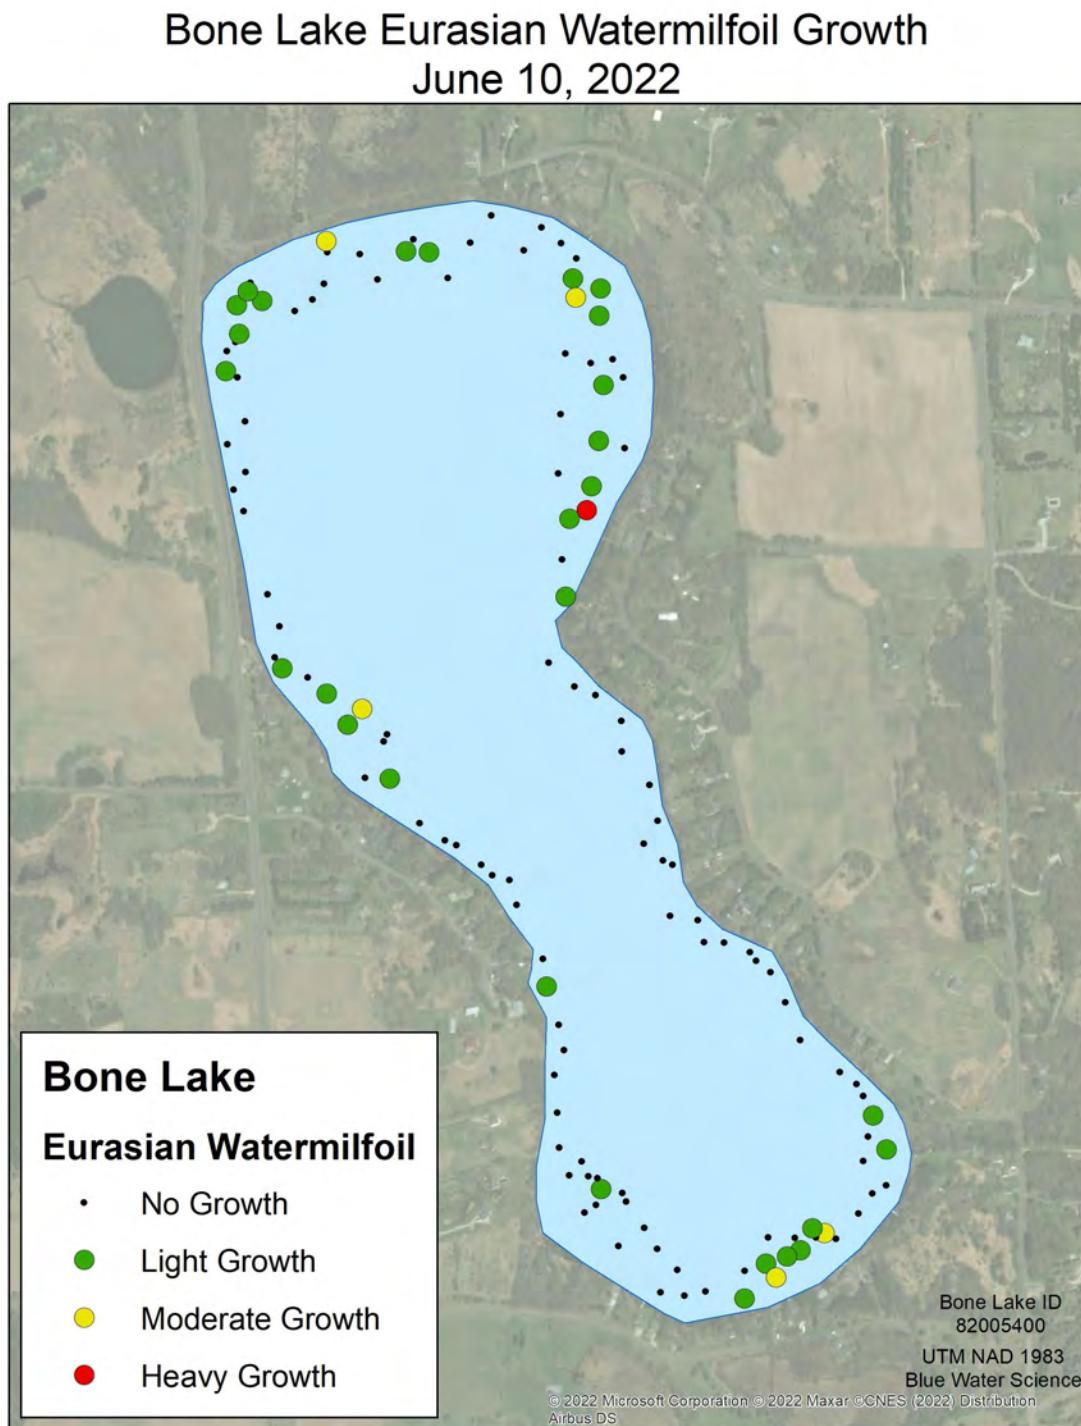
An EWM delineation was conducted on June 10, 2022. EWM was found at 34 sites out of 132 sites sampled (Figure 5). No areas were delineated for treatment (Figure 5).

Figure 5. EWM coverage for Bone Lake on June 10, 2022.

Key: black dot = no growth, green dots = light growth, yellow dots = moderate growth, and red dots = heavy growth.

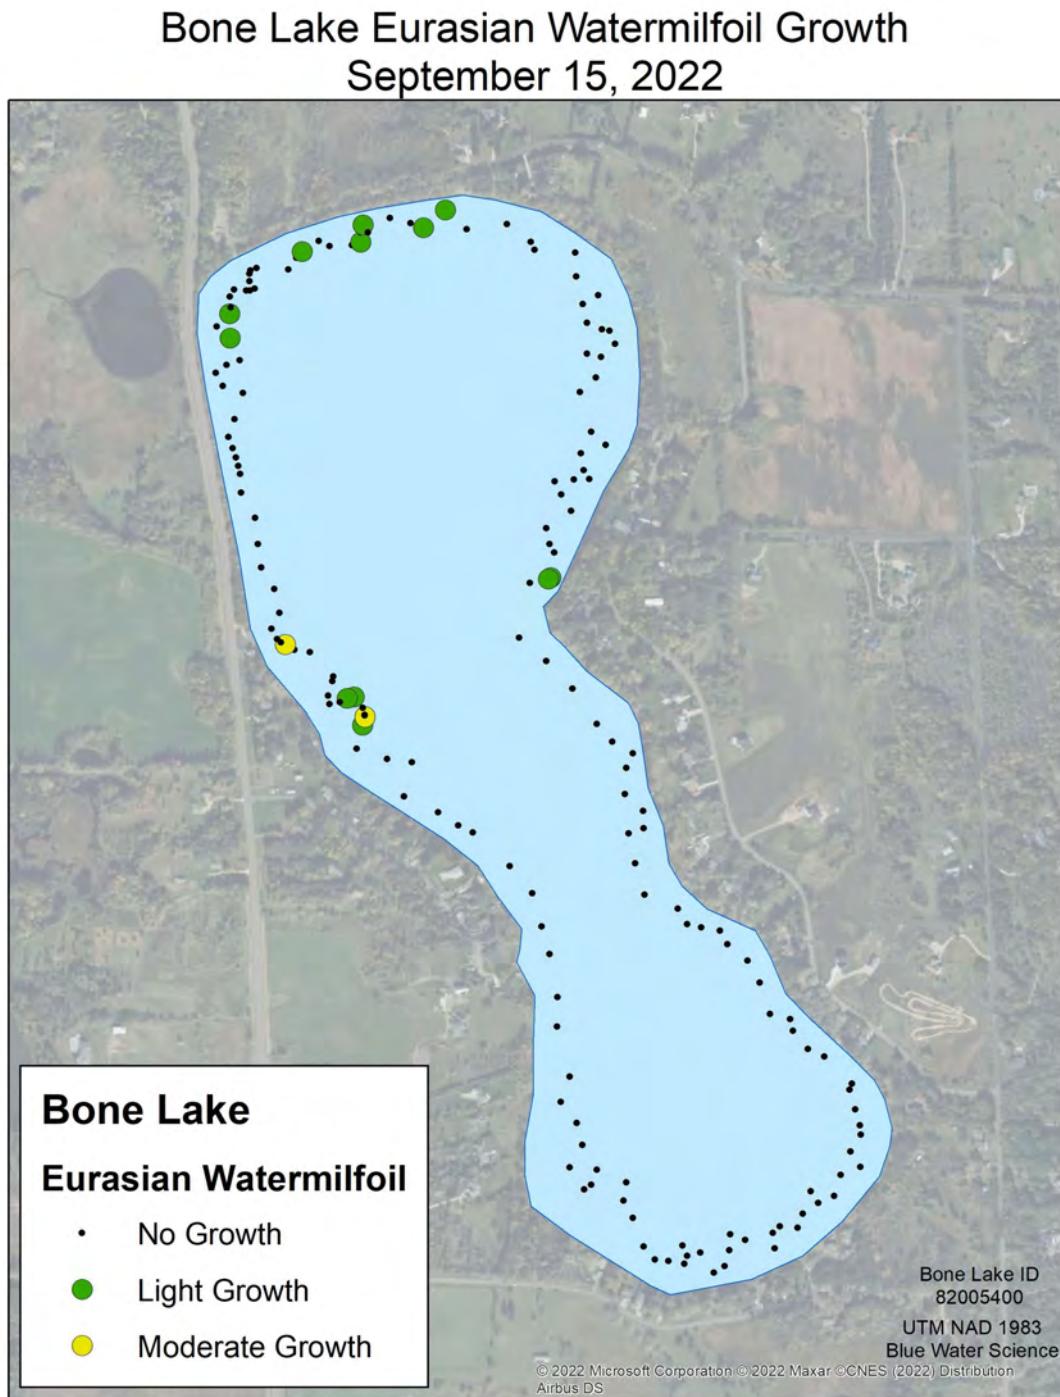
EWM growth was assessed on September 15, 2022 and 14 occurrences of EWM were observed in Bone Lake (Figure 6). EWM growth was light and only found in the northern nearshore areas.

Figure 6. EWM coverage for Bone Lake on September 15, 2022.

Key: black dot = no growth, green dots = light growth, and yellow dots = moderate growth.

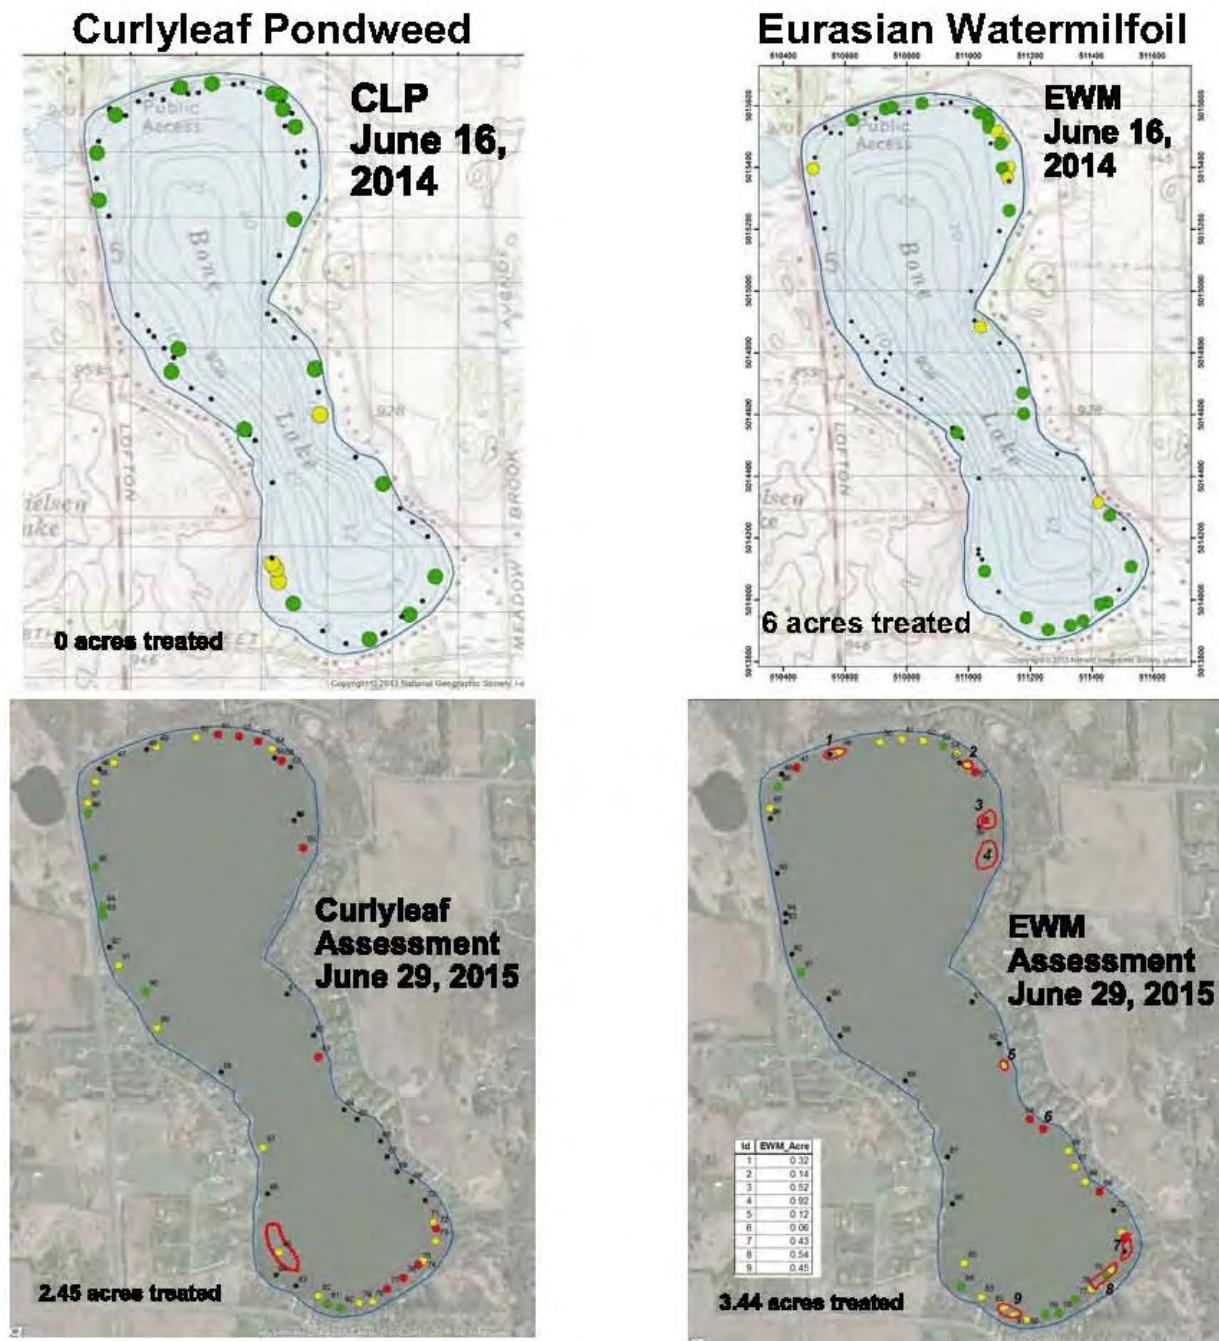
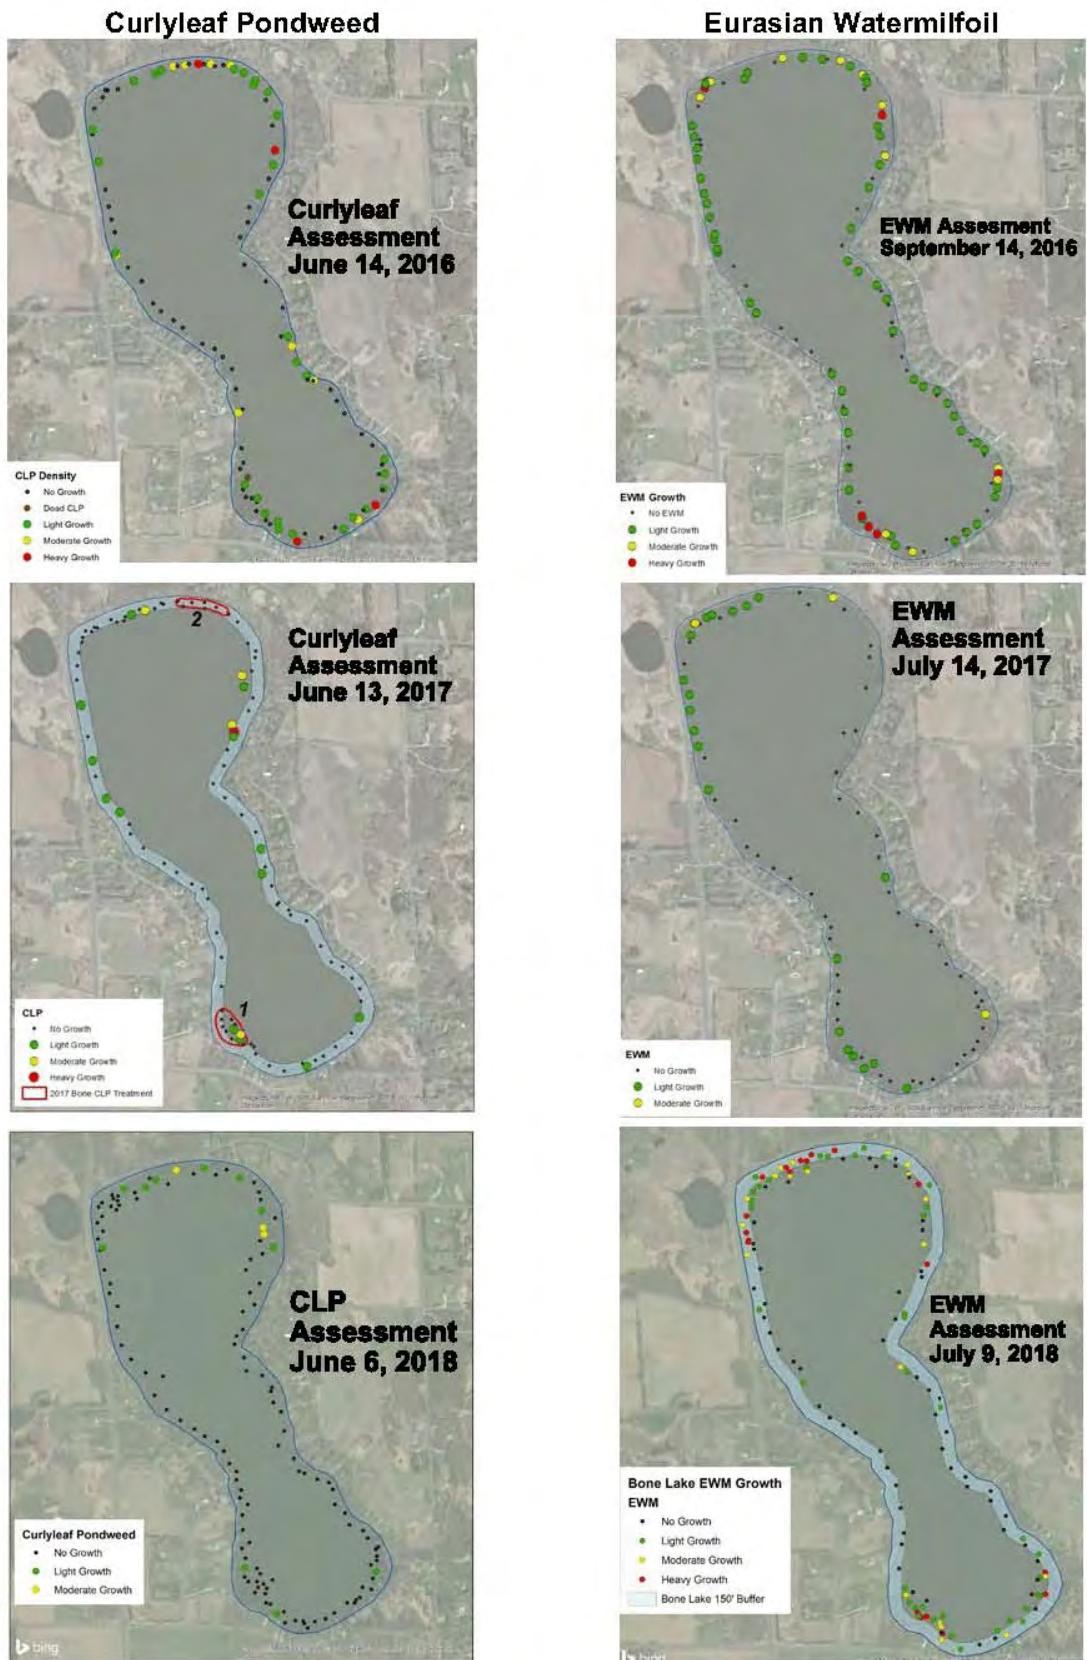
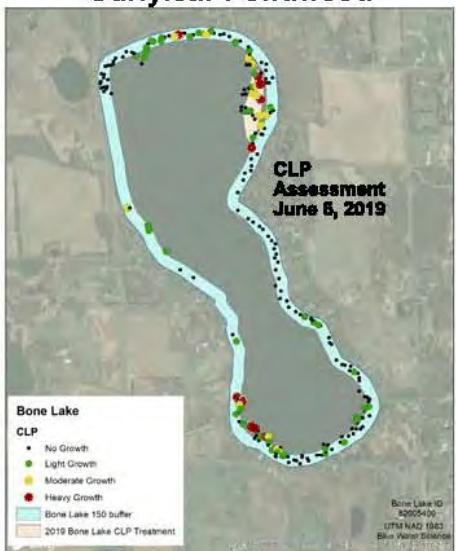
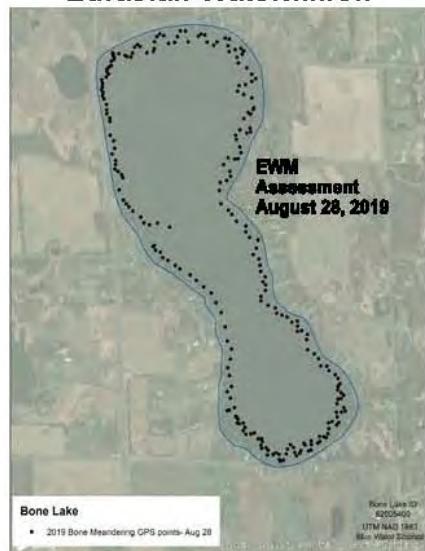
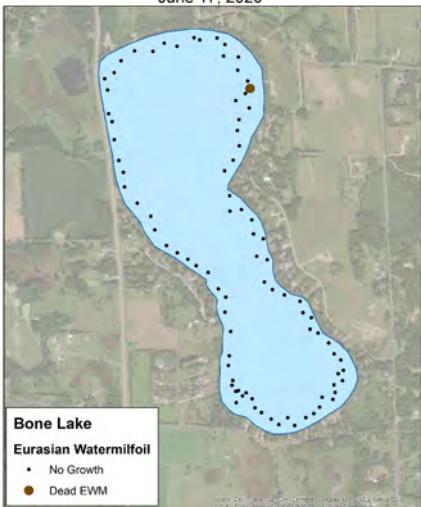
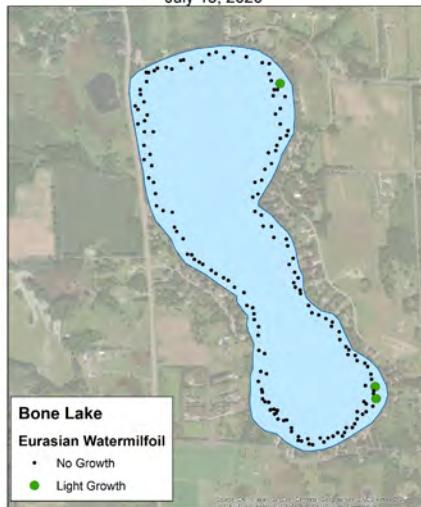
Figure 7. CLP and EWM maps for 2014 through 2022 (continued on the next 2 pages).

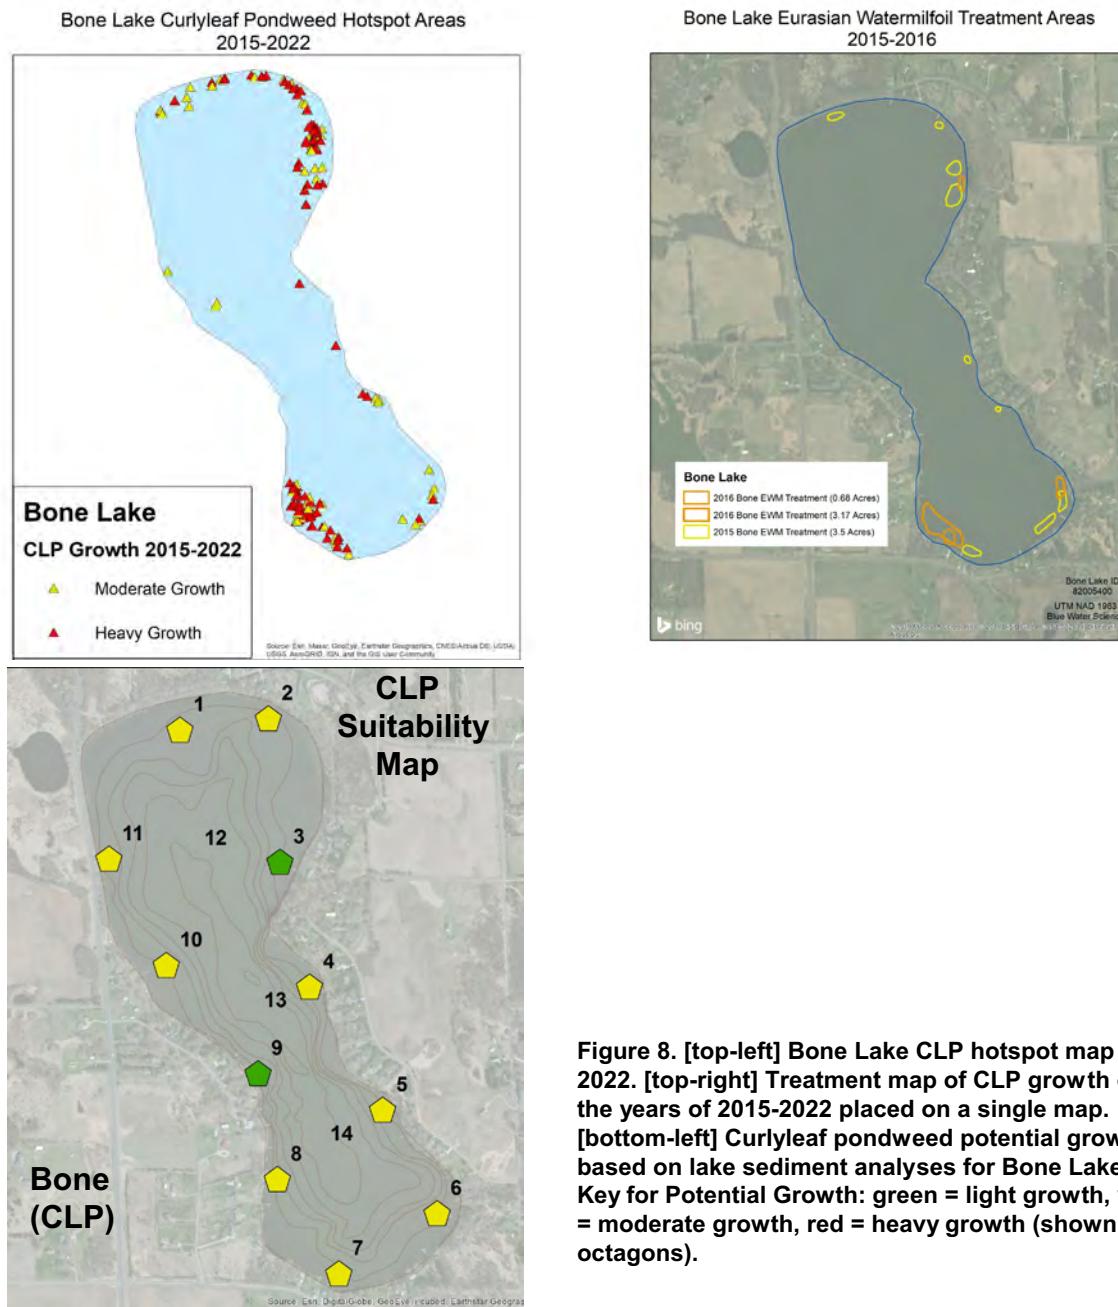
A summary of CLP treatments from 2015 through 2022 is shown in Figure 8. CLP growth has been variable for the last couple of years. Lake ice, snow cover, and even cloudy days can limit curlyleaf growth. A hotspot map of sites of CLP moderate and heavy growth for 2015 through 2022 is shown in Figure 8. In the last 5 years CLP growth has been most evident in the northern and southern ends of Bone Lake where growing conditions are conducive to heavy plant growth. CLP has typically grown to a water depth of 6 feet or less.

Figure 8. [top-left] Bone Lake CLP hotspot map 2015-2022. [top-right] Treatment map of CLP growth over the years of 2015-2022 placed on a single map. [bottom-left] Curlyleaf pondweed potential growth based on lake sediment analyses for Bone Lake. Key for Potential Growth: green = light growth, yellow = moderate growth, red = heavy growth (shown with octagons).

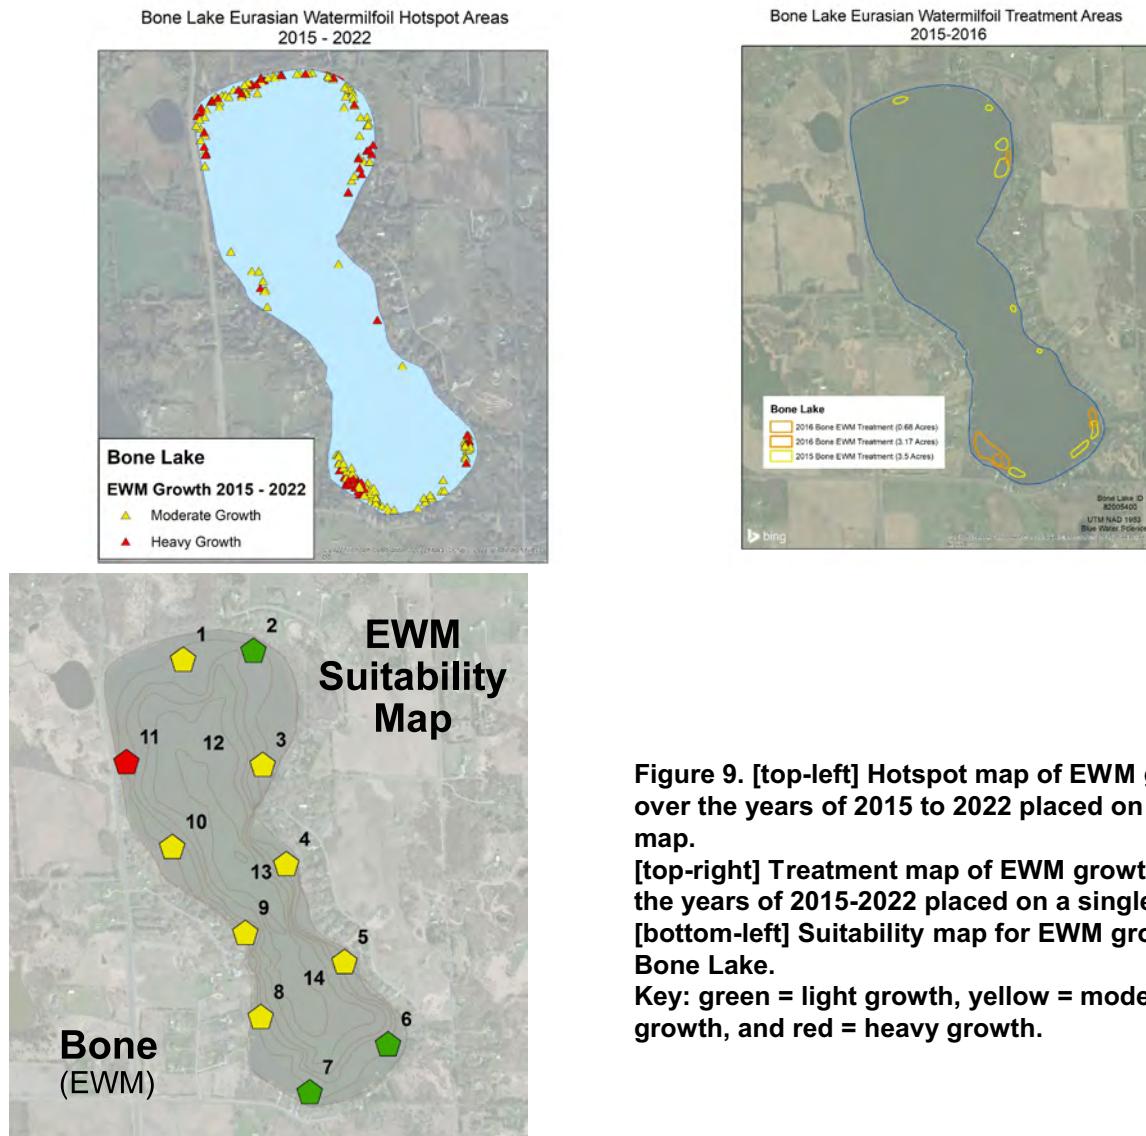
EWM has been in Bone Lake since 2006. Although control of EWM has been ongoing since 2006, EWM continued to expand around the lake. A map showing the occurrence of moderate to heavy growth of EWM in Bone Lake from 2015 through 2022 is shown in Figure 9. Some nearshore areas in the north and south ends of Bone Lake support consistently significant growth. These “hotspot” areas are shown in Figure 9.

Heavy milfoil growth has been correlated with high sediment nitrogen conditions and from a soils survey conducted in 2014, Bone Lake has at least 1 area with high lake sediment nitrogen conditions. The potential for long term milfoil growth, based on lake sediment sampling, predicts mostly moderate growth with the potential for annual heavy growth limited to the northwest side of Bone Lake.

For Bone Lake, it is estimated the plants have the potential to grow down to at least 7 feet of water depth based on low Secchi transparencies, restricting milfoil growth to nearshore areas. Results of the sediment survey indicate growth would be primarily light on a long term basis.

Figure 9. [top-left] Hotspot map of EWM growth over the years of 2015 to 2022 placed on a single map.
[top-right] Treatment map of EWM growth over the years of 2015-2022 placed on a single map.
[bottom-left] Suitability map for EWM growth in Bone Lake.
Key: green = light growth, yellow = moderate growth, and red = heavy growth.
