Prepared by: EOR

For the Comfort Lake-Forest Lake Watershed District

(5228-L) WASHINGTON JUDICIAL DITCH 6 ASSESSMENT AND FEASIBILITY STUDY

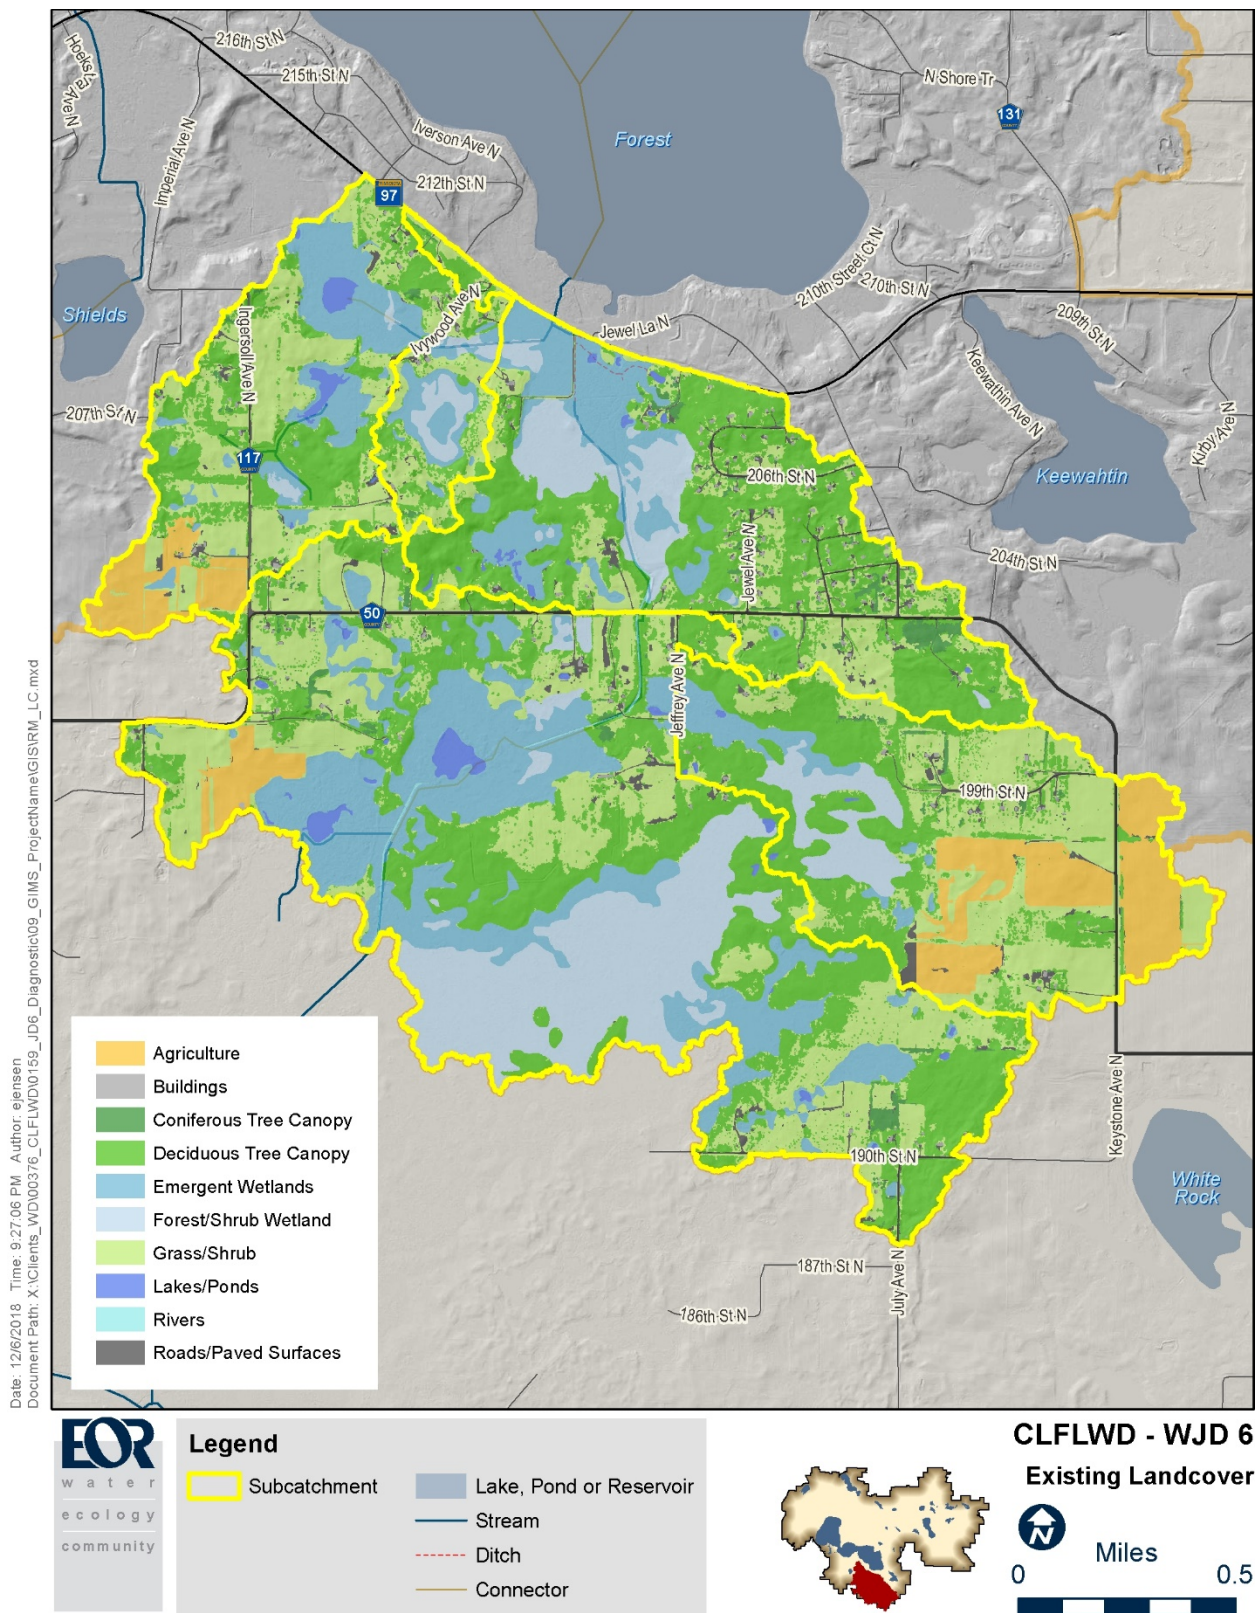
Figure 1. WJD 6 Subwatershed Existing Land Cover

(Note that the grass/shrub category includes hay fields and former pastures that may be cropped in the future)

The WJD 6 subwatershed largely consists of wetland areas and large lot residential development (Figure 1). According to the Minnesota Land Cover Classification System (MLCCS), the WJD 6 watershed is 32% deciduous tree canopy, 27% grass/shrub, 17% emergent wetlands, 12% forest/shrub, 6% agriculture, and 6% other. Note that the grass/shrub category includes hay fields and former pastures that may be cropped in the future. Very little active farming still occurs along the ditch system and the ditch system is largely in disrepair. A portion of the ditch system also runs through the DNR owned Hardwood Creek Wetland Management Area (WMA). However, implementation planning based only on current land use could miss phosphorus hotspots and therefore result in identification of practices with poor cost-effectiveness. Therefore, targeted monitoring and field reconnaissance is needed in this subwatershed to identify legacy phosphorus hotspots and develop non-structural management practices to address phosphorus hotspots.

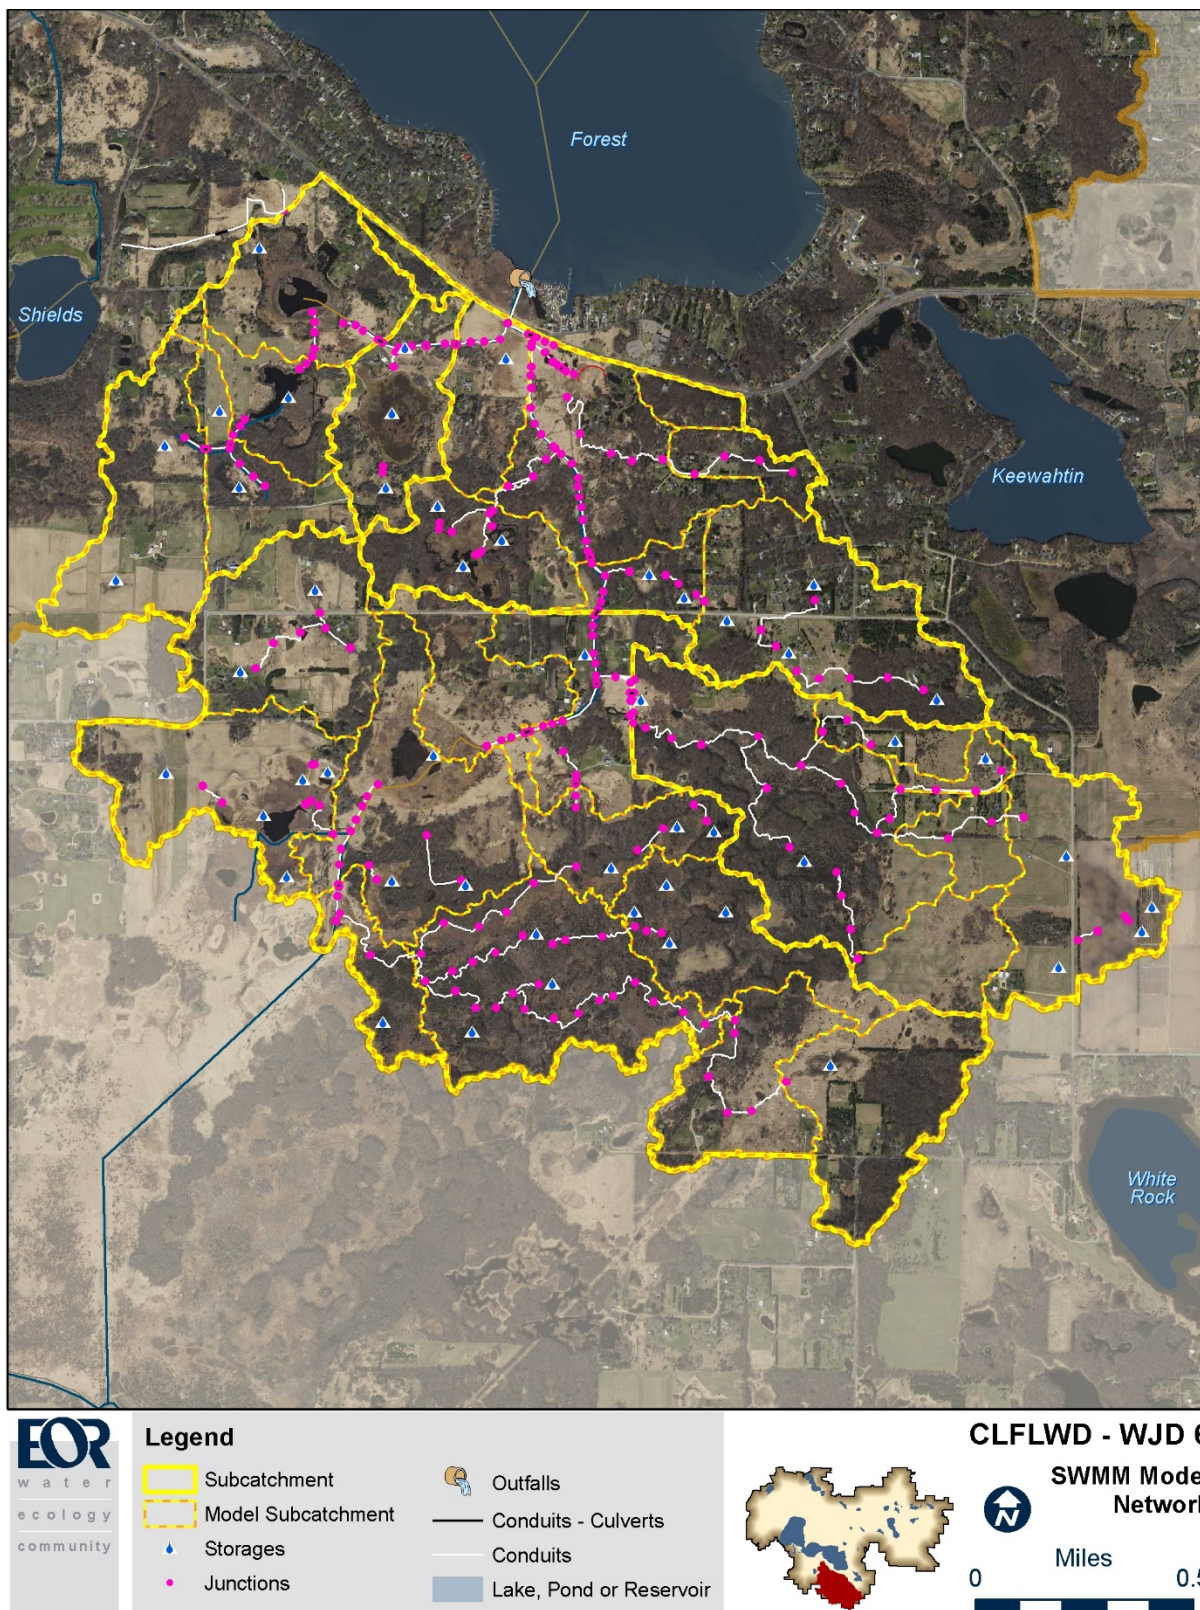
Figure 5. Updated SWMM Model Subcatchments, Storage Nodes, and Junctions

The former model consisted of 14 subcatchments covering approximately 1,200 acres, including 7 junctions, 7 storages, and 13 links. However, some areas had multiple overland flow routes and, as such, not all of this area was tributary to WJD 6 for all events. The new model consists of 30 subcatchments covering 2,109 acres, including 262 junctions, 72 storages, and 230 links. Over half of the watershed (1,332 acres) drains through the culvert under 202nd Ave N. Portions of the watershed appear to be landlocked under some conditions due to the large number of depressions and wetlands present. Seventy-two storage areas (all larger than 1 acre in size at overflow) have been incorporated into the new model, which will significantly improve the usefulness of the model in identifying the relative contribution of WJD 6 flows coming from different portions of the watershed.

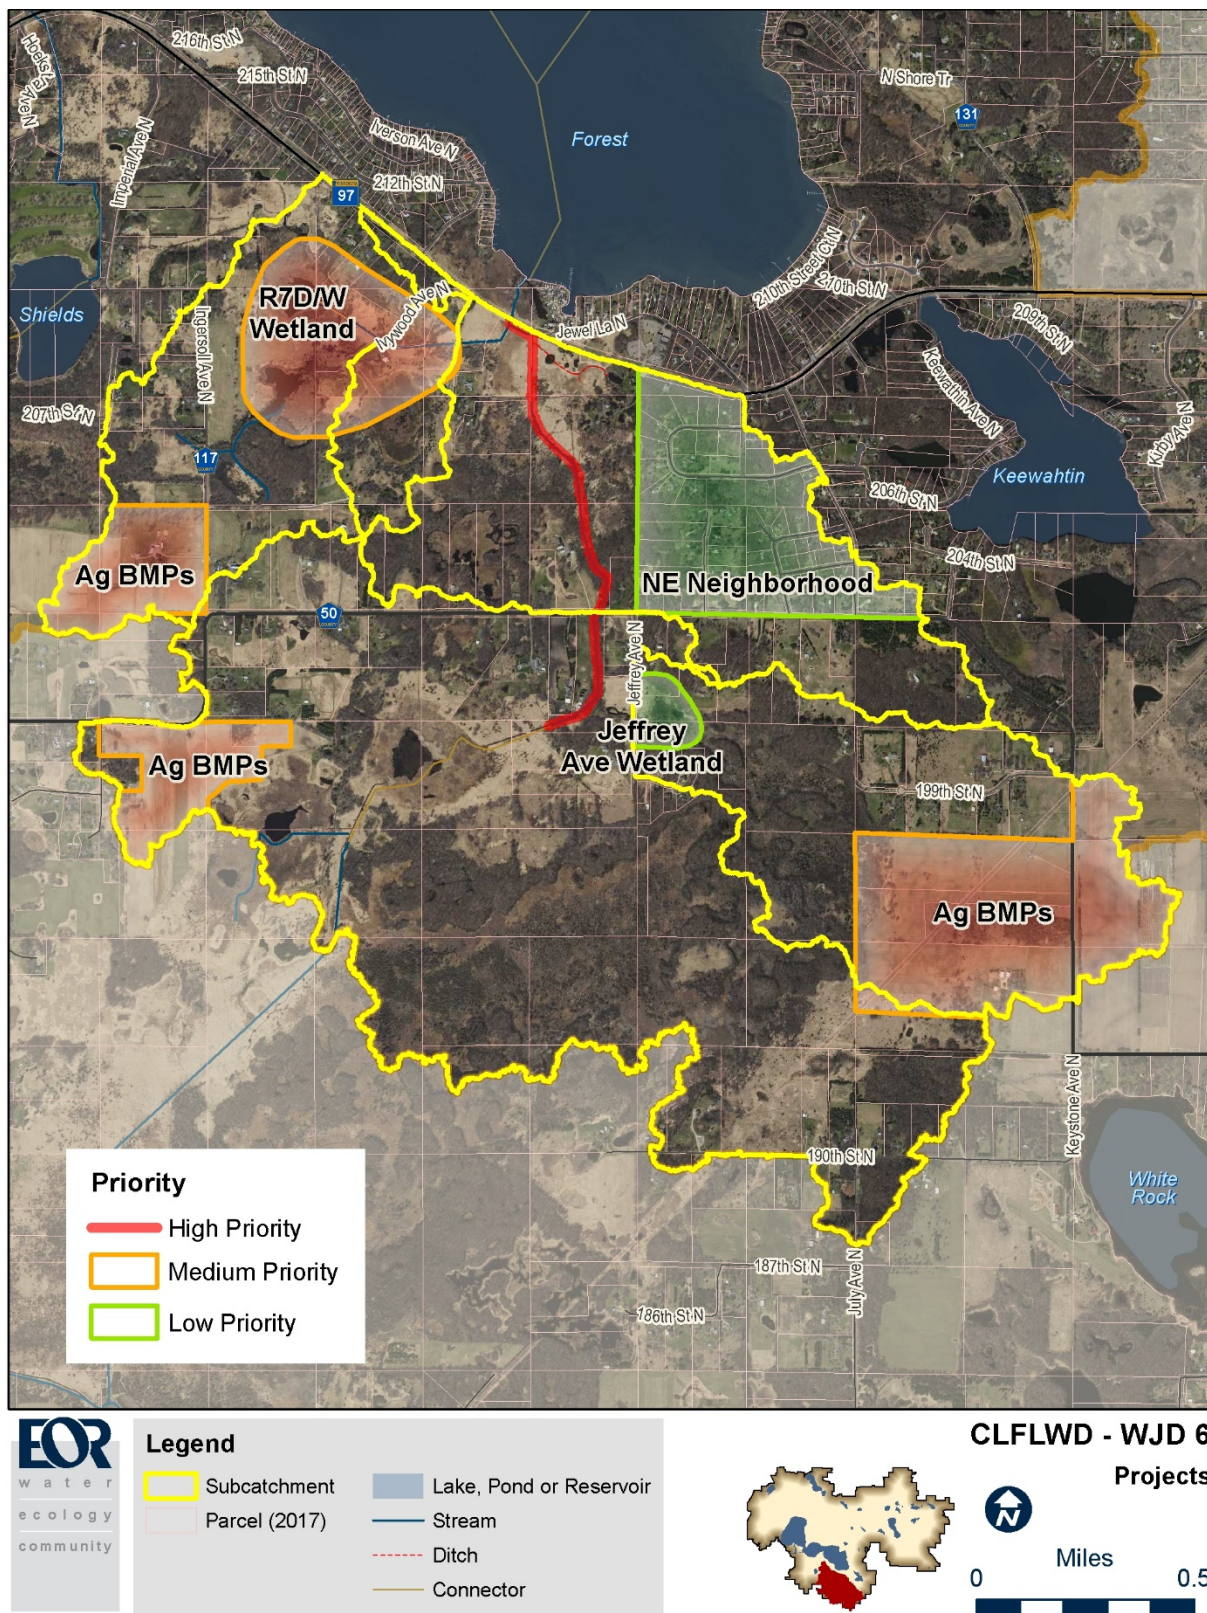
Figure 6. WJD 6 Subwatershed Potential Project Location and Prioritization

Through the data collection and review process completed in 2018, several potential project locations were identified in the WJD 6 subwatershed. The location of these project areas are shown in Figure 6 and described below. These projects are ordered from most favorable cost/benefit to least favorable cost/benefit. It is recommended that the District first focus on projects labeled as medium to high priority.
