Date: 4/03/2023
To: CLFLWD Board of Managers
From: Mike Kinney, District Administrator
Subject: 2022 DIY and CAT Water Monitoring Report

**Do-It-Yourself Diagnostic &
Citizen Assisted Tributary
Monitoring Programs**

January 2023

Comfort Lake–Forest Lake Watershed District

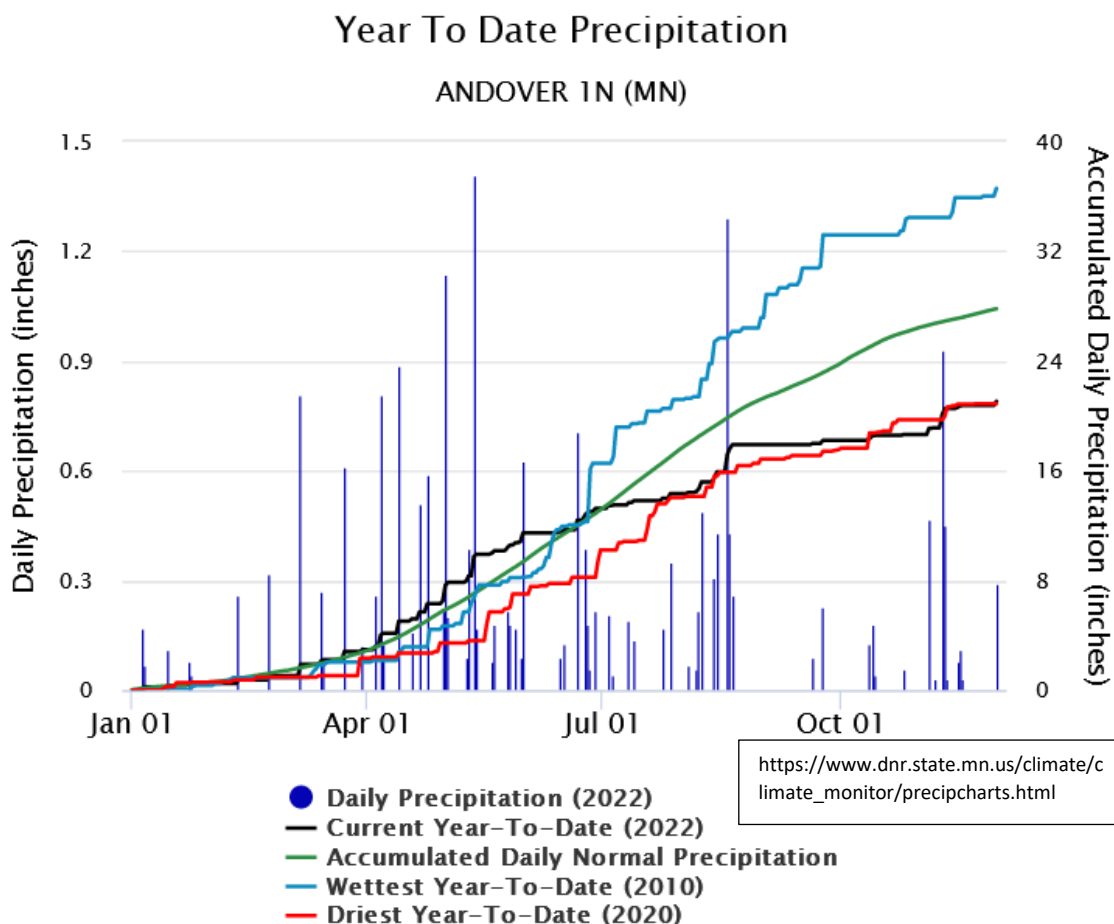
Figure 2. 2022 precipitation summary for the closest MNDNR monitoring station to the CLFLWD.

Similar to 2021, the 2022 monitoring season proved to be somewhat challenging due to region-wide summer drought conditions. Minnesota DNR precipitation data indicates that 2022 actually had average precipitation totals, but the majority of that precipitation came in the early spring, prior to the 2022 monitoring season. A long period of below average precipitation began in June of 2022 and continued through the fall. This limited the number of mid / late season sampling events that took place and resulted in fewer water quality data points than anticipated. To compensate, staff sampled precipitation events with less than the recommended 0.75 inches of rainfall. This allowed additional sampling opportunities but lead to many data gaps as these smaller precipitation events did not fully activate the entire drainage network. As such, the DIY and CAT data sets for 2022 are incomplete and the results from these efforts are not as conclusive as anticipated.

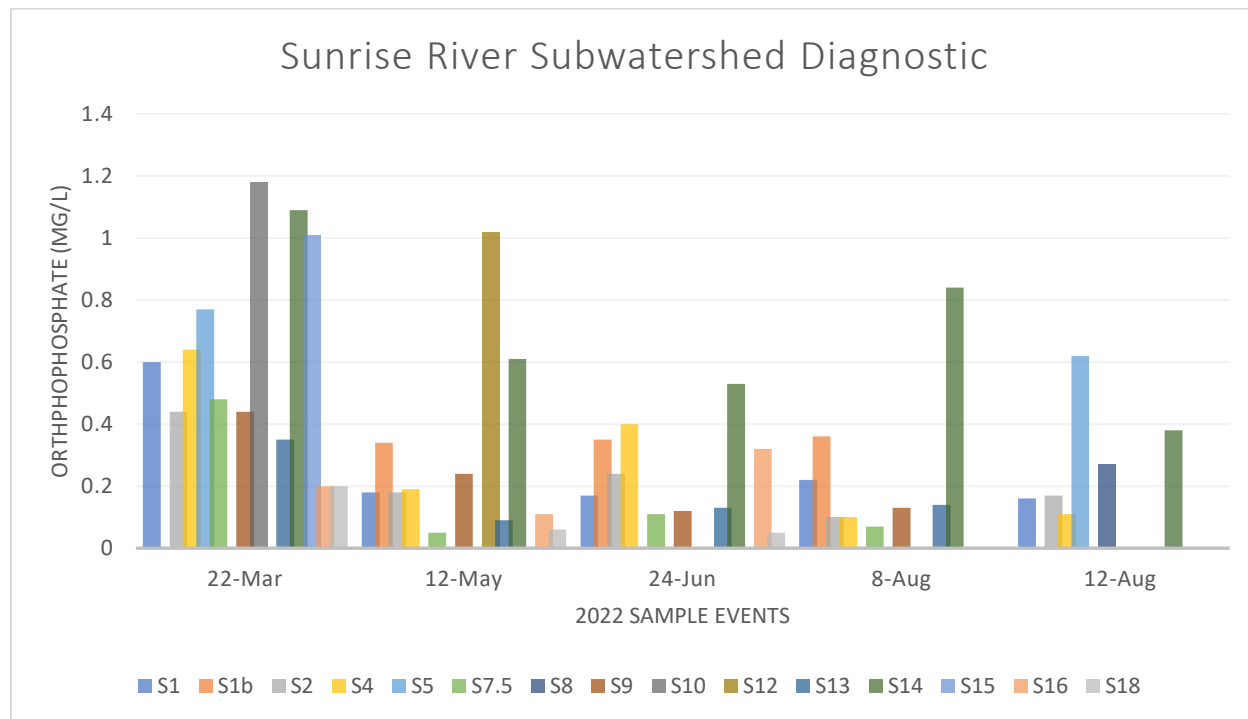
Figure 4. Results from 2022 Sunrise River Subwatershed DIY diagnostic monitoring effort. All results are in mg/l of orthophosphate. S5, S10, S12, S15 are roadside ditch/culvert sites. S14 is the County Line site.

The majority of the water quality grab samples collected in 2022 had orthophosphate levels around 0.20 mg/l (similar to past years). Several monitoring locations did have elevated orthophosphate levels in some of the samples, but these results are confounded by the drought conditions (little to no flow, standing water) and subsequent lack of data to fully evaluate these locations as a nutrient source. As such, these results (Figures 4 - 6, Table 2) may not be representative of the nutrient load during an average precipitation year.

The sites mentioned above with elevated orthophosphate levels included most notably S5 (a roadside manhole), sites S10 (culvert), S12 (culvert near agriculture field), and S14 and S15 (both roadside ditches). It is not surprising that these sites had elevated orthophosphate levels as they are closely associated with roadways and all lack natural treatment. Stormwater sheets directly off the road surfaces into this stormwater infrastructure with little to no vegetation filtering or soil infiltration. Furthermore, few samples were taken at any of these sites (excluding S14) and any conclusions gathered from this data should be viewed in this context. These findings give credence to the District's enhanced street sweeping program as a key nutrient reduction strategy as road surface runoff is a substantial source / conveyance of orthophosphate for the district.

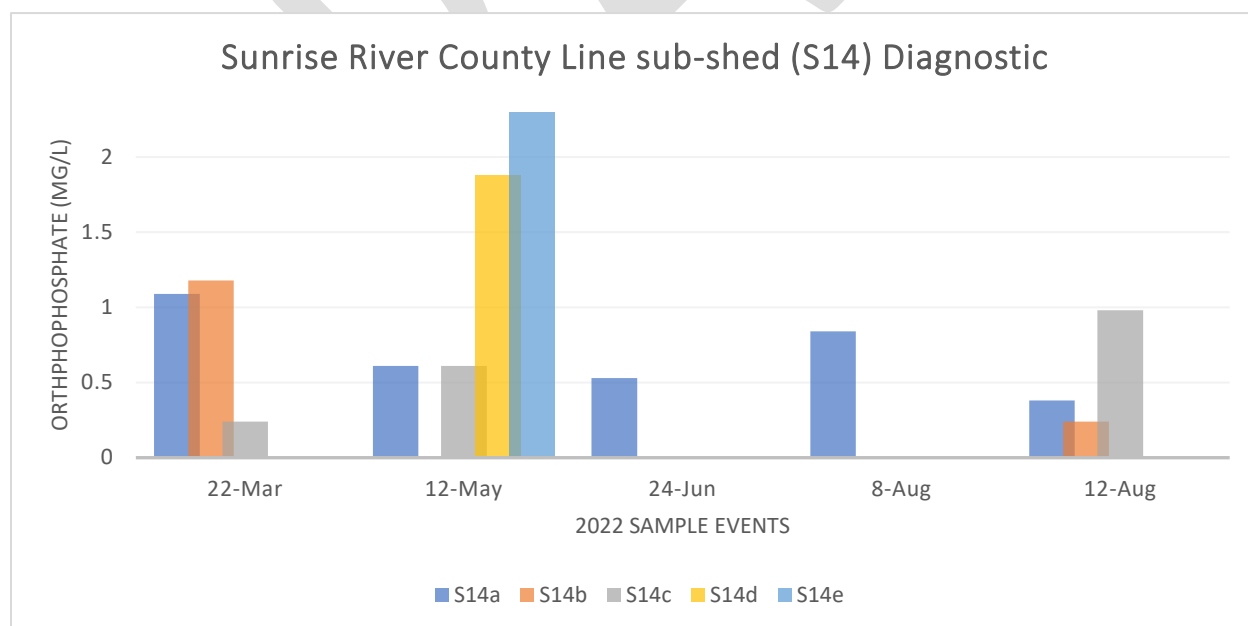
Figure 5. Results from 2022 Sunrise River Subwatershed DIY diagnostic monitoring effort at the County Line monitoring location subwatershed. All results are in mg/l of orthophosphate.

Samples collected from the County Line sub-shed (S14a-e, located near the Washington / Chisago County line) had consistently elevated orthophosphate levels. Unfortunately, drought conditions limited

sample collection, and as such, no specific source of nutrient was identified in this area. Further investigation at this location is warranted to pinpoint the main source of nutrient.

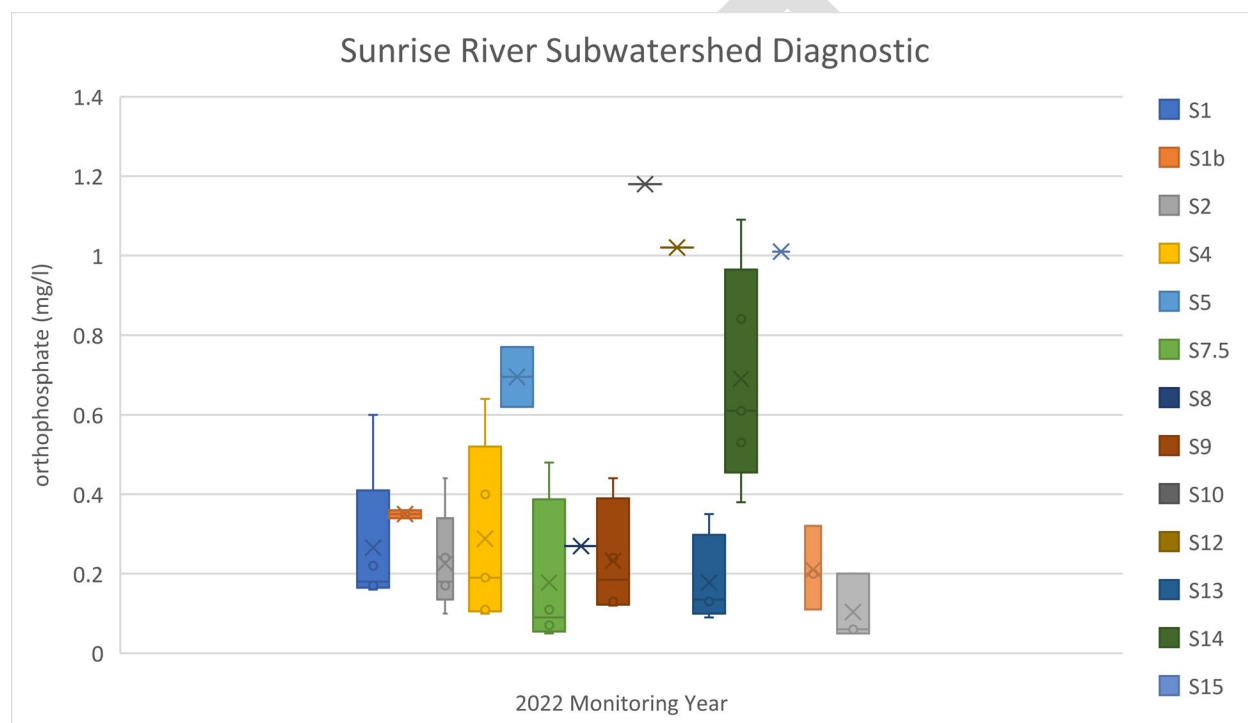
Figure 6. Results from 2022 Sunrise River Subwatershed DIY diagnostic monitoring effort represented as box and whisker plots. County line sub-shed data not included in this figure. The box represents the interquartile range (25% on each side of the median), the line in the box is the median, the X is the mean, and the whiskers represent the lower and upper extremes or maximum values. Any circles/dots beyond the whisker ends indicate data outliers.

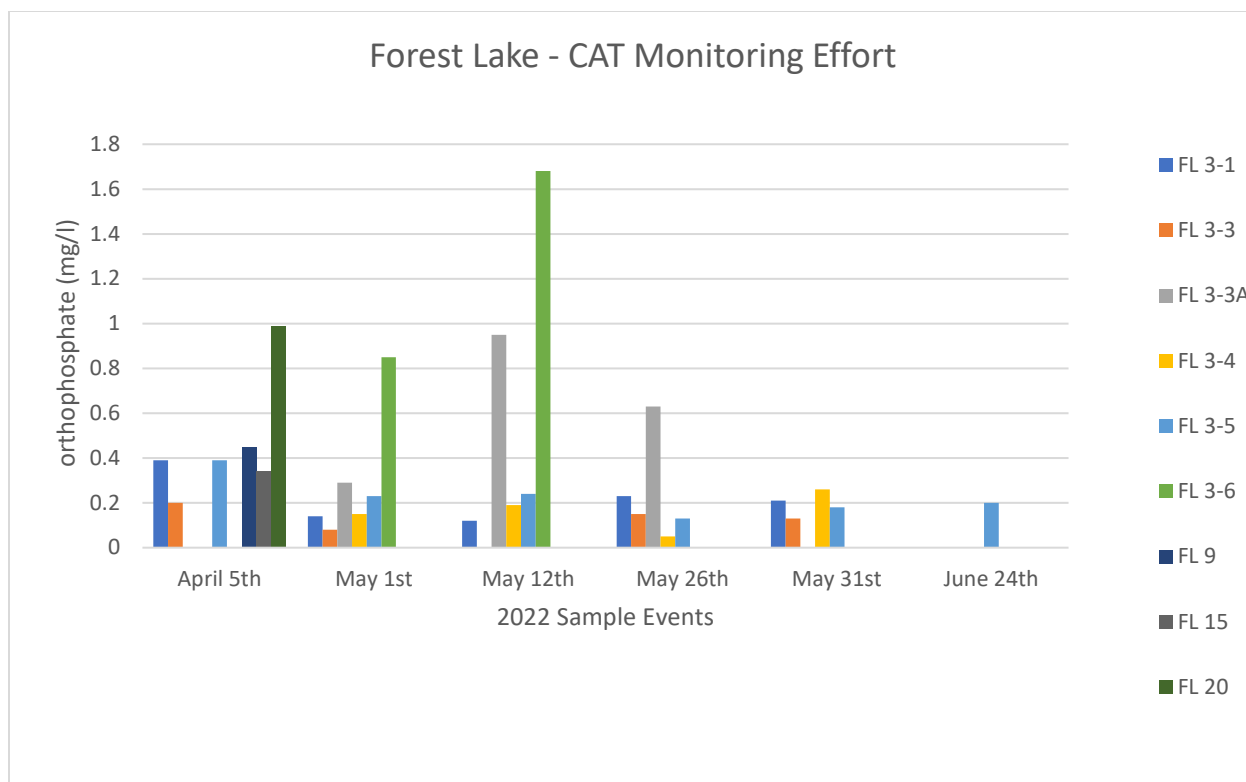
Figure 8. Results from 2022 Forest Lake Second and Third Basin CAT monitoring effort. All results are in mg/l of orthophosphate.

The results from the 2022 Forest Lake CAT effort were limited by the drought conditions and therefore, may not be representative of the nutrient loading during an average precipitation year. The majority of the water quality samples that were collected had orthophosphate levels near or less than 0.20 mg/l (similar to past years) but the data set is not robust enough to confirm these results (Figure 8, Figure 9, Table 4). Several grab samples collected did show highly elevated levels, but these samples were collected at extremely low flow or from stagnant water. It is likely that these samples contained some ditch sediments and thus are not representative of the actual nutrient load at these locations. As such, the results from the 2022 monitoring effort should be viewed in this context and repetition of this effort during an average precipitation year should be considered.

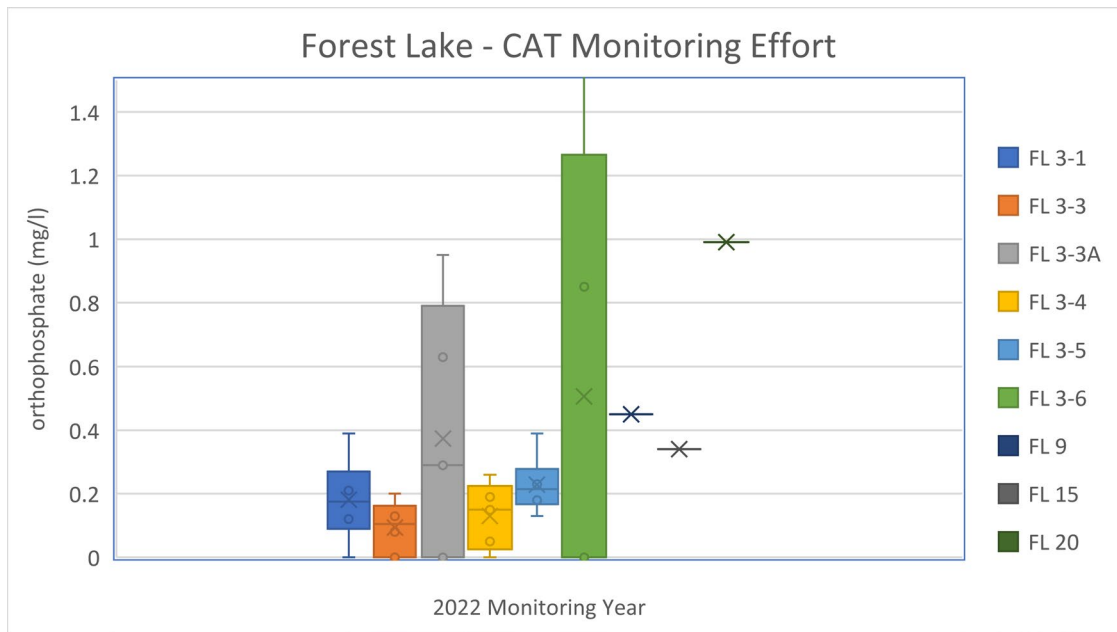
Figure 9. Results from 2022 Forest Lake Second and Third Basin CAT monitoring effort represented as box and whisker plots. The box represents the interquartile range (25% on each side of the median), the line in the box is the median, the X is the mean, and the whiskers represent the lower and upper extremes or maximum values. Any circles/dots beyond the whisker ends indicate data outliers.
