# 2022 Water Monitoring Report

*April 13, 2023 Regular Board Meeting*

Emmons & Olivier Resources

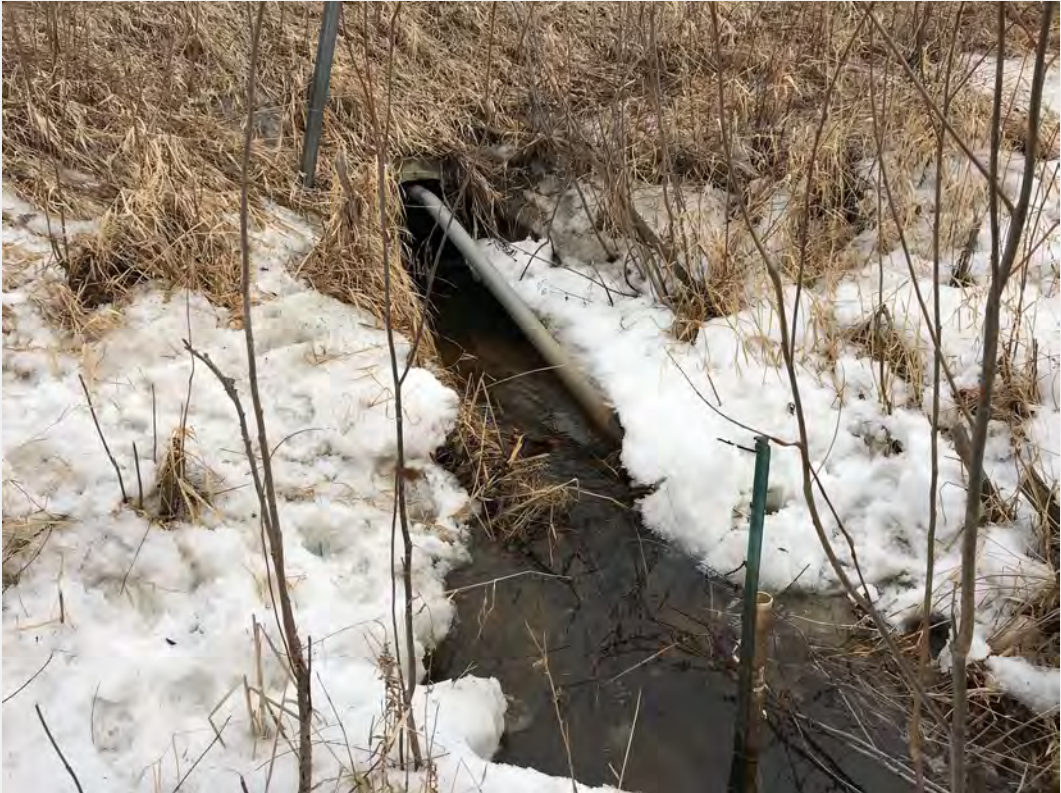
Outlet pipe  
downstream of  
Castlewood  
Agricultural Field
