Curlyleaf Pondweed Delineation and Assessment Surveys for Moody Lake, Chisago County, Minnesota, 2023

Prepared for:
Comfort Lake/Forest Lake
Watershed District
Forest Lake, Minnesota

Prepared by:
Steve McComas
Jo Stuckert
Connor McComas
Blue Water Science

November 30, 2023

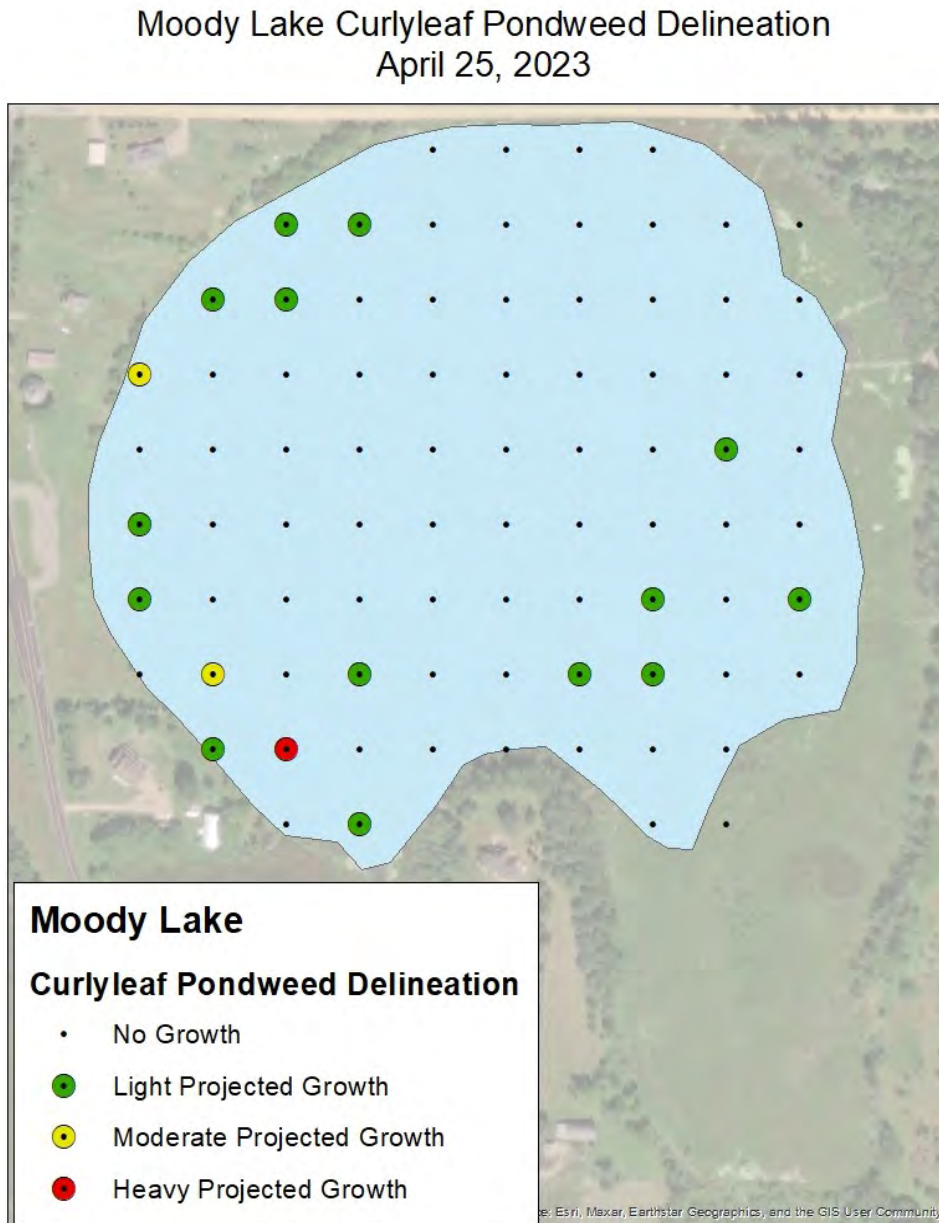
Figure 3. Curlyleaf pondweed from the point intercept survey conducted on April 25, 2023.
Key: Green dots = light growth, red dots = heavy growth, and black dot = sample site, no plants.

A point intercept survey was conducted to delineate CLP on April 21, 2022 (Figure 3). Results from the survey found that CLP stem densities at most of the sites were not predicted to produce heavy growth of CLP abundance in June therefore no areas were delineated for treatment. No treatment occurred in 2022. Coontail and elodea was the only other submerged plant species observed (Tables 1 and 2).

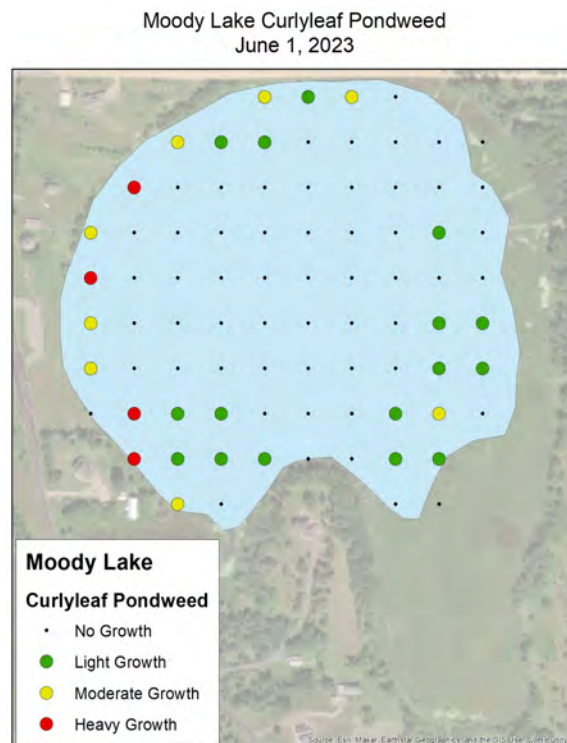
Figure 4. Curlyleaf pondweed coverage for Moody Lake on June 1, 2023. Key: black dots = no growth, green dot = light growth, yellow dots = moderate growth, and red dots = heavy growth.

Results of the June 1, 2023 assessment using a point intercept survey found there were 5 submerged plant species, chara, coontail, curlyleaf pondweed, elodea, and flatstem pondweed with coontail being the dominant plant (Tables 3 and 4). No CLP treatment occurred in 2023 and CLP distribution increased from 17 sites to 28 sites. The heaviest CLP growth was on the west side of Moody Lake (Table 3 and Figure 4). Results from the assessment found native plants growing out to a depth of 11 feet (Table 4).

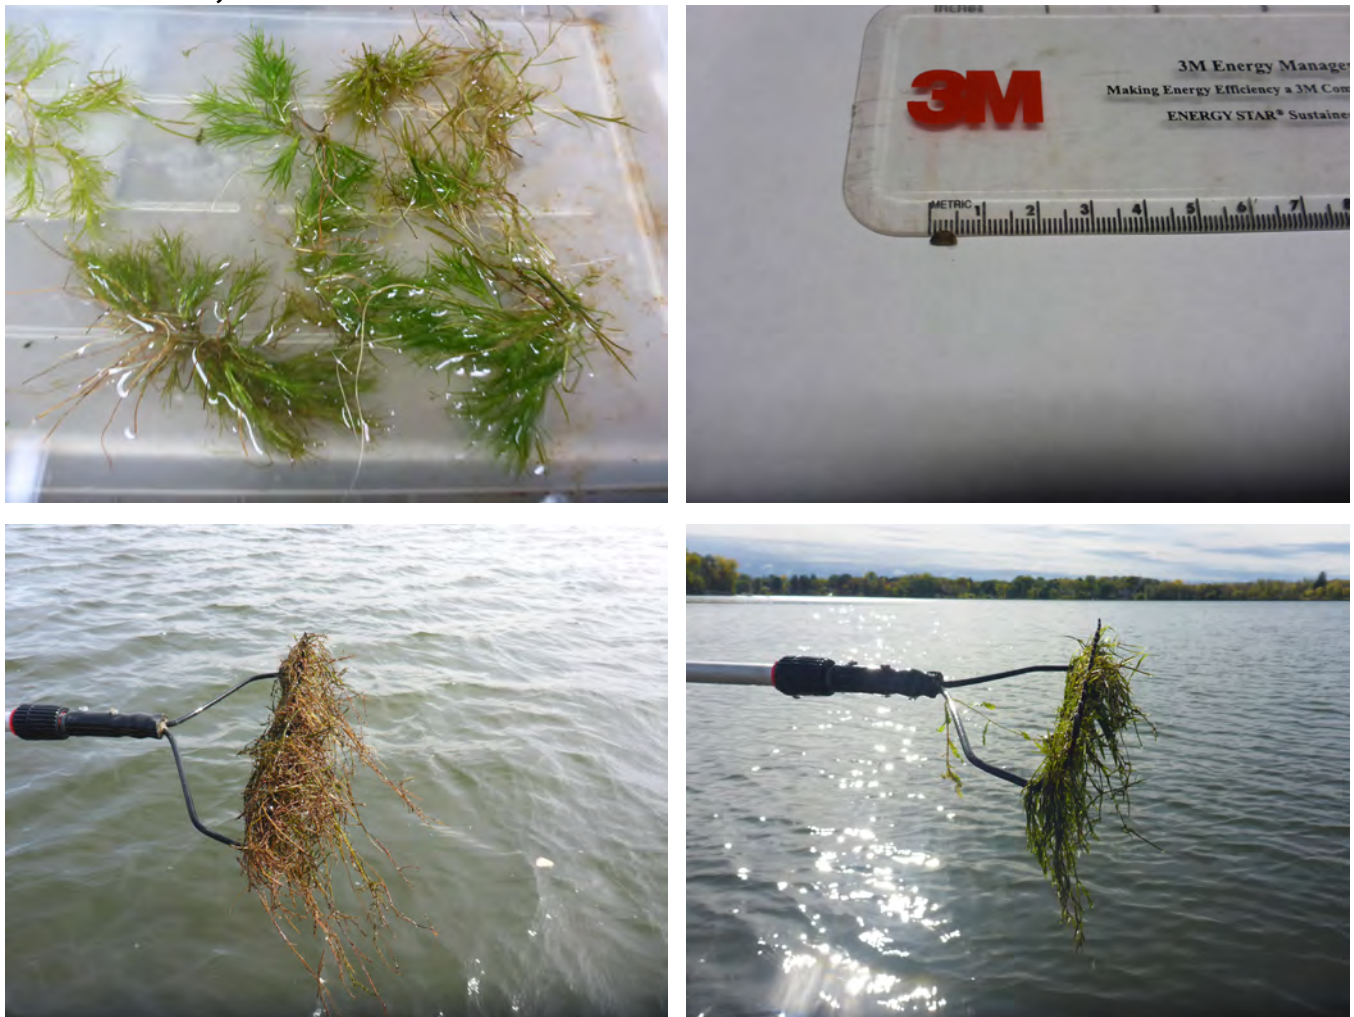
Figure 2. A single zebra mussel was found during the July 20, 2023 point intercept survey (top photos). Plants were still actively growing in Bone Lake in October but no zebra mussels were found (bottom pictures).

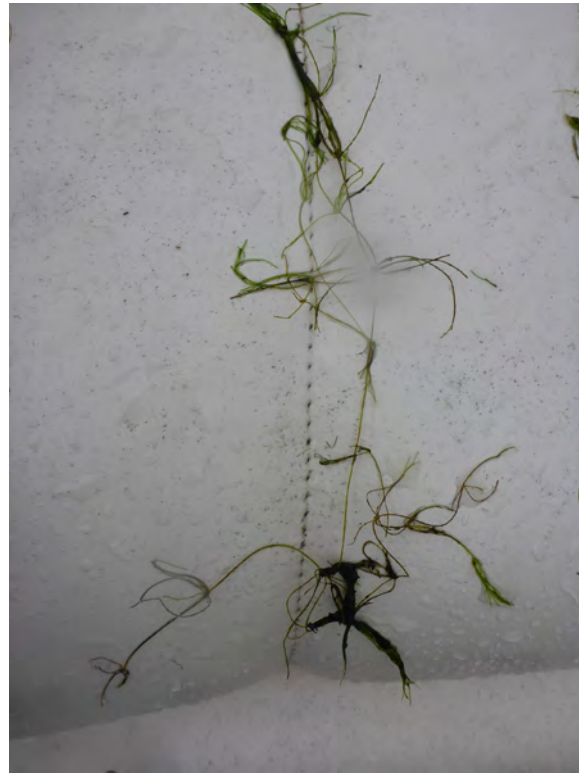
Actual size of bulbils
Below: orange antheridia

Figure 3a. [left] Starry stonewort identification page from the University of Minnesota Aquatic Invasive Species Research Center (MAISRC).

Starry stonewort looks a lot like some growth forms of chara and nitella (Figure 3). Starry stonewort was not observed in Bone Lake in 2023.

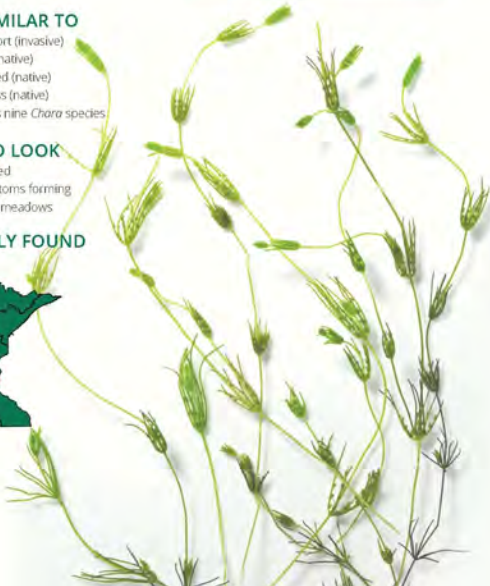
Rough stems; whorled branchlets

Figure 3b. *Chara* identification page from the MAISRC.

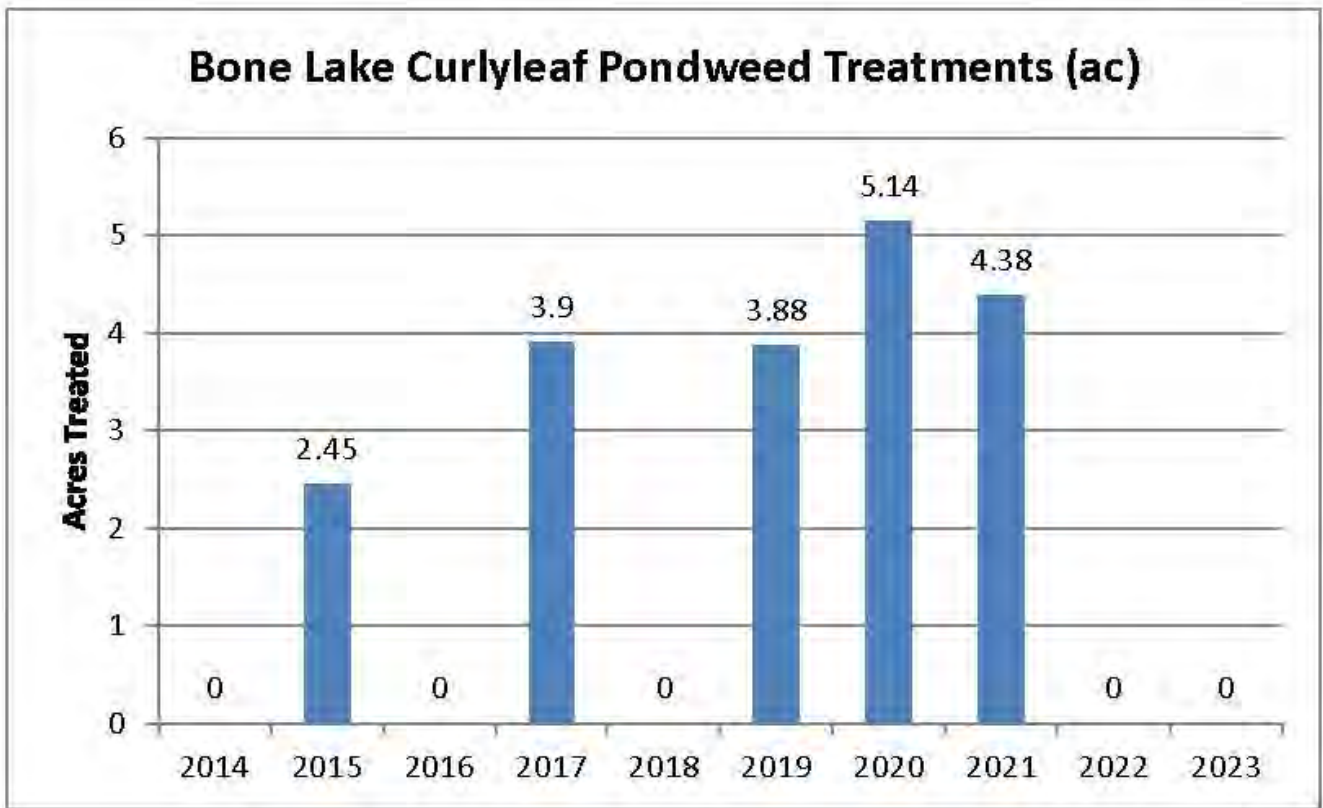
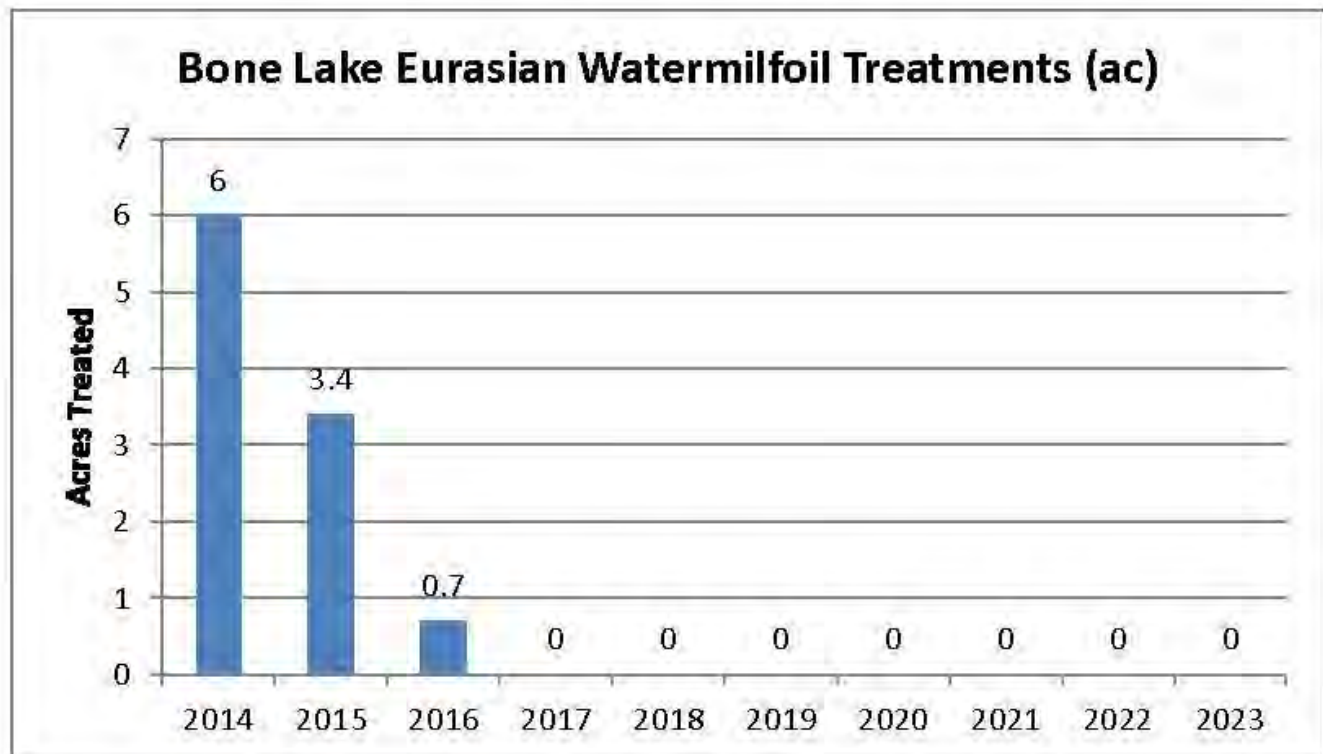
Figure 3. Summary of CLP and EWM treatment acreage for 2014-2023.

Summary of CLP and EWM Bone Lake Treatments: CLP has been treated in 5 out of the last 10 years. EWM has been treated in 3 out of the last 10 years. However, no CLP or EWM was treated in 2023 (Figure 3).

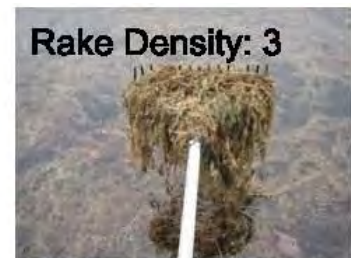
Chart of Aquatic Plant Density Ratings

Figure 7. Aquatic plant density ratings from 1 to 3.

Point Intercept Survey: An aquatic plant survey of Bone Lake using a point intercept sampling method was conducted by Blue Water Science on July 20, 2023. A map and sampling grid were prepared by Blue Water Science and a consisted of a total of 368 points that were distributed throughout the lake (Figure 6). Points were spaced 50 meters apart. Each point represented about 0.6 acres. At each sample point, plants were sampled with a rake sampler. A plant density rating was assigned to each plant species on a scale from 1 to 3 (Figure 7). A density of a “1” indicated sparse growth with one or two stems present on the rake sampler. A 3 rating indicated matting surface plant growth.

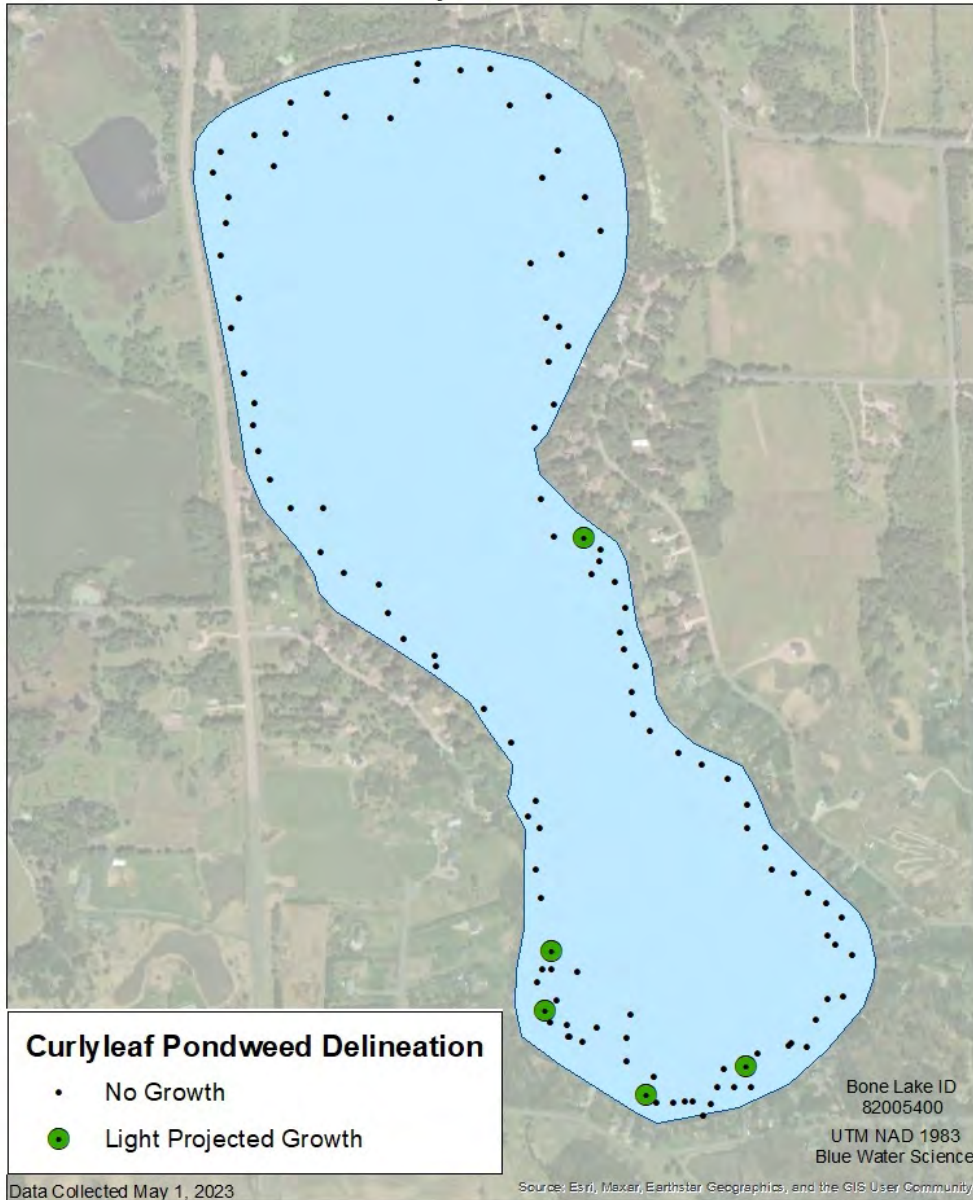
Figure 8. Curlyleaf coverage for Bone Lake on May 1, 2023. Key: black dot = no growth and green dots = light growth.

A CLP delineation conducted on May 1, 2023 and found CLP was present at 5 sample sites out to a total of 117 sampled sites. No CLP treatment was not recommend in 2023 (Figure 8).

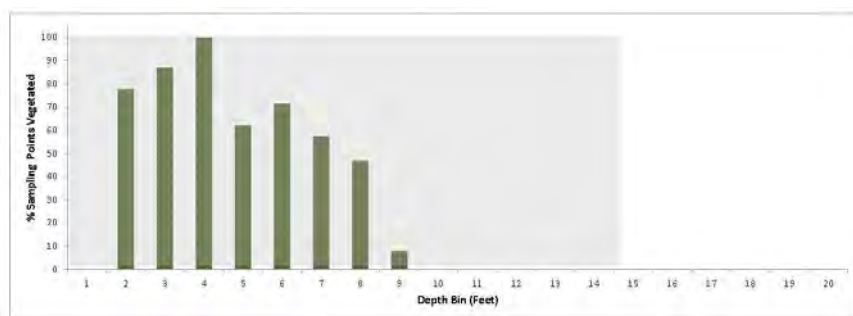
Figure 11. Depth of plant colonization (in feet).

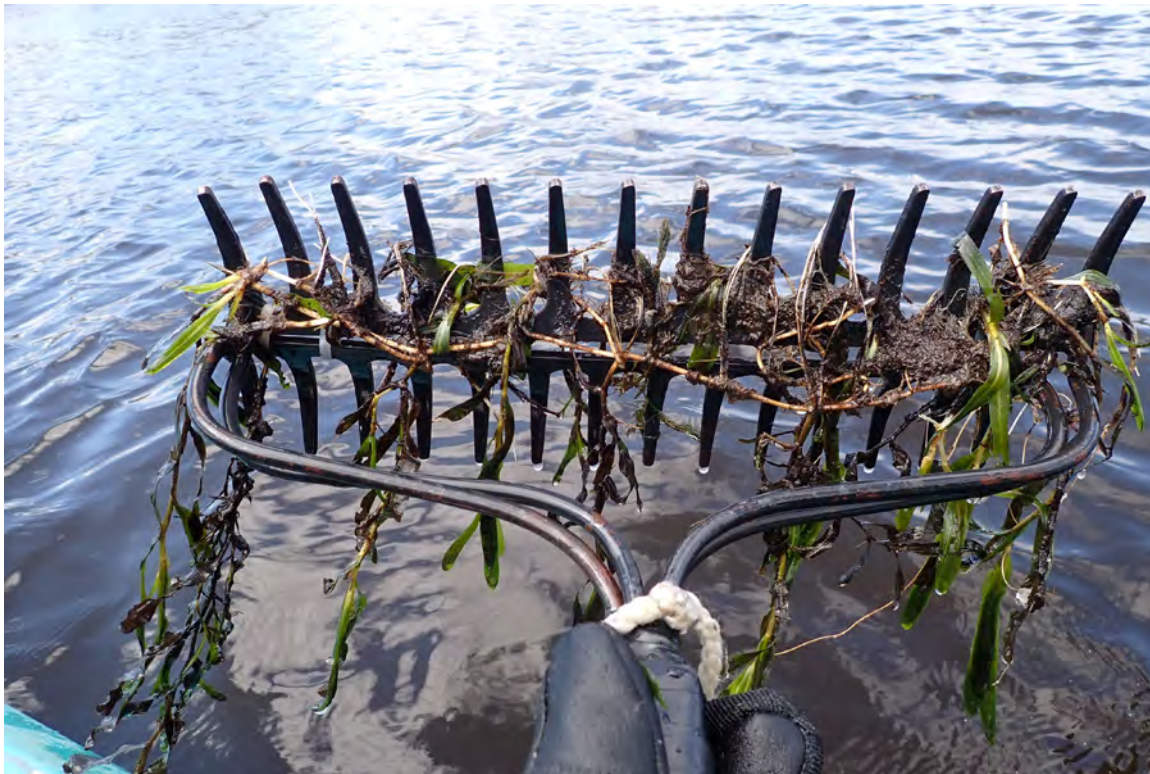
Figure 3. Curlyleaf pondweed rake density on April 25, 2023.

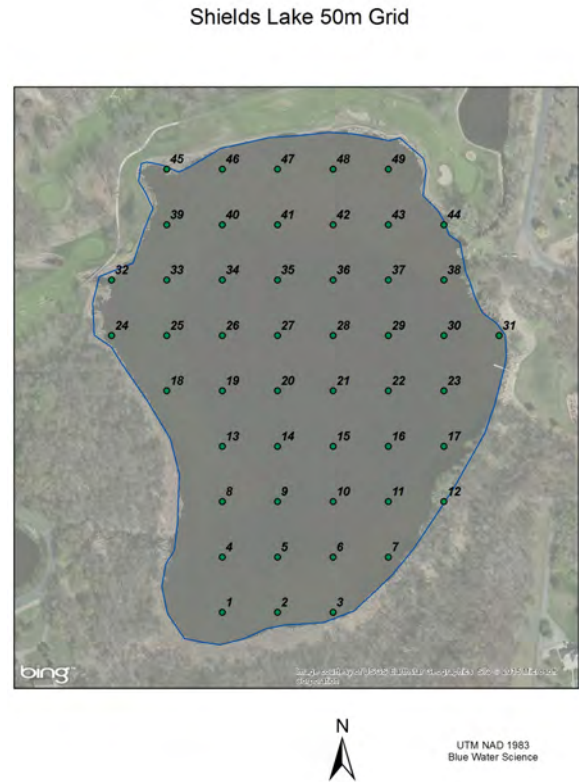
Figure 4. Curlyleaf pondweed coverage for Shields Lake on June 1, 2023. Key: black dots = no growth, green dot = light growth, and brown dots = dead curlyleaf pondweed.

Results of the June 1, 2023 assessment using a point intercept survey found three native submerged plant species, including curlyleaf pondweed, coontail, and elodea (Table 2). The curlyleaf pondweed was observed in the lake both living and dead (Table 3 and Figure 4). Results from the assessment found native plants growing out to a depth of 6 feet (Table 4)(Figure 5).

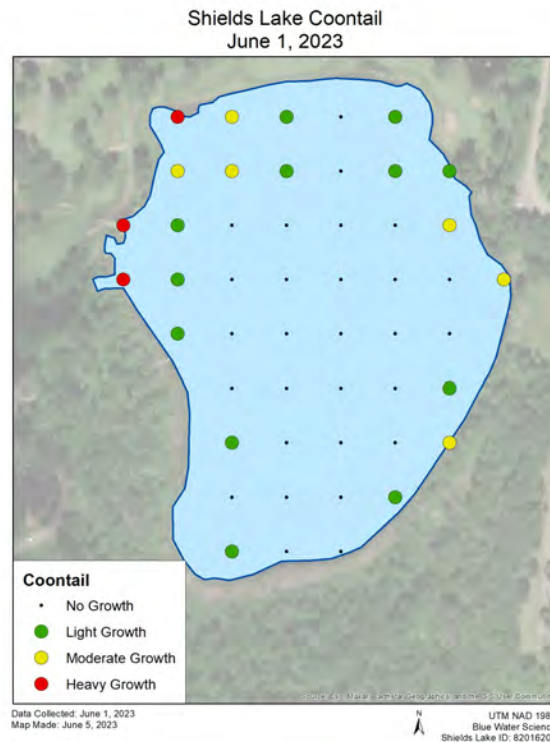
Figure 5. Coontail coverage for Shields Lake on June 1, 2023. Key: black dot = no growth, green dots = light growth, yellow dots = moderate growth, and red dot = heavy growth.

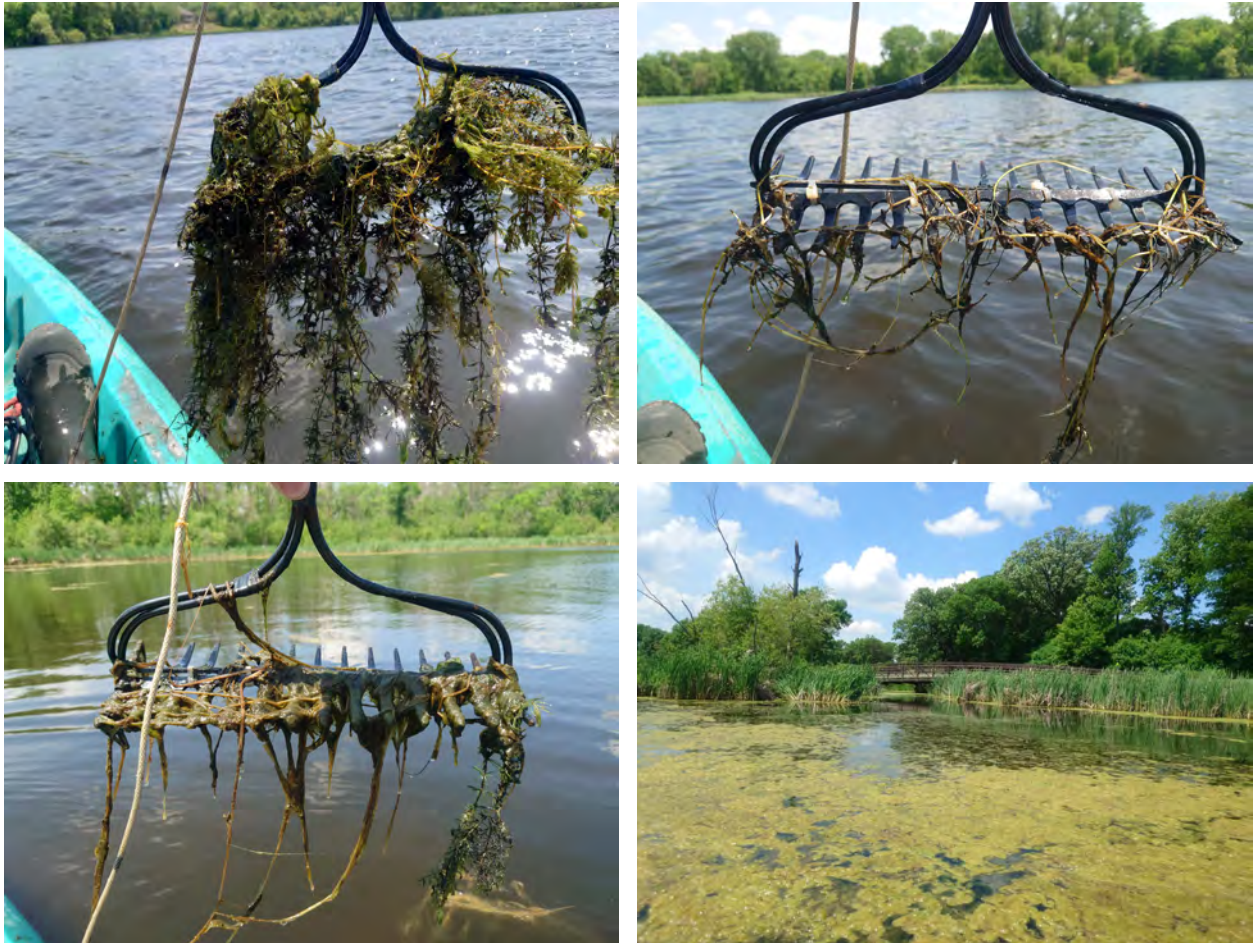
Figure 6. Aquatic plant growth on June 1, 2023.

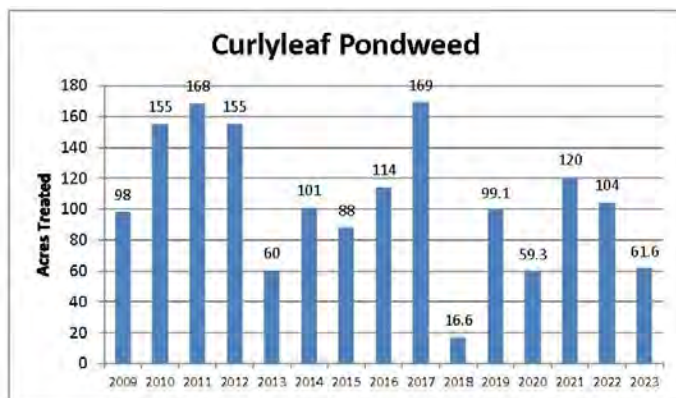
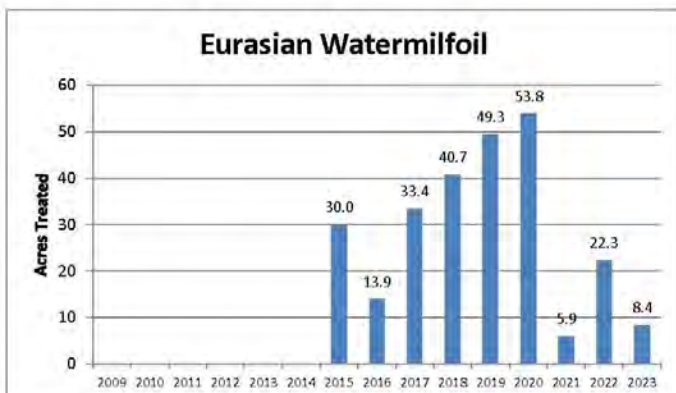
Figure 3. [top] Curlyleaf pondweed treated from 2009-2023. [bottom] Eurasian watermilfoil treated from 2015-2023. Eurasian watermilfoil was first found in Forest Lake in 2015.

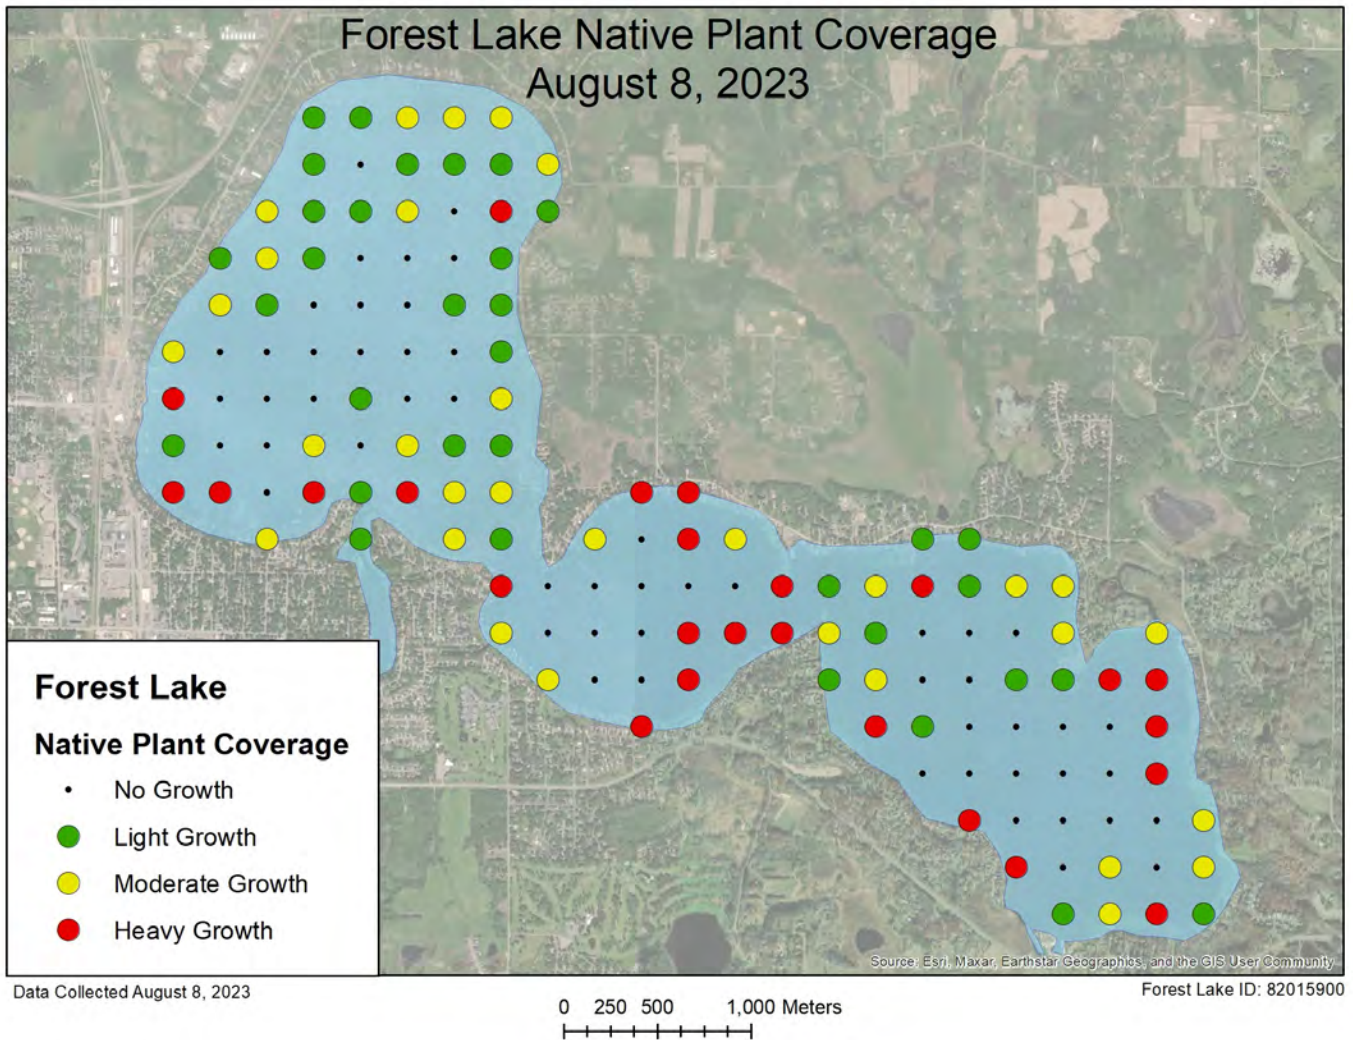
Figure 1. Native aquatic plant coverage of Forest Lake on August 8, 2023.

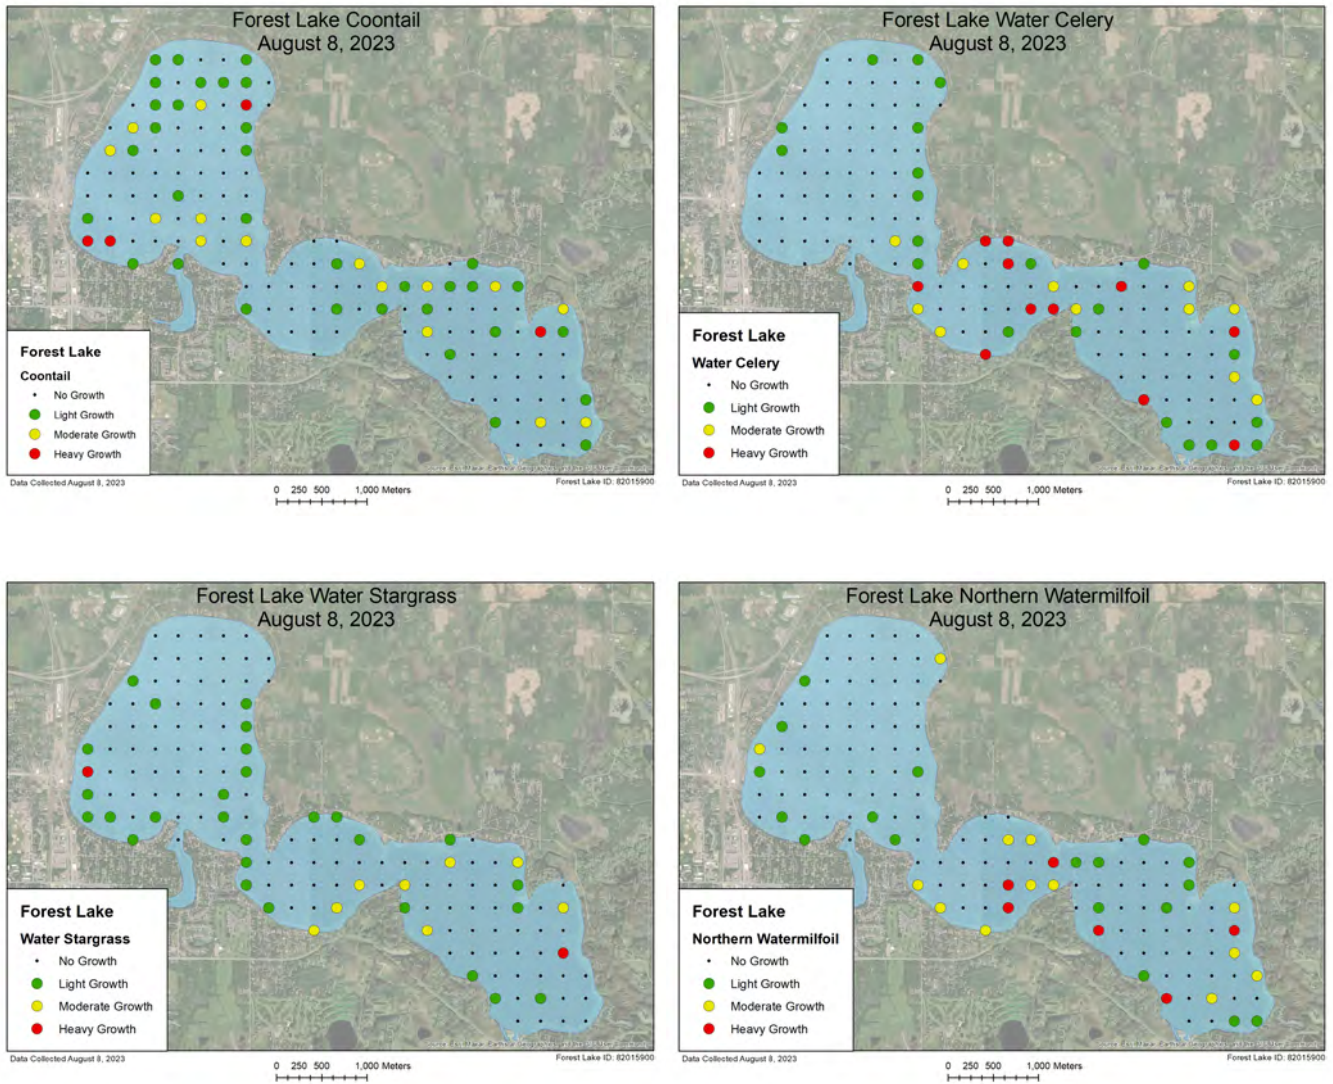
Figure 2. Coontail, water celery, water stargrass, and northern watermilfoil were the most common native submerged plants in 2023.

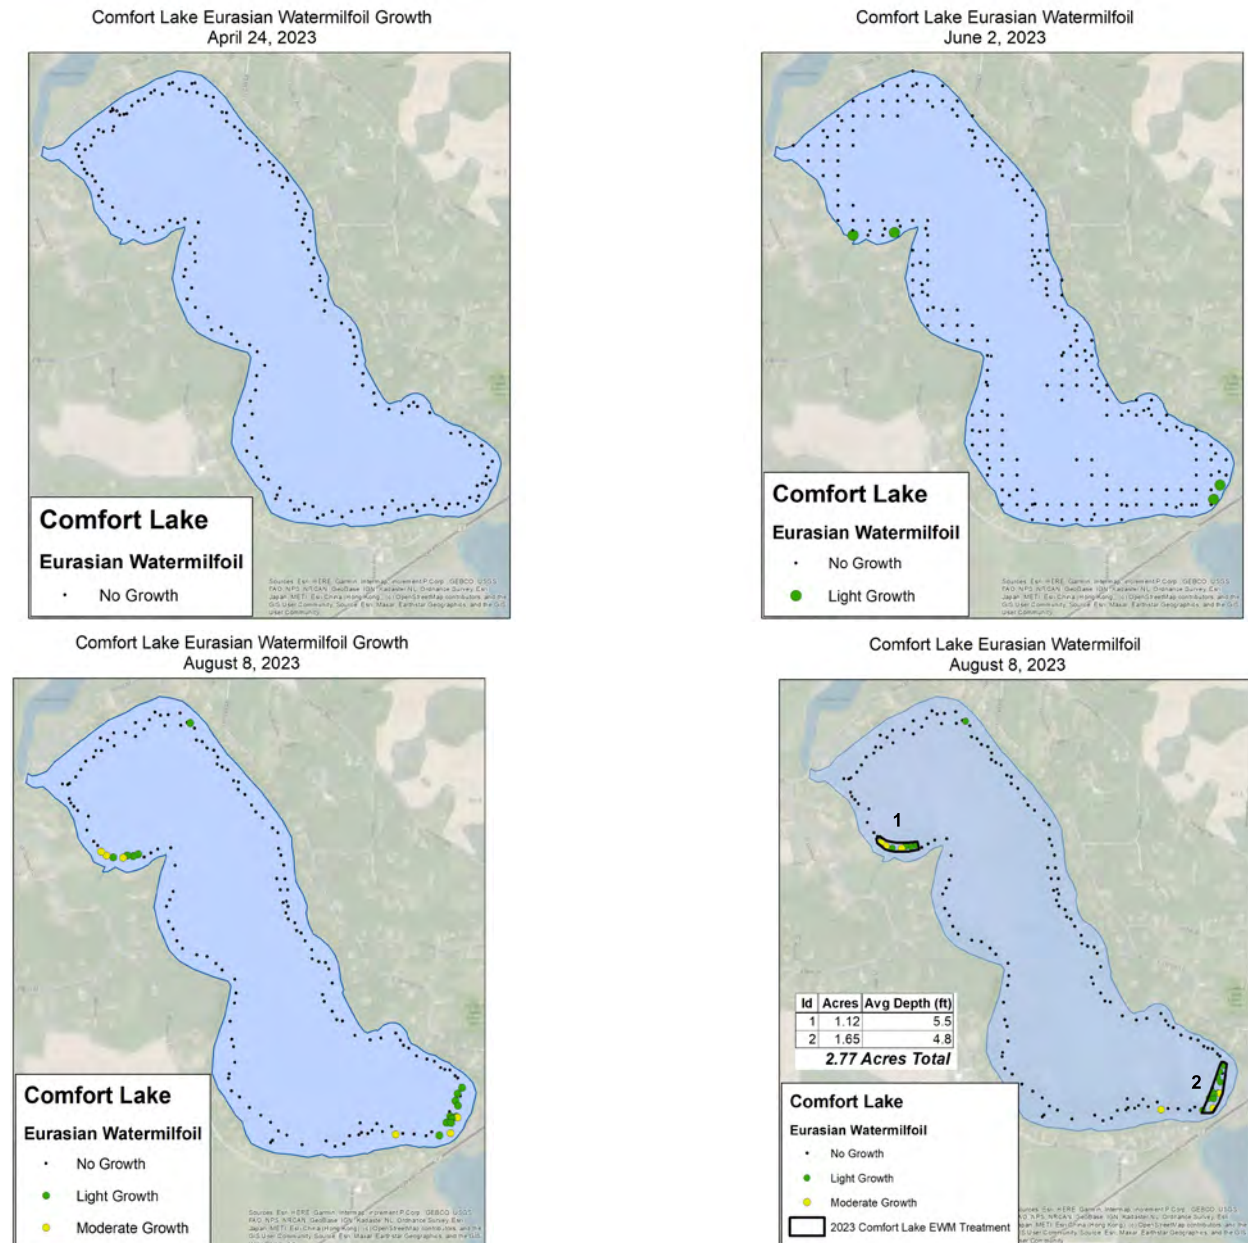
Figure 2. [top-left] DELINEATION: Map of EWM distribution from the April 24, 2023 survey. No EWM was sampled. **[top-right] ASSESSMENT:** Map of point intercept and meander survey for June 2, 2023. EWM was found at 4 sites and all light growth. **[bottom-left] DELINEATION/ASSESSMENT:** Map of a meander survey on August 8, 2023. EWM was found at 21 sites. **[bottom-right] TREATMENT:** Map of meander survey for August 8, 2023 showing the two treatment areas. EWM was treated on September 19, 2023.

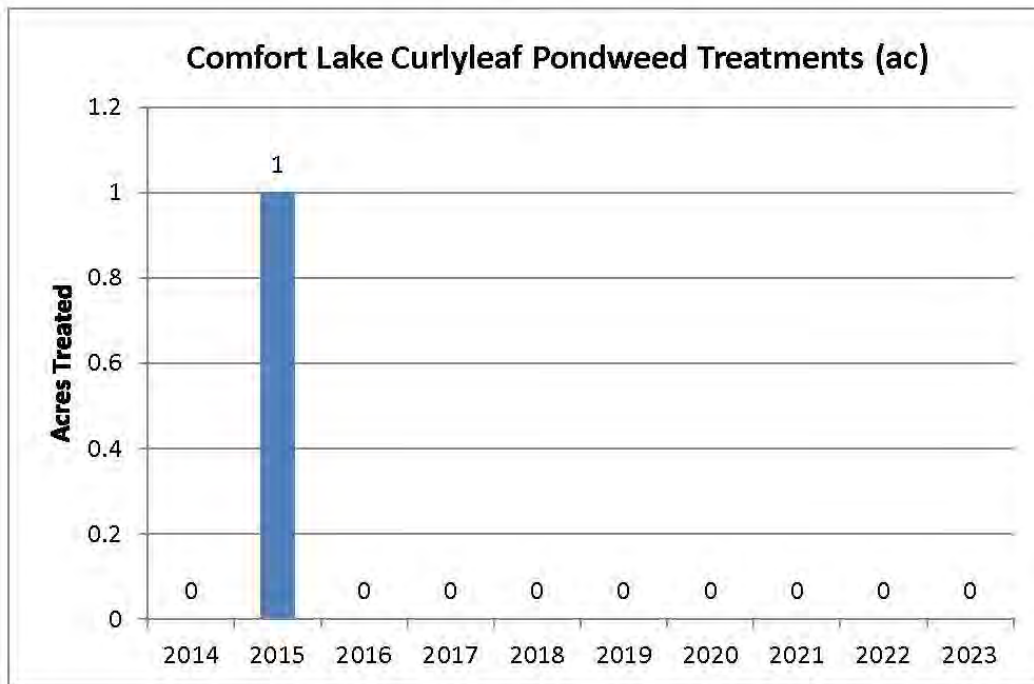
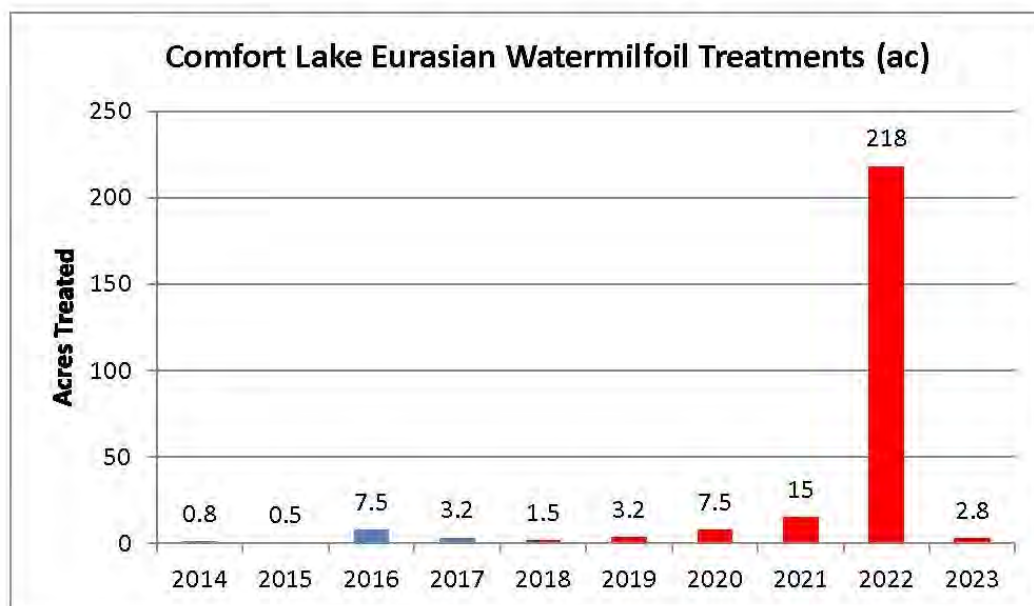
Figure 3. CLFLWD Sponsored Treatments with blue bars and Comfort Lake Association sponsored treatments with red bars: [top] Curlyleaf pondweed treated in 2014-2023. [bottom] Eurasian watermilfoil treated in 2014-2023 (2018 is estimated based on individual permits and 2019, 2020, and 2021 treatments were by the Comfort Lake Association). A full lake fluridone treatment was conducted in 2022. An EWM treatment of 2.77 acres occurred in 2023.

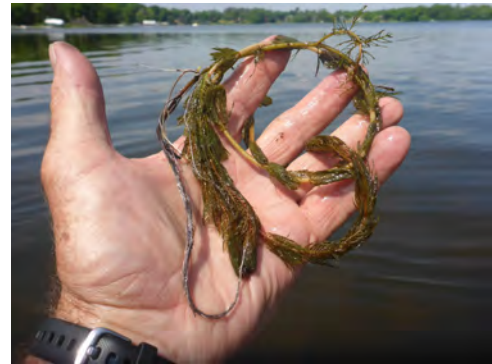
Figure 4. Eurasian watermilfoil on June 2, 2023.

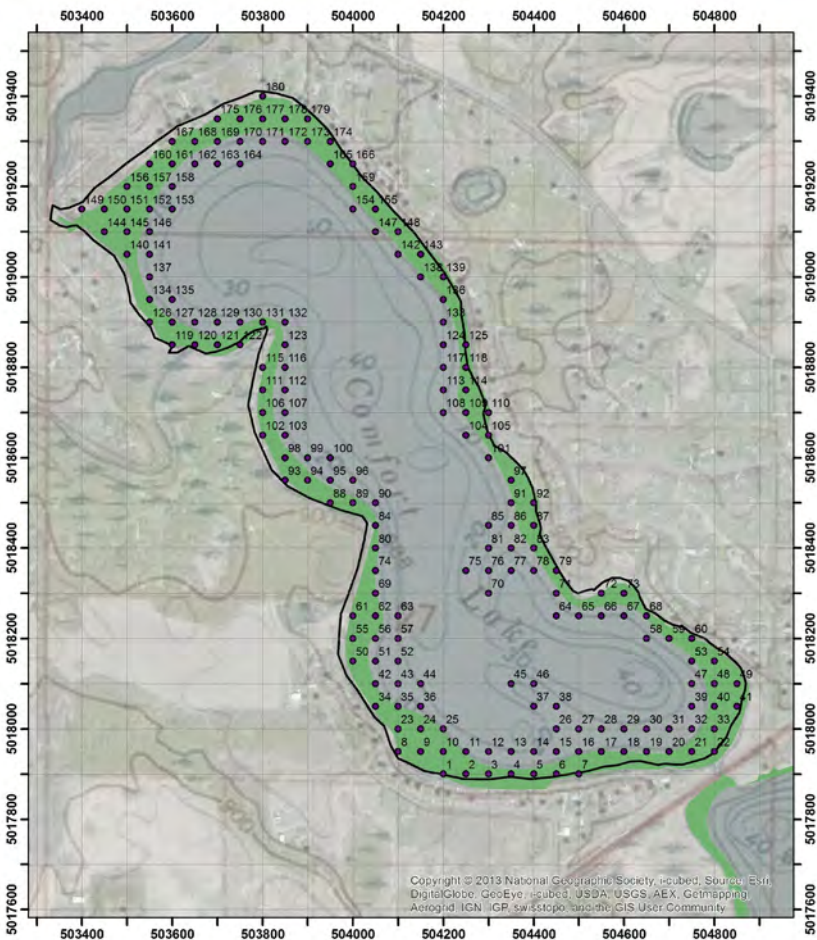
Figure 6. Sample location map for the aquatic plant surveys conducted on Comfort Lake. Green shading represents the littoral zone of Comfort Lake.

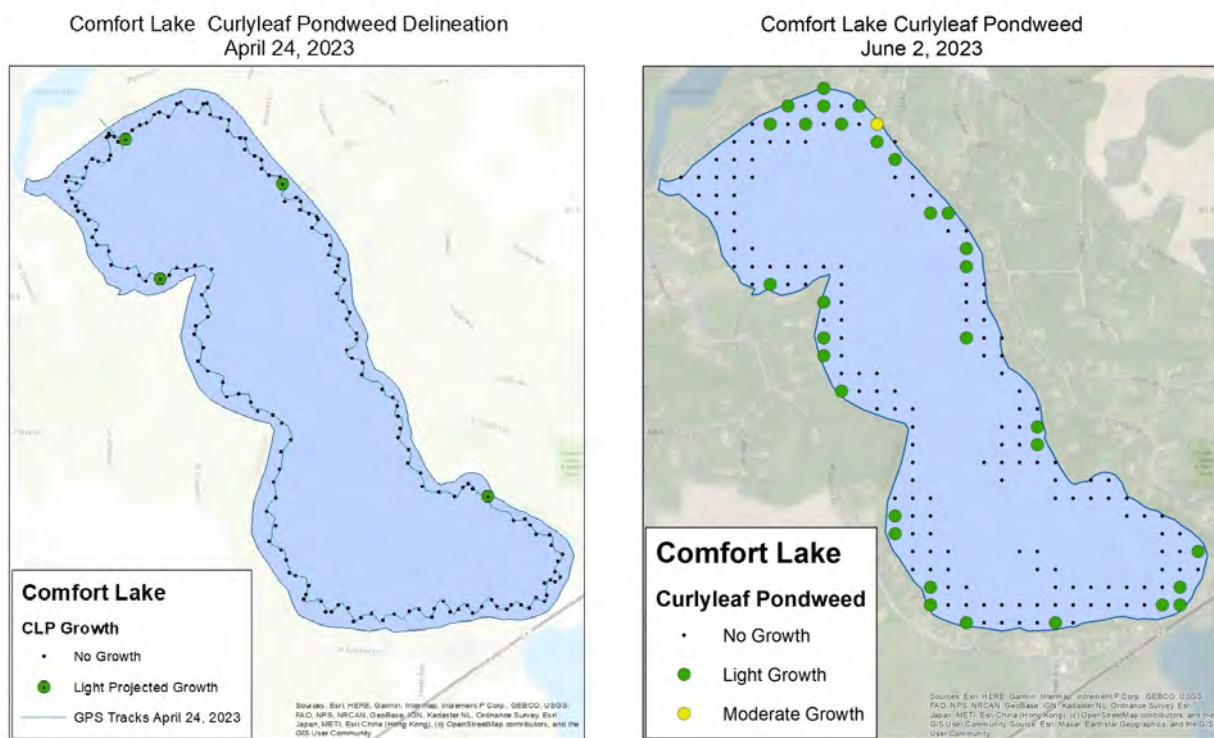
Figure 8. [left] DELINEATION: Map of curlyleaf pondweed distribution from the April 24, 2023 meander survey. Key: black dots = sample locations and green dot = light growth potential. **TREATMENT:** No curlyleaf pondweed treatment occurred in 2023. **[right] ASSESSMENT:** Map of curlyleaf pondweed assessment sites for June 2, 2023 included a point intercept combined with a meander survey. Key: black dots = no curlyleaf growth, green dots = light growth, and yellow dots = moderate growth.

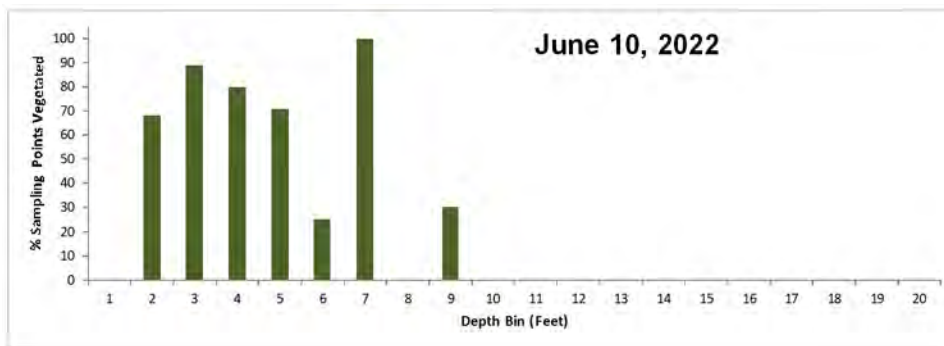
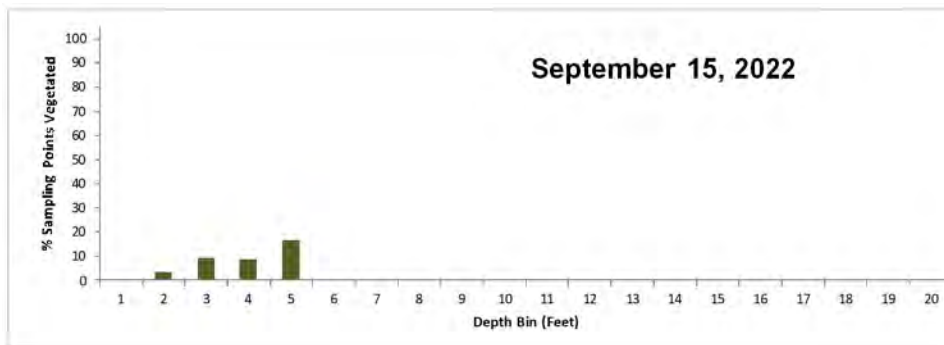
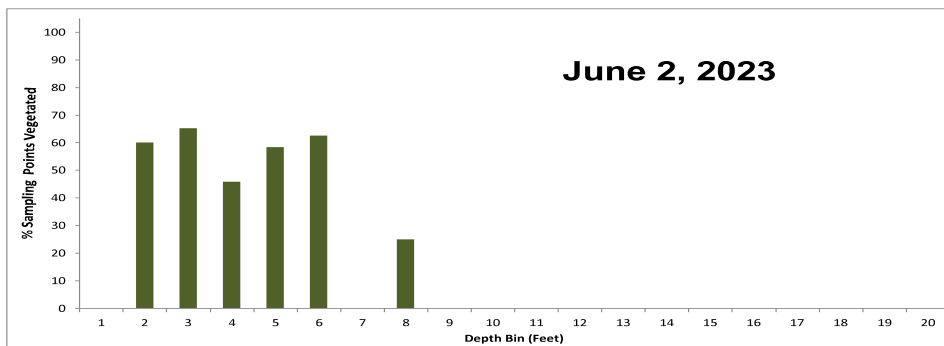
Figure 10. Number of vegetated sites by depth.

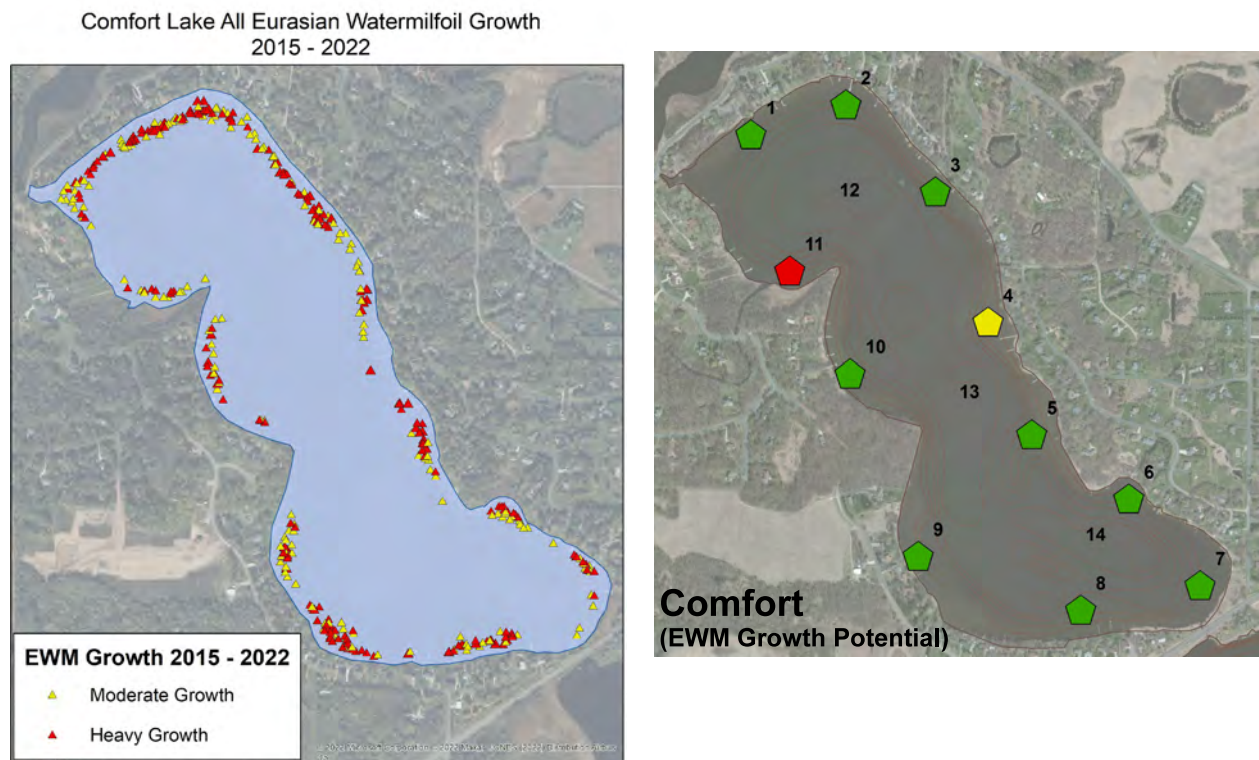
Figure 11. [left] EWM growth distribution and density for 2015-2022. [right] EWM potential growth based on lake sediment analyses for Comfort Lake. Key: green = light growth, yellow = moderate growth, and red = heavy growth.
