## **Curlyleaf Pondweed Delineation and Assessment and a Point-Intercept Plant Survey For Comfort Lake, Chisago County, 2014**

Delineation: May 20, 2014  
Assessment: June 16, 2014  
Summer Point-Intercept Survey: July 21, 2014

Prepared for:  
**Comfort Lake/Forest  
Lake Watershed District  
Forest Lake, Minnesota**

Prepared by:  
**Steve McComas  
Blue Water Science  
St. Paul, MN 55116**

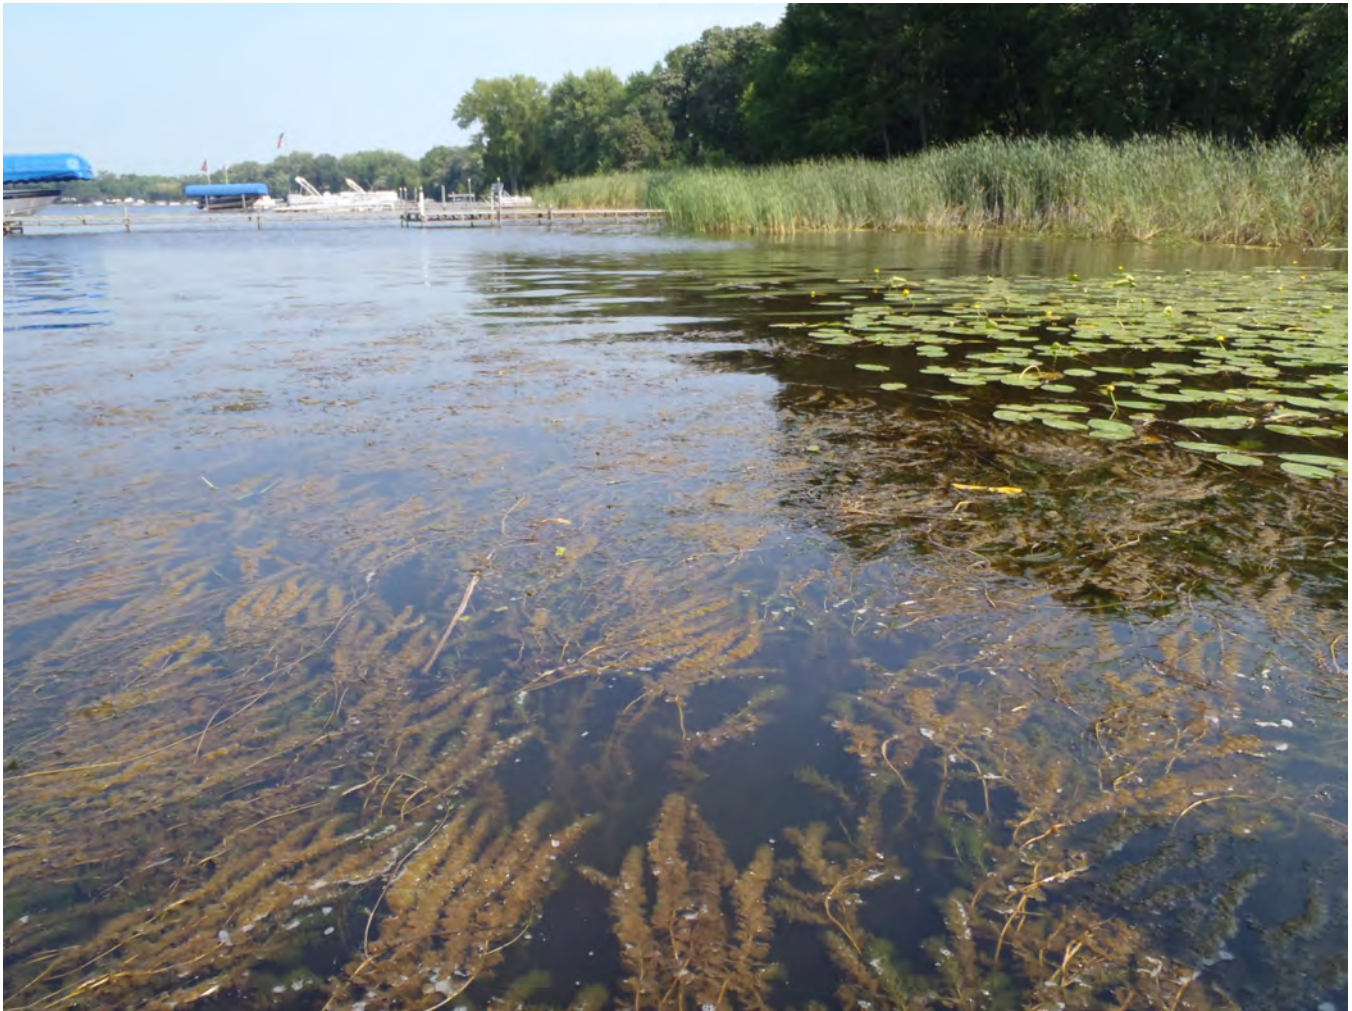
Eurasian Watermilfoil Observation in Comfort Lake on July 21, 2014

**Discovery of Eurasian Watermilfoil:** During the point-intercept survey on July 21, 2014, Eurasian watermilfoil (EWM) was identified at three sites (Figure S3). EWM was verified by the MnDNR on August 6, 2014 at 13 sites. Due to the lateness of the season, only the EWM area at the public access was treated. EWM will be monitored in the next few years to characterize distribution and abundance.

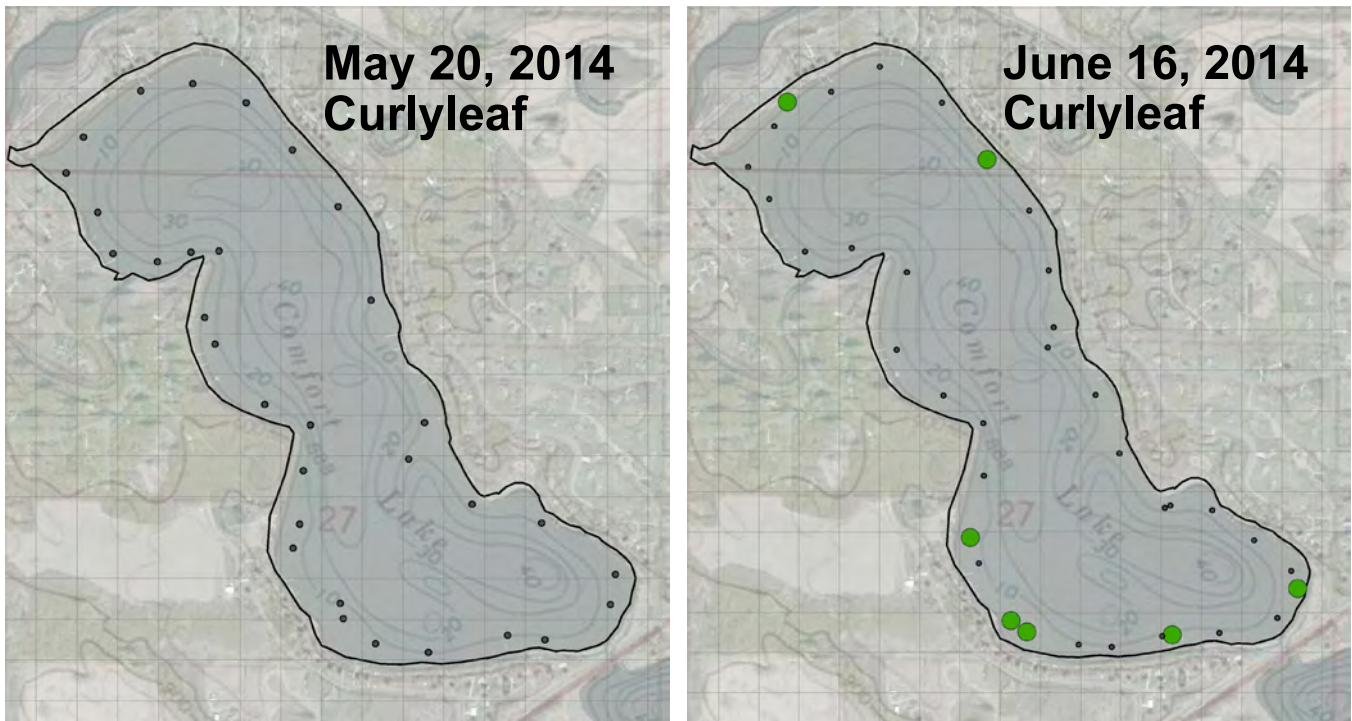
Figure S1. [left] **DELINEATION:** Map of curlyleaf pondweed distribution from the May 20, 2014 survey. Black dots = sample locations. No curlyleaf pondweed was observed on May 20, 2014. **TREATMENT:** No curlyleaf pondweed treatment occurred in 2014. [right] **ASSESSMENT:** Map of curlyleaf pondweed assessment sites for June 16, 2014. Black dots = no curlyleaf and green circles = light growth.

In the delineation survey, curlyleaf was not found in Comfort Lake (Figure S1) but a few native plants were sampled. No curlyleaf pondweed treatment occurred in 2014.

About a month later, in the June curlyleaf assessment, curlyleaf had sprouted and was found at 7-sites but growth was mostly light (Figure S1).

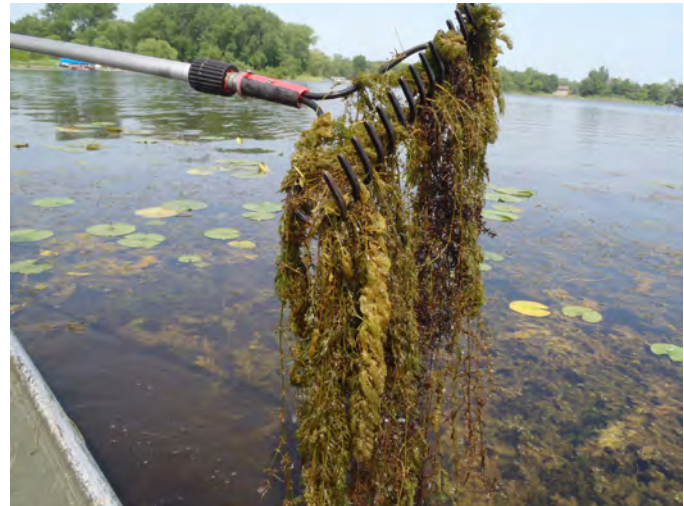
**Figure S2. Coontail at a density of a “3” on a sample rake.**

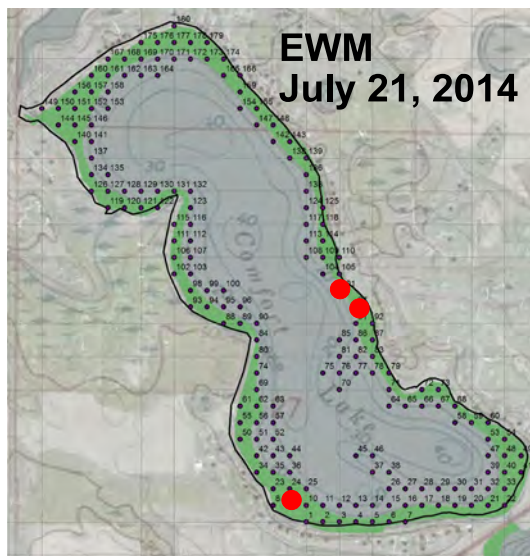
**Figure S3. EWM locations (red dots) on the July 21, 2014 point-intercept survey.**

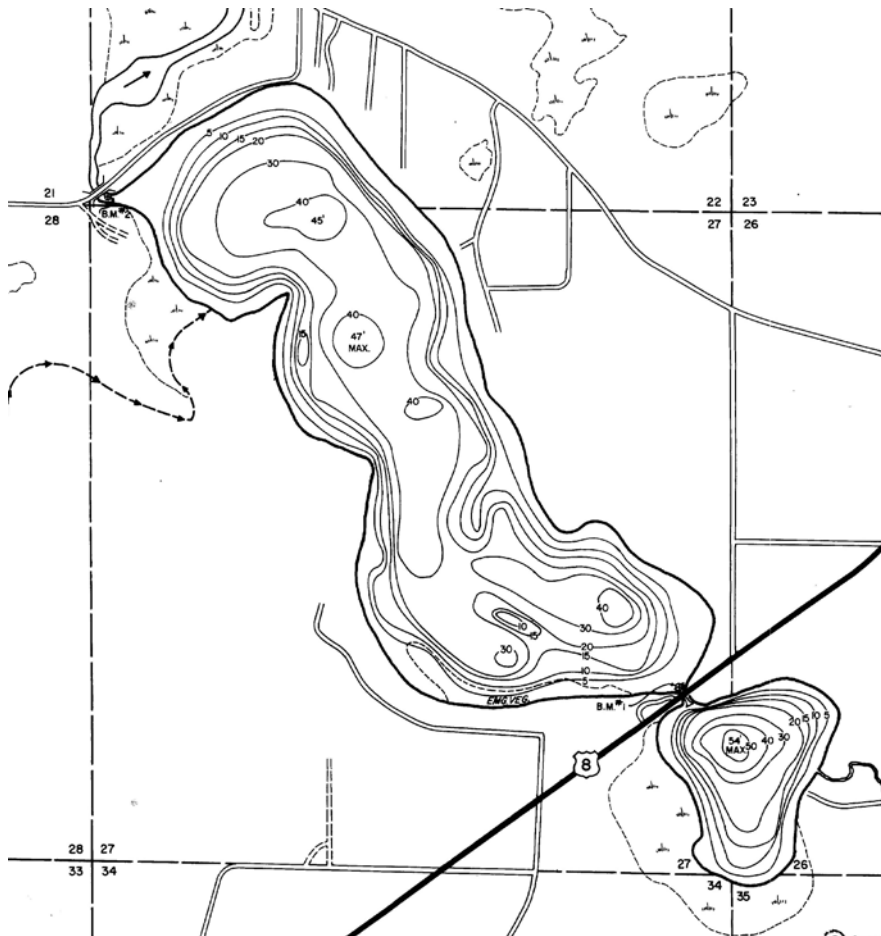
Figure 1. Contour map of Comfort Lake (source: MnDNR).

Comfort Lake has an area of 218 acres with a littoral area of 90 acres (MnDNR). The maximum depth of Comfort Lake is 37 feet. The extent of heavy growth of curlyleaf pondweed is unknown. The objectives of the curlyleaf surveys were to delineate the acreage of curlyleaf pondweed to treat and then treat is necessary and then after treatment, assess the effectiveness of the treatment.

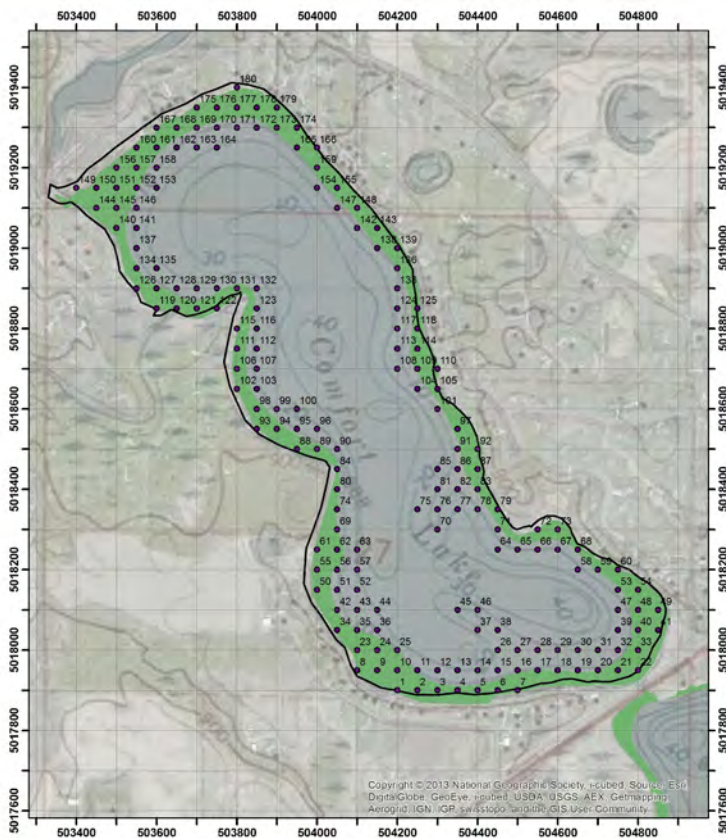
**Figure 2. Sample location map for the aquatic plant surveys conducted on Comfort Lake. Green shading represents the littoral zone of Comfort Lake.**

**Summer Point-Intercept Survey Methods:** A point intercept aquatic plant survey of Comfort Lake was conducted by Blue Water Science on July 21, 2014, and 180 points were sampled out to 15 feet of water depth (Figure 2). The deepest depth of plant colonization in Comfort Lake was out to 6 feet, although all sites were sampled. Sample points were placed 50 meters apart on a grid that covered the lake. Each sample point was equal to 0.62 acres. At each sample point, a sampling rake was lowered into the water and a plant sample was taken. The plant species were recorded and the density of each species was assigned. Densities were based on the coverage on the teeth of the rake. Density ratings were from 1 to 5 with 1 being sparse and 5 being a matted nuisance. Based on these sample sites, plant distribution maps were constructed. A chart showing examples of curlyleaf growth conditions are shown on the next page.

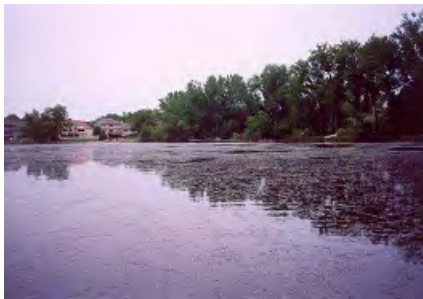
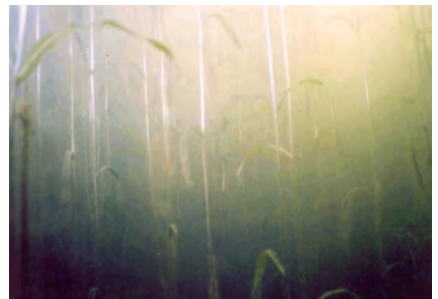
Broken surface canopy conditions.

Biomass: 50 - 85 g-dry wt/m<sup>2</sup>

Estimated TP loading: 2.2 - 3.8 lbs/ac

*MnDNR rake sample density equivalent for moderate growth conditions: 2, 3 or sometimes, 4.*

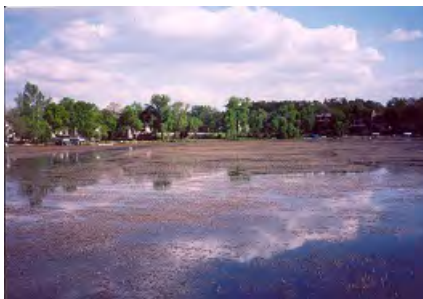
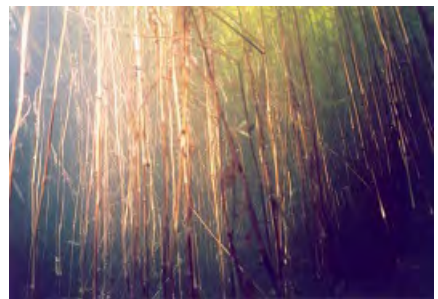
Solid or near solid surface canopy conditions.

Biomass: >300 g-dry wt/m<sup>2</sup>

Estimated TP loading: >6.7 lbs/ac

*MnDNR rake sample density has a scale from 1 to 4. For certain growth conditions where plants top out at the surface, the scale has been extended: 4.5 is equivalent to a near solid surface canopy and a 5 is equivalent to a solid surface canopy. Heavy growth conditions have rake densities of a 4 (early to mid-season with the potential to reach the surface), 4.5, or 5.*

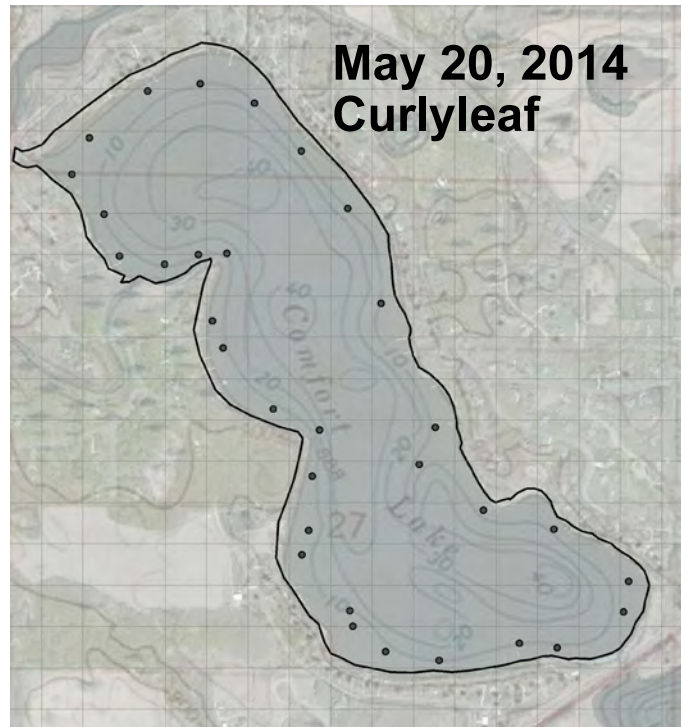
**Figure 3. Map of curlyleaf delineation in Comfort Lake on May 20, 2014. No curlyleaf was observed.**

A curlyleaf delineation was conducted using rake sampling on May 20, 2014. Thirty-two sites were examined. At this time of the year curlyleaf was not found in Comfort Lake (Table 1 and Figure 3).

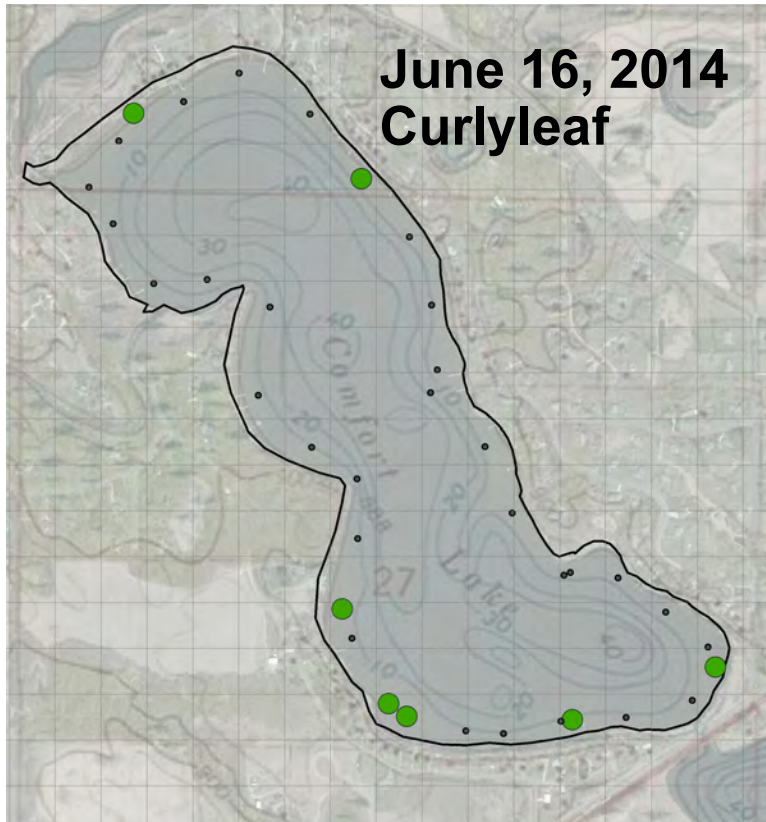
**Figure 4. Map of curlyleaf distribution in Comfort Lake on June 16, 2014. Green circles = light growth and black dots = sample locations.**

A total of 37 sites were assessed with rake sampling on June 16, 2014. Curlyleaf was found at 7 sample sites out of the 37 that were monitored (Table 2). Curlyleaf growth was found to be light at all 7 sites (Figure 4 and Table 2).

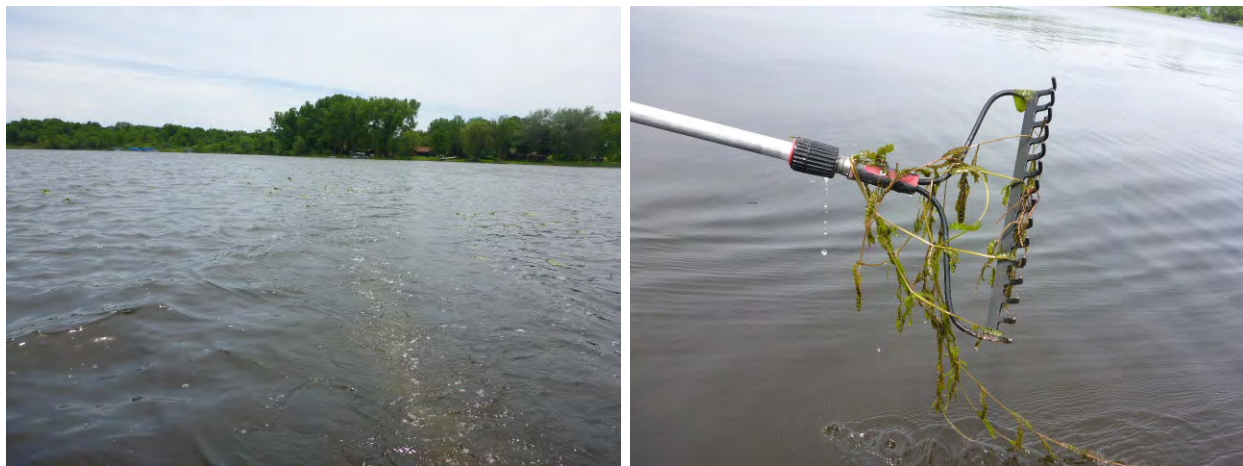
**Figure 5. Curlyleaf pondweed was found around Comfort Lake on June 16, 2014. [left] View of Comfort Lake, no plants were reaching the lake surface. [right] Curlyleaf was sampled at a density of a "1".**

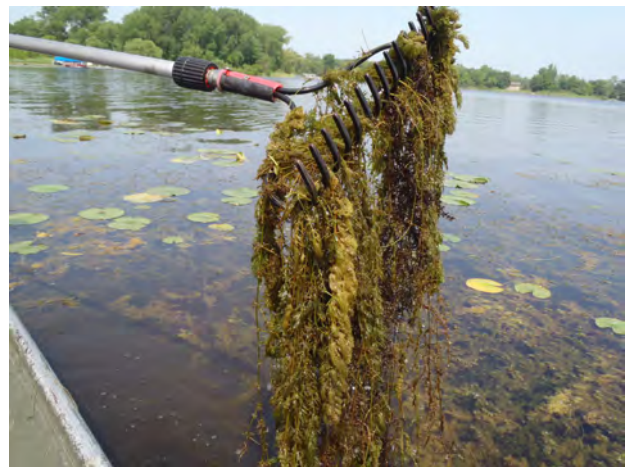
**Figure 6. Coontail at a density of a “3” on a sample rake.**

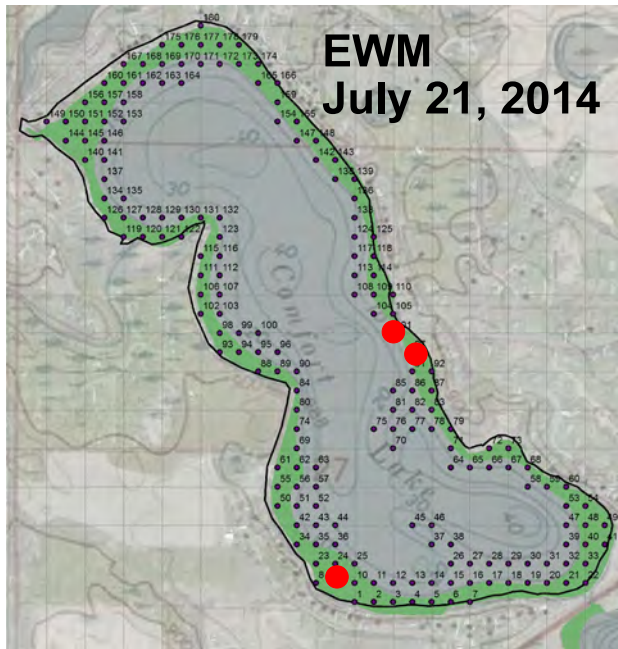
During the point-intercept survey on July 21, 2014, Eurasian watermilfoil (EWM) was identified at three sites (Figure 7a). EWM was verified by the MnDNR on August 6, 2014 at 13 sites (Figure 7b). Due to the lateness of the season, only the EWM area at the public access was treated (Figure 7c). EWM will be monitored in the next few years to characterize distribution and abundance.

Figure 7a. EWM locations (red dots) on the July 21, 2014 point-intercept survey.

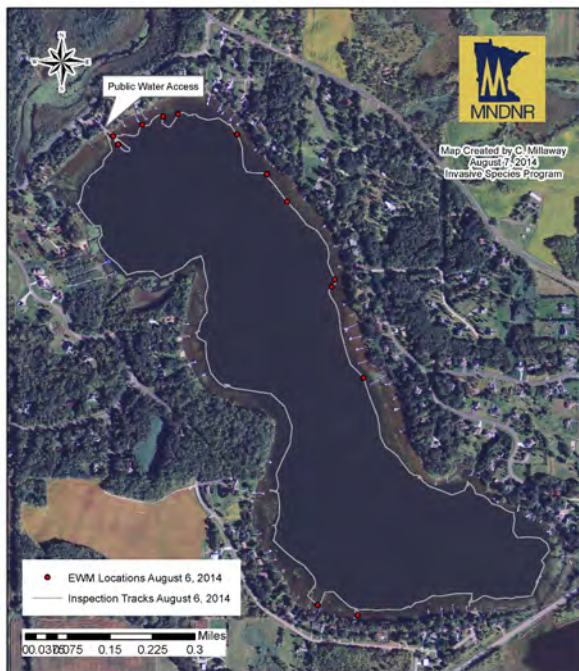
Comfort Lake, Chisago County (13005300)  
Eurasian watermilfoil Inspection: August 6, 2014  
Invasive Species Program

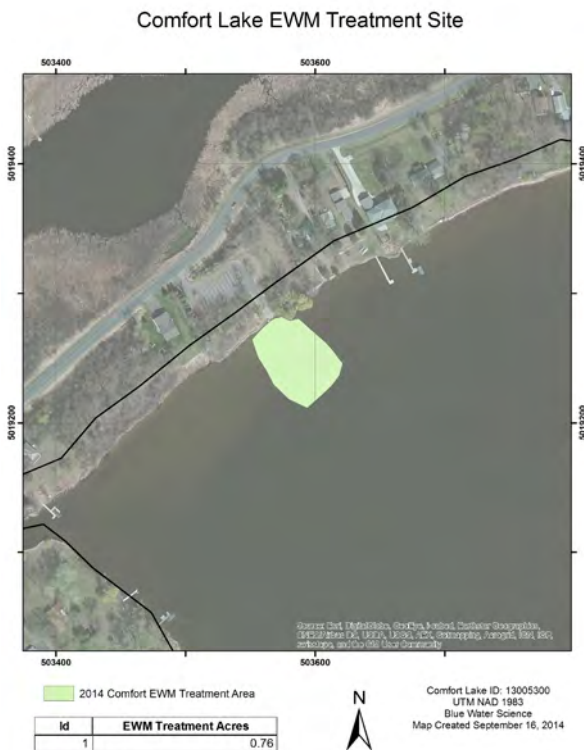
Figure 7c. EWM treatment area in front of the public access.

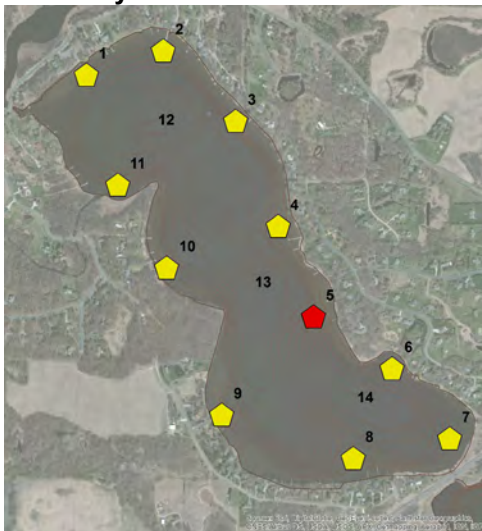
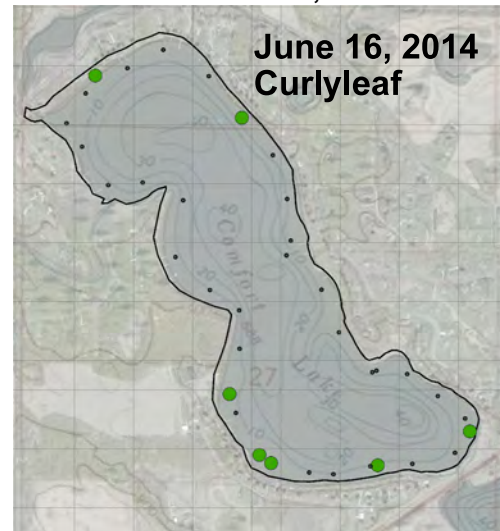
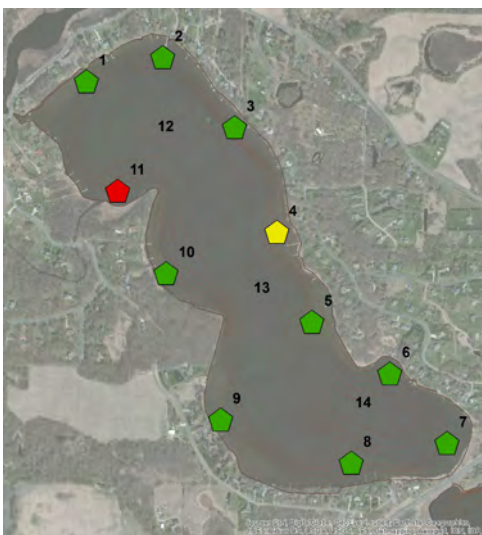
Lake sediment sampling has been used to predict lake bottom areas that have the potential to support heavy curlyleaf pondweed plant growth. Based on the key sediment parameters of pH, sediment bulk density, organic matter, and the Fe:Mn ratio (McComas, unpublished), the predicted growth characteristics of curlyleaf pondweed in Comfort Lake are shown in Figure 8.

Lake sediment sampling also has been used to predict lake areas that have the potential to support various types of EWM growth. Based on the key sediment parameters of  $\text{NH}_4$  and organic matter (McComas, unpublished), a map was prepared that predict the type of growth that could be expected in the future in Comfort Lake (Figure 8).

**Figure 8. [top] Curlyleaf pondweed predicted (left) and actual (right) growth maps. [bottom] Eurasian watermilfoil predicted (left) and actual (right) growth maps.**
