Comfort Lake-Forest Lake Watershed District

Date: February 8<sup>th</sup>, 2024  
To: CLFLWD Board of Managers  
From: Mike Kinney, District Administrator  
Subject: Shoreline Program Update

# 2023 SHORELINE INVENTORY

January 2024

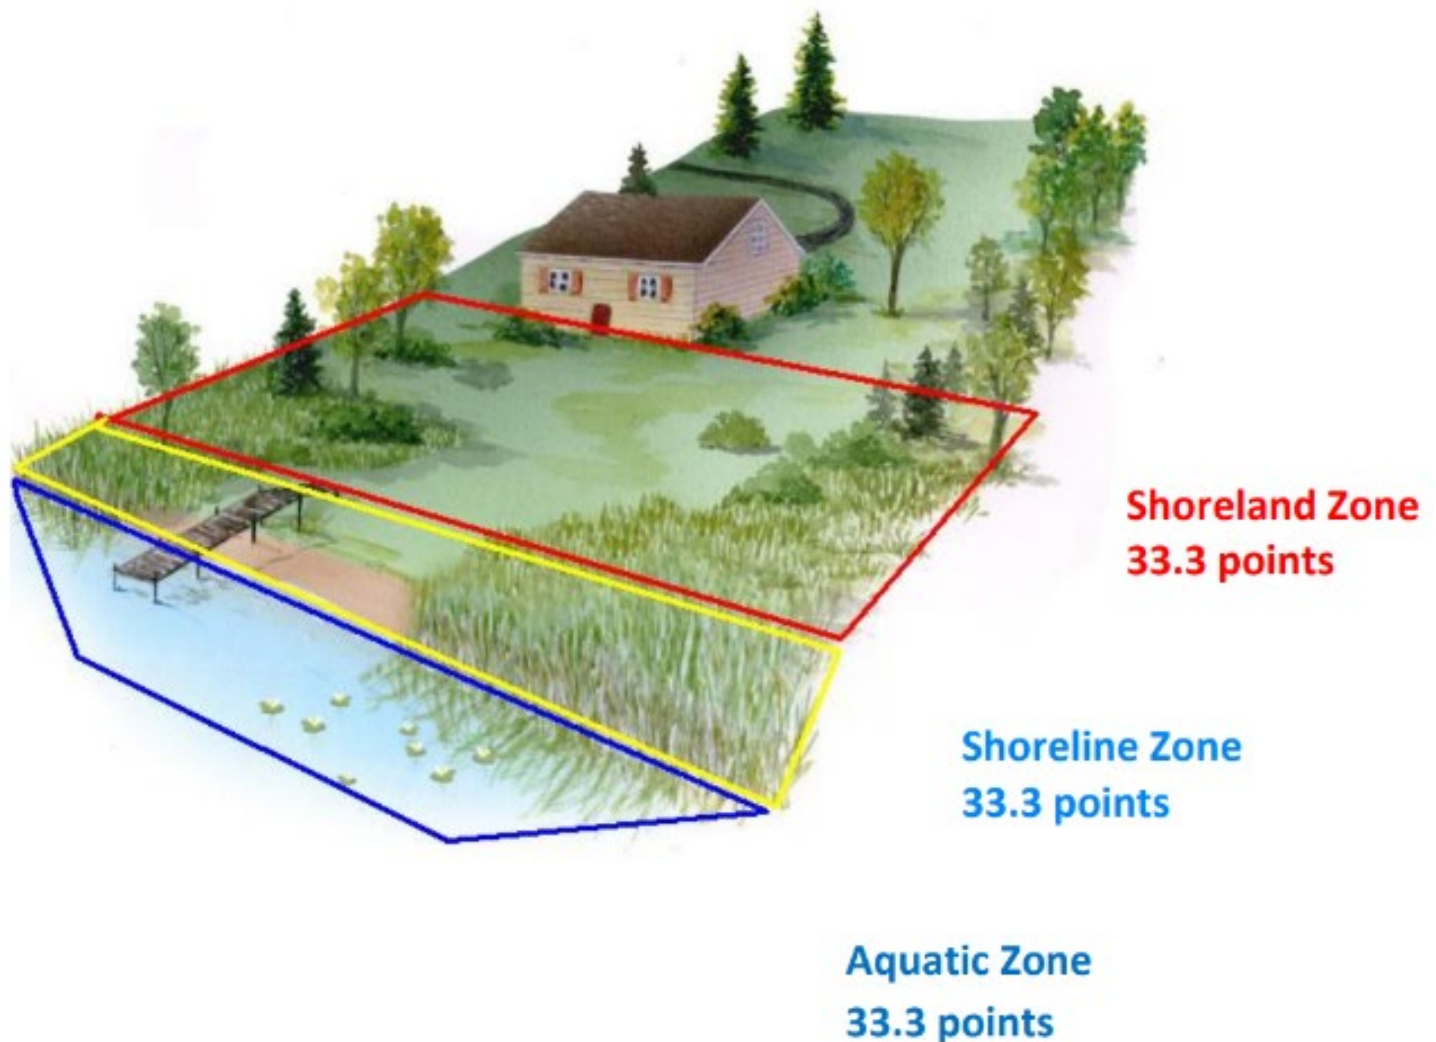
**FIGURE 2 – STS ZONES**

The STS method breaks out habitat zones into shoreland, shoreline, and aquatic, each with their own score. This allows the data to better inform management decisions about land use and development on the lakes surveyed. The primary focus of this report will be on the shoreland and shoreline zones. While STS has an emphasis on habitat, many of the same characteristics that make quality shoreline habitat also reduce shoreline erosion and improve water quality.

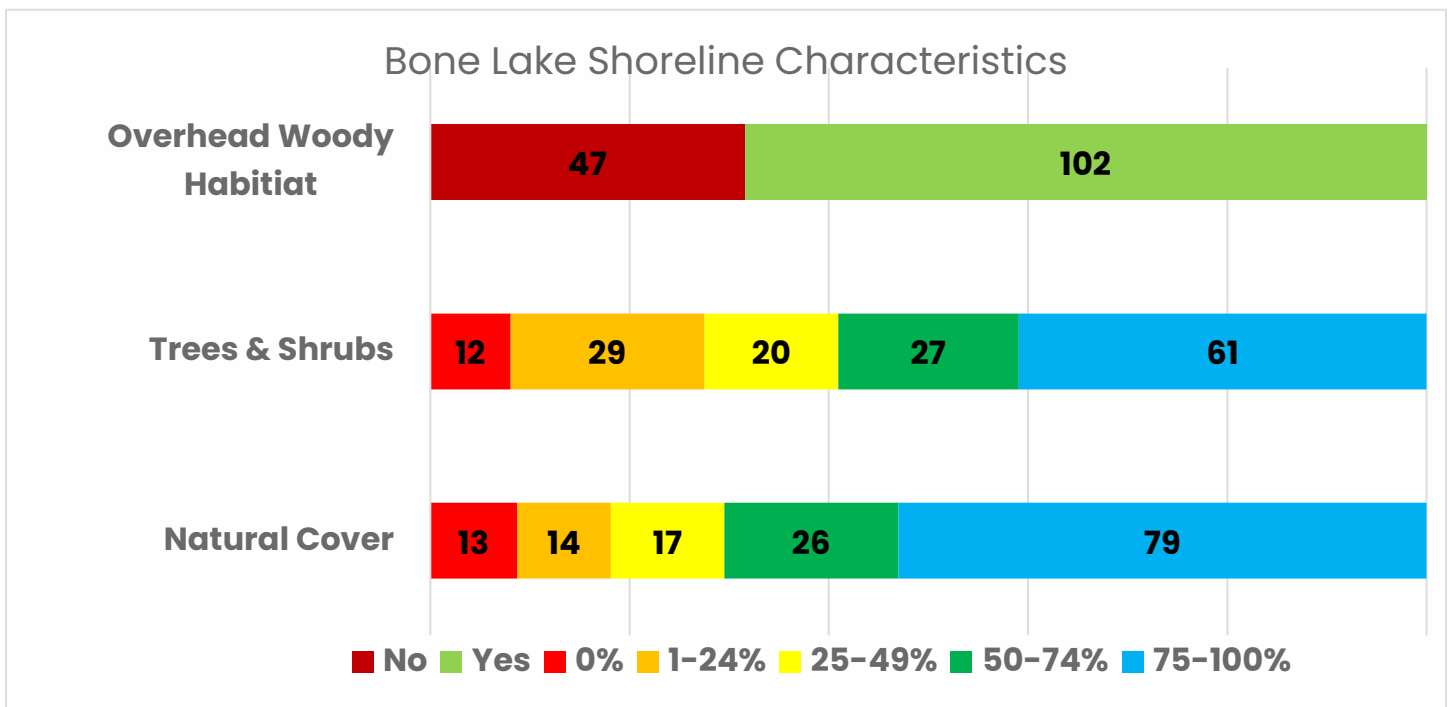
FIGURE 8- CHARACTERISTICS OF BONE LAKE SHORELINE

The shoreline cover metric is useful for assessing the presence of a buffer but does not include characteristics of the rest of the shore area. The total shoreline score includes the percent of natural cover, the presence of trees, shrubs, or wetland, and the presence of overhanging woody habitat, such as fallen trees or branches. It can be noted in Figures 6 & 7 that the percentage of shoreline with a “High” score is lower than the number meeting the natural cover goals. The breakdown of characteristics of each survey point can be viewed in figure 8. Note that 13 points completely lacked natural cover.

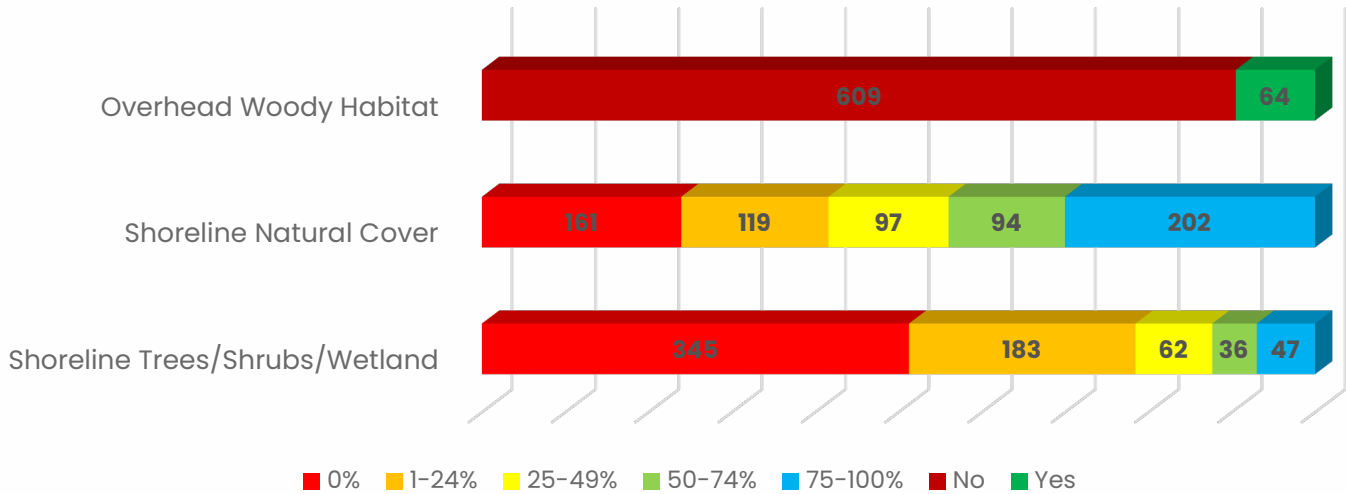
FIGURE 27- FOREST LAKE SHORELINE CHARACTERISTICS

More details on the characteristics of the shoreline can be viewed in figure 27. Notable in this figure is that there are 161 points that had 0% natural cover, and 345 sites with zero trees, shrubs, or wetland. These sites that have 0% canopy or natural cover are a high priority for addressing shoreline issues and are having a significant impact on water quality and shoreline habitat on Forest Lake. The lack of shoreline canopy can be seen clearly in figure 28 where each red point is a site with zero trees, shrubs, or wetland.

- ❑ Plant a tree! – 345 points  
without shoreline trees or shrubs
- ❑ Don't go there? Don't mow  
there! – 161 points without any  
natural vegetation
- ❑ If a tree falls in the lake... leave it!  
– 609 points without overhanging  
woody habitat

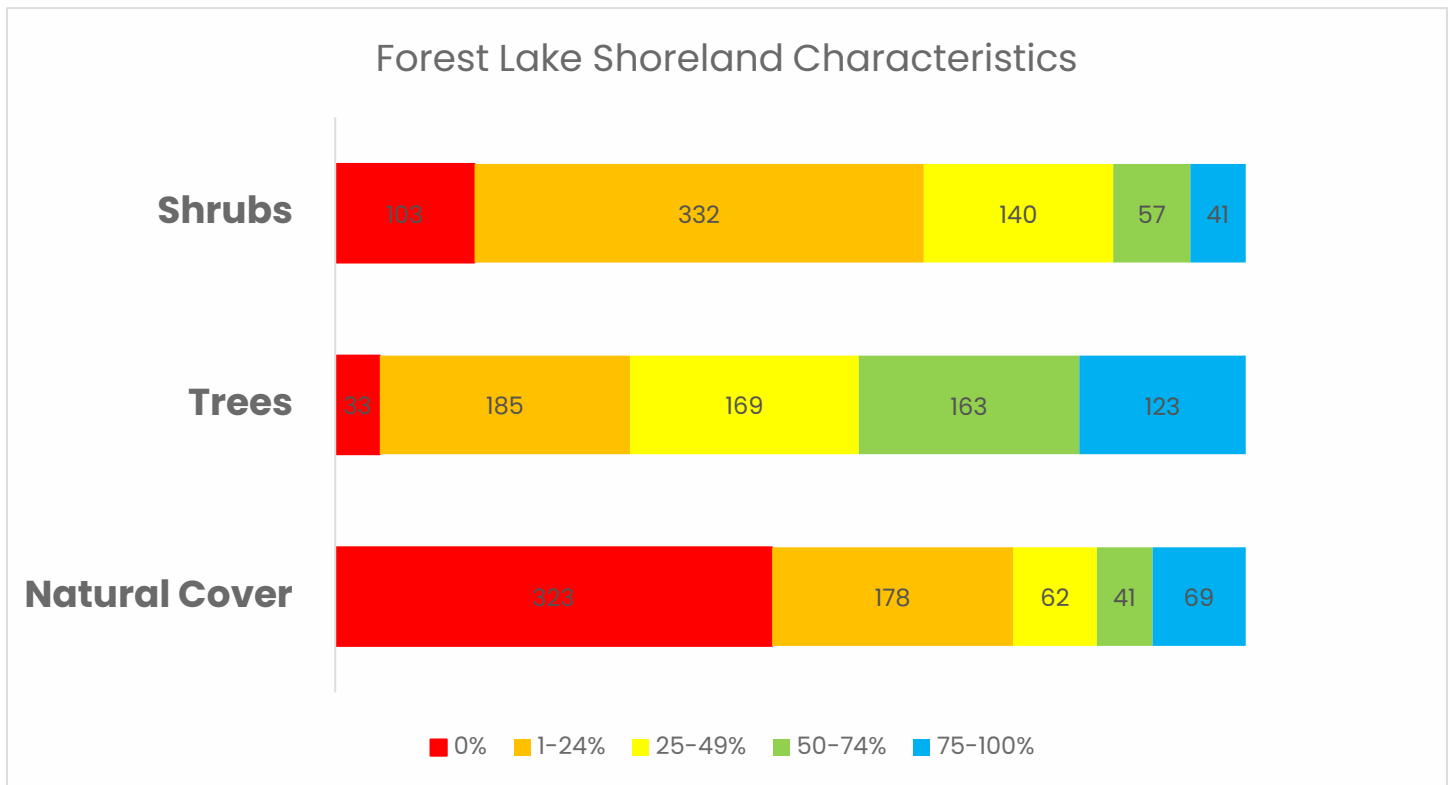
FIGURE 29 – FOREST SHORELAND CHARACTERISTICS

The shoreland zone of Forest Lake scored 13.87/33, or Very Low. While a higher score than the shoreline zone, there was still a lack of natural cover on 323 points. More details of the shoreland characteristics can be viewed in figure 29. The priority for targeting shoreland areas is improving the 33 points that lack canopy cover, and the 75% of points that have under 25% natural cover.

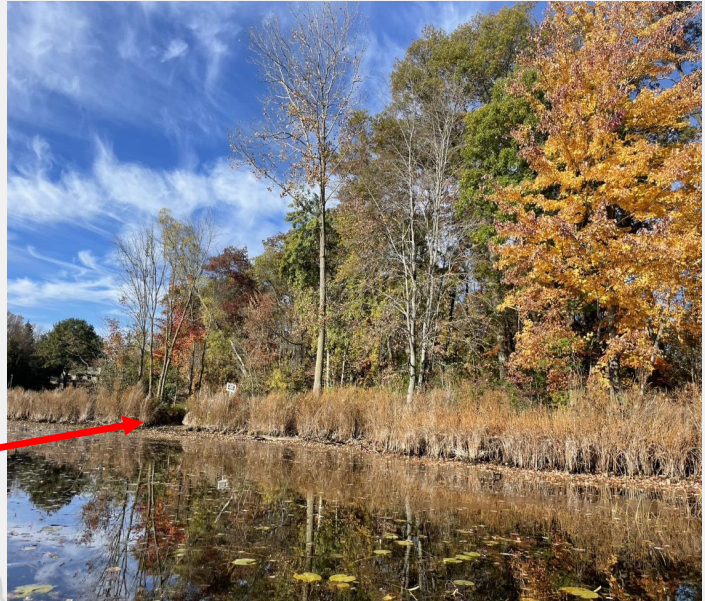
Lake Keewahtin Example:  
100% natural shoreline cover  
100% shoreline trees or shrubs

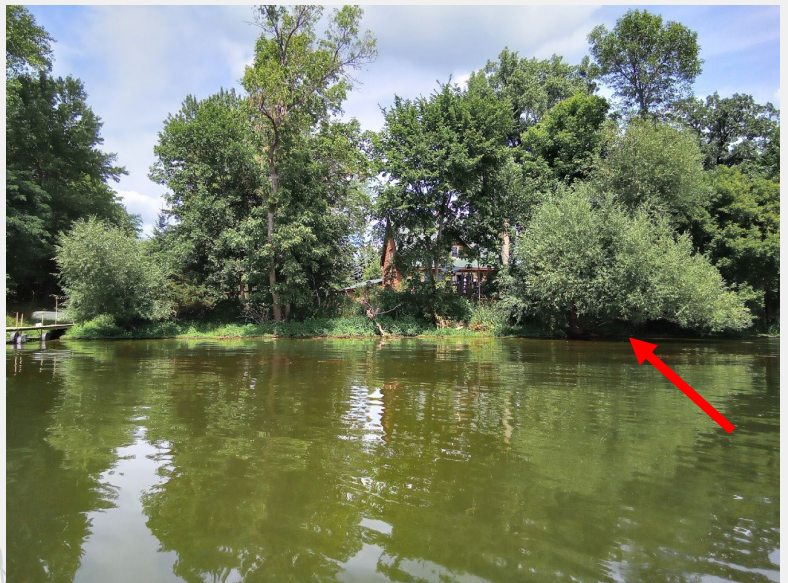
Bone Lake Example:  
75-100% natural shoreline  
cover  
75-100% shoreline trees or  
shrubs

*Note the overhanging woody  
habitat*

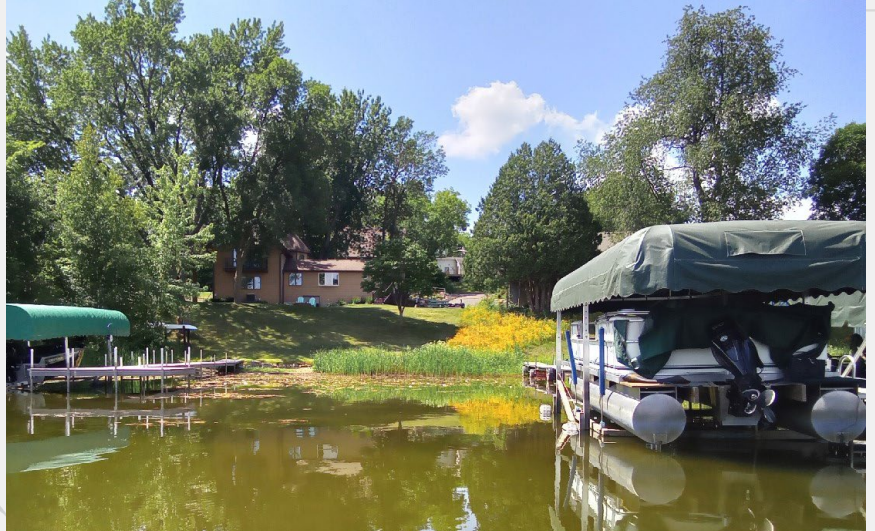
Bone Lake Example:  
50-74% natural shoreline  
cover  
1-24% shoreline trees or  
shrubs

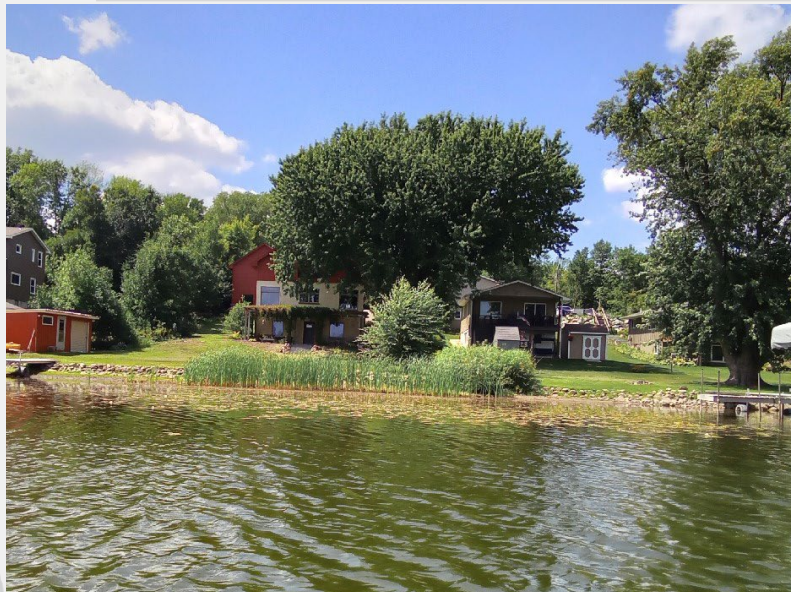
Bone Lake Example:  
25-49% natural shoreline  
cover  
25-49% shoreline trees,  
shrubs, or wetland

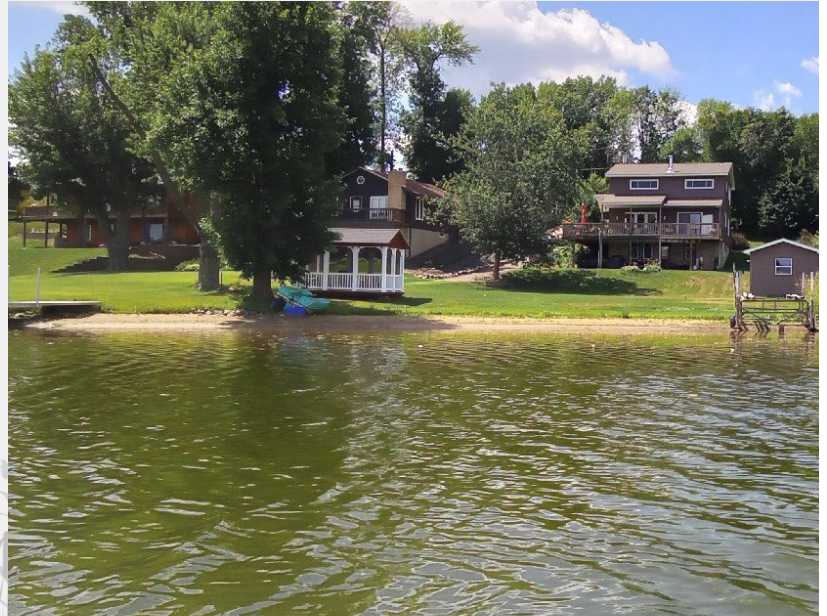
Bone Lake Example:  
0% natural shoreline cover

1-24% shoreline trees, shrubs,  
or wetland
