MEMORANDUM
Comfort Lake-Forest Lake Watershed District

Date: March 18, 2024
To: CLFLWD Board of Managers
From: Mike Kinney, District Administrator
Subject: 2023 DIY and CAT Water Monitoring Report

D.I.Y & C.A.T
Diagnostic
Monitoring Report

2023

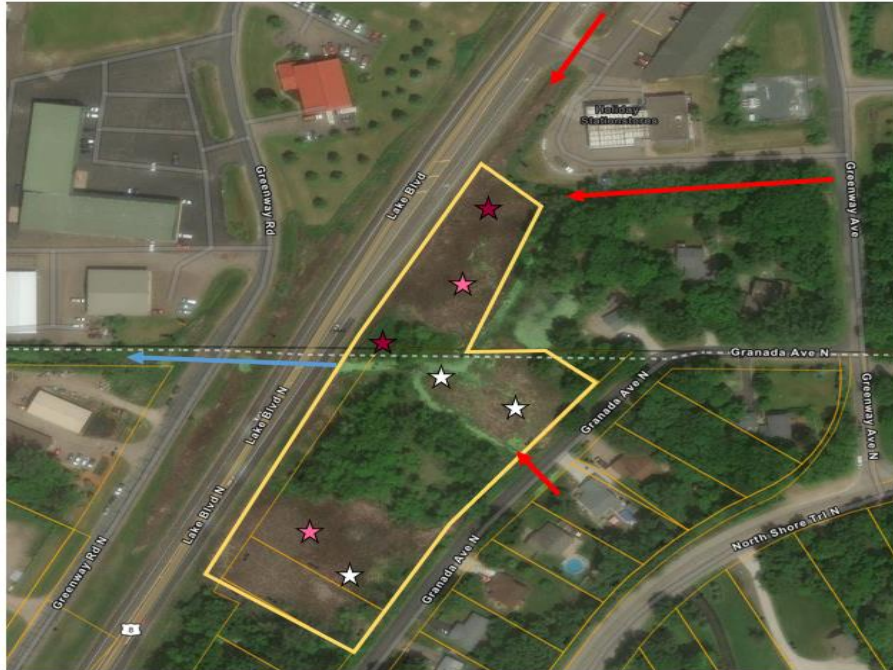
Figure 5. Overview Map of the County Line Wetland Soil Monitoring. The yellow Polygon indicates the study area and the stars indicate where the wetland soil cores were collected. The darker red the star appears, the higher the phosphorus concentration. The red arrows indicate inlet flow paths and the blue arrow indicates outflow.

Wetland soil samples were collected in the County Line sub-shed in 2023 to further evaluate the wetlands as a potential source of nutrient. Seven soil samples were collected from the wetland complex adjacent to Highway 8 (Figure 5). The soil samples were sent to the University of Minnesota soil lab for analysis. The results indicated the areas closest to the highway had elevated levels of Bray phosphorus (Table 4). This information was shared with Chisago County to help inform the coming Highway 8 expansion. The County expressed willingness to include the removal of these sediments (if within the

highway right-of-way or highway expansion envelope) during the reconstruction/expansion of the highway. When/if implemented, this would help to reduce the nutrient loads being exported from these wetland complexes.
