2023 SHORELINE INVENTORY

Prepared by Aidan Read

January 2024

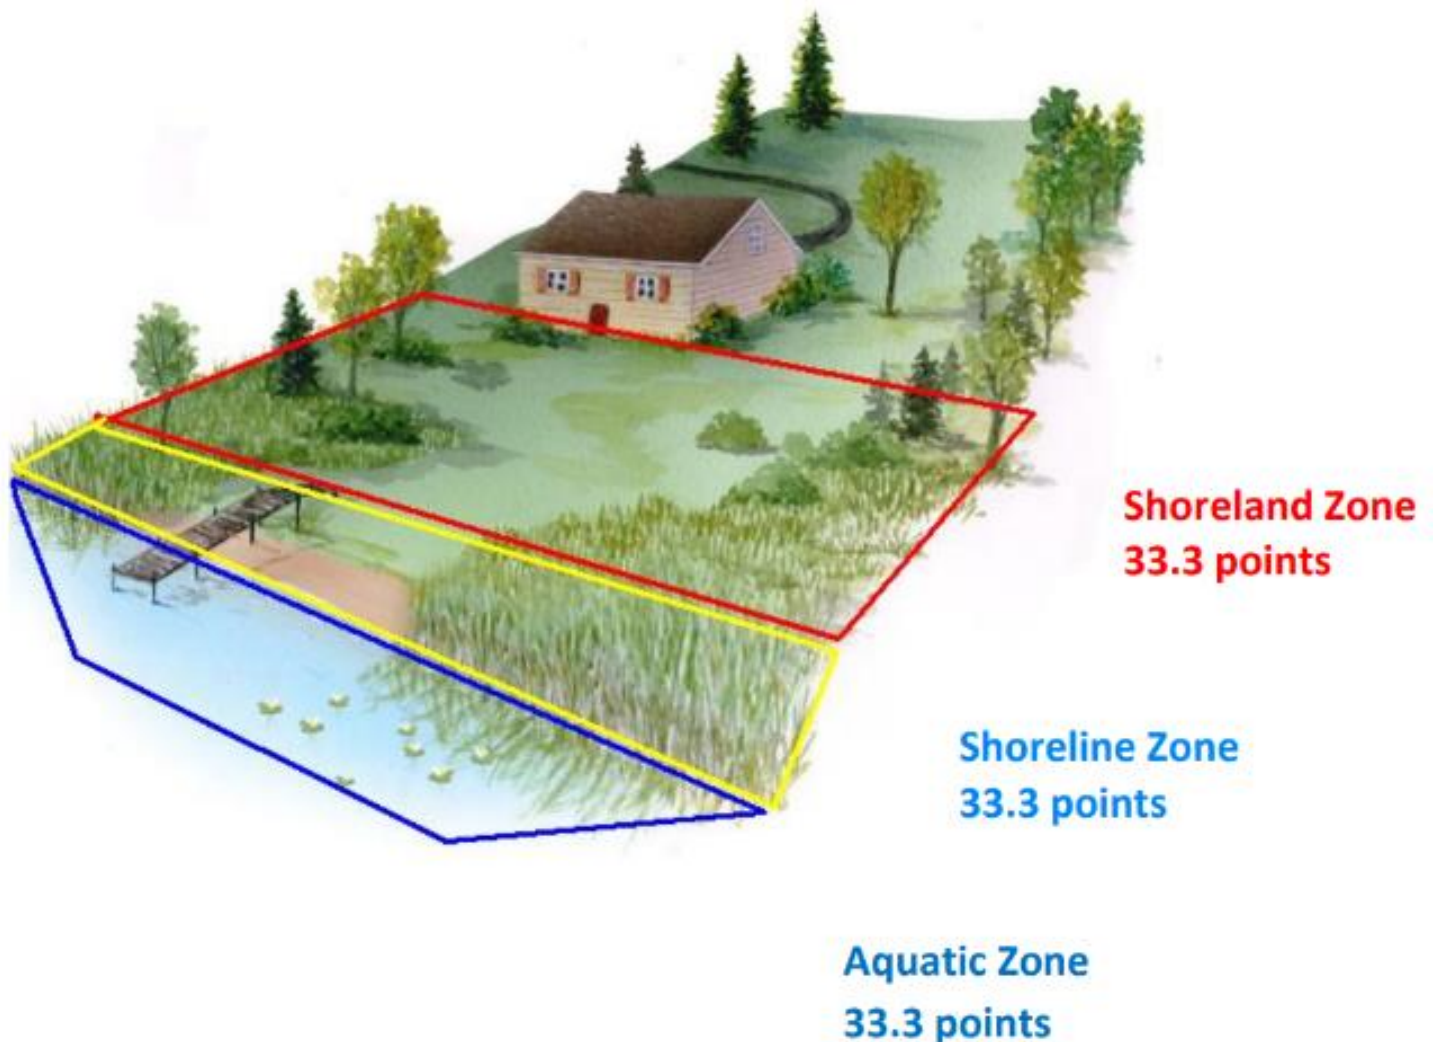
FIGURE 2 – STS ZONES

The STS method breaks out habitat zones into shoreland, shoreline, and aquatic, each with their own score. This allows the data to better inform management decisions about land use and development on the lakes surveyed. The primary focus of this report will be on the shoreland and shoreline zones. While STS has an emphasis on habitat, many of the same characteristics that make quality shoreline habitat also reduce shoreline erosion and improve water quality.

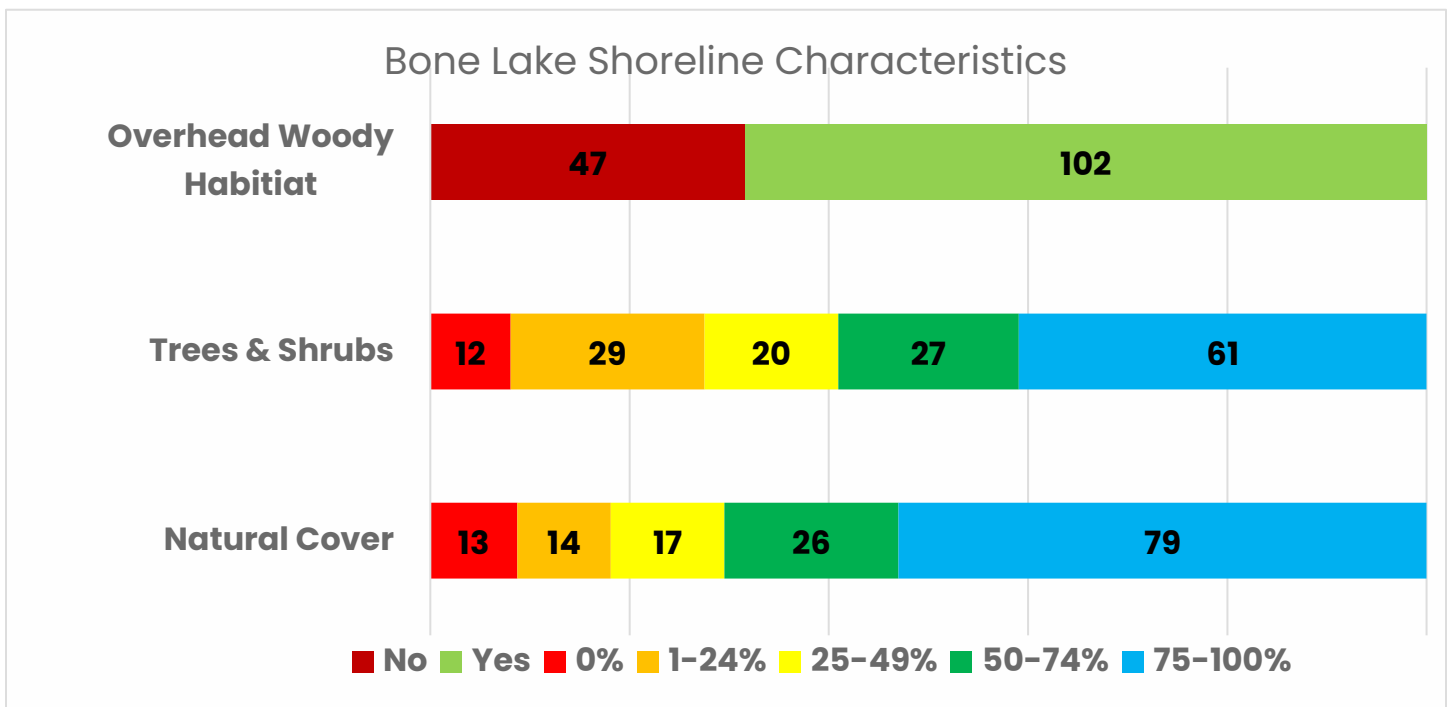
FIGURE 8- CHARACTERISTICS OF BONE LAKE SHORELINE

The shoreline cover metric is useful for assessing the presence of a buffer but does not include characteristics of the rest of the shore area. The total shoreline score includes the percent of natural cover, the presence of trees, shrubs, or wetland, and the presence of overhanging woody habitat, such as fallen trees or branches. It can be noted in Figures 6 & 7 that the percentage of shoreline with a “High” score is lower than the number meeting the natural cover goals. The breakdown of characteristics of each survey point can be viewed in figure 8. Note that 13 points completely lacked natural cover.

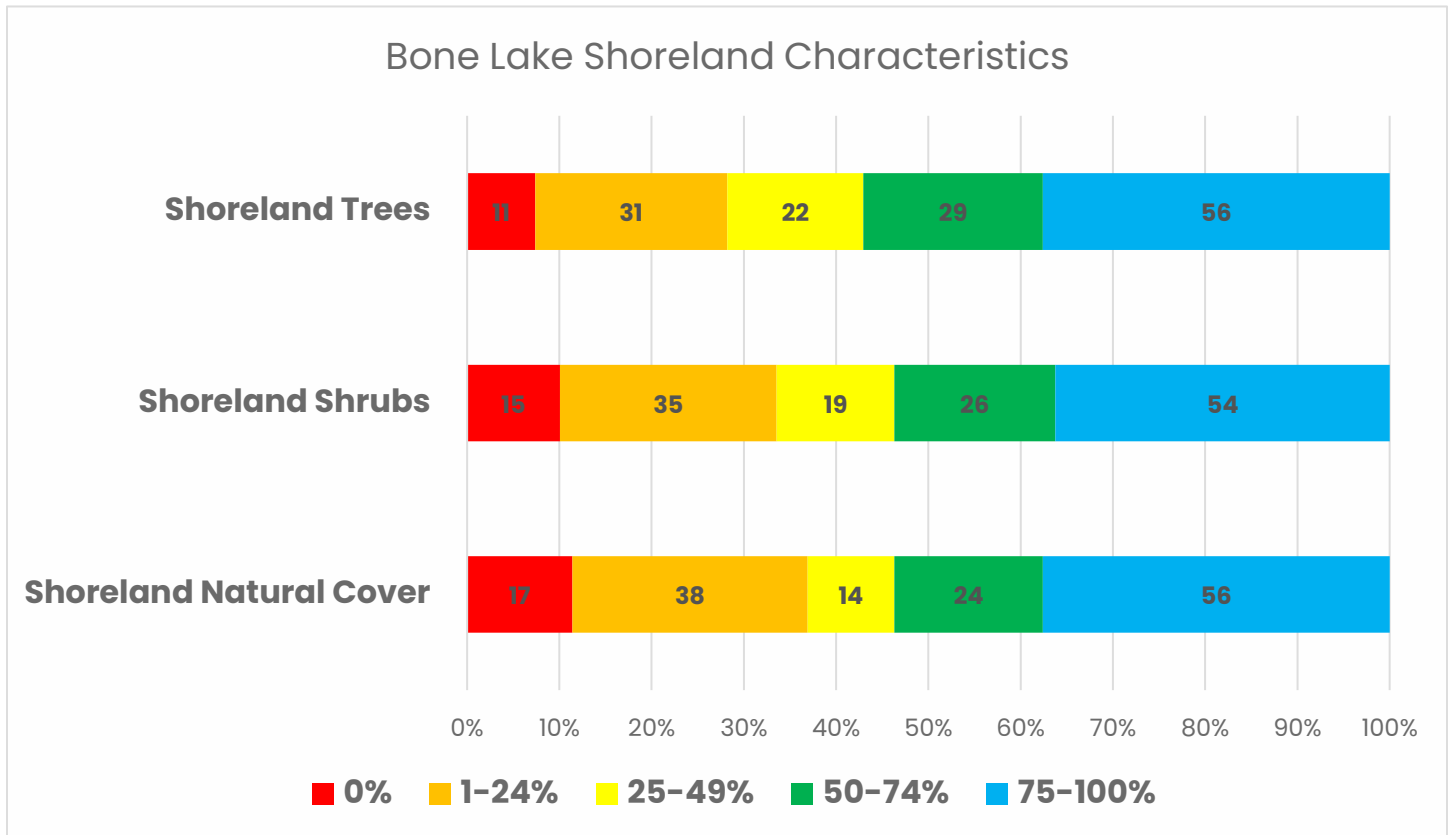
FIGURE 9 – BONE LAKE SHORELAND CHARACTERISTICS

The shoreland zone extends from the shoreline upslope, as can be viewed in figure 2. The shoreland zone of Bone Lake scored Low with 20.9/33. Notable from the shoreland zone on Bone Lake is the absence of any trees, shrubs, or natural cover on a number of survey points. Areas with a complete lack of natural vegetation and canopy have an outsized impact on runoff and lake water quality.

- Plant a tree! – 12 points without shoreline trees or shrubs
- Don't go there? Don't mow there! – 27 points with less than 25% natural vegetation
- If a tree falls in the lake... leave it! – 47 points without overhanging woody habitat

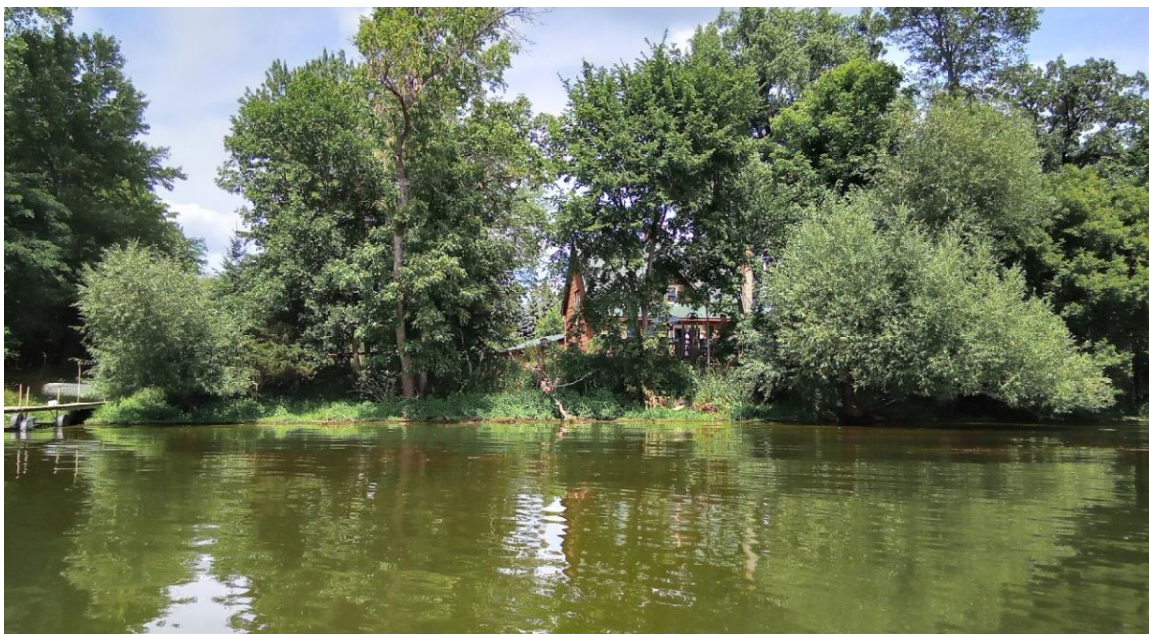
FIGURE 10 – BONE LAKE PROPERTY WITH 75-100% SHORELINE TREES OR SHRUBS, AND SHORELINE NATURAL COVER

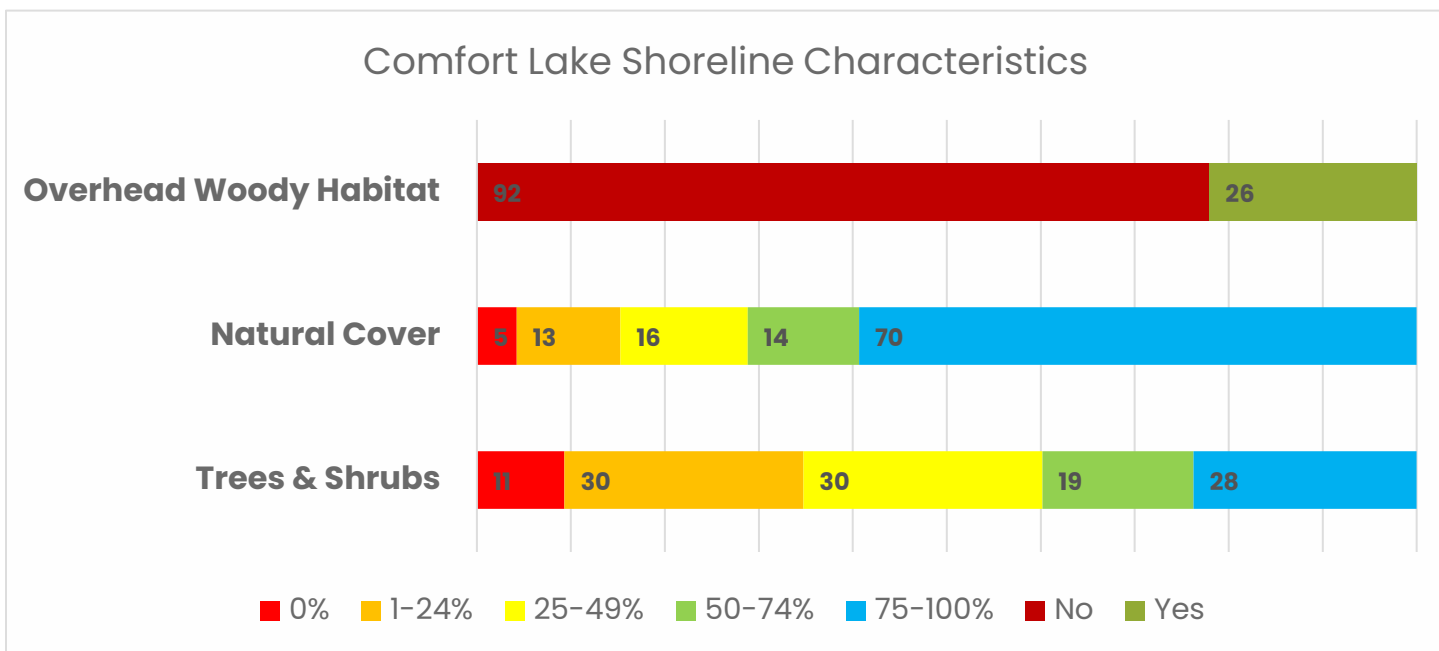
FIGURE 18 – SHORELINE CHARACTERISTICS OF COMFORT

The shoreline cover metric is used by our WMP but does not include characteristics of the rest of the shore area. The total shoreline score includes the percentage of natural cover, the presence of trees, shrubs, or wetland, and the presence of overhanging woody habitat, such as fallen trees or branches. It can be noted in Figures 16 & 17 that the percentage of shoreline with a “High” score is lower than the number meeting the natural cover goals, and that half (47%) of survey points earned a “Very Low” shoreline score. The breakdown of characteristics of each survey point can be viewed in figure 8. Note that five points completely lacked natural cover.

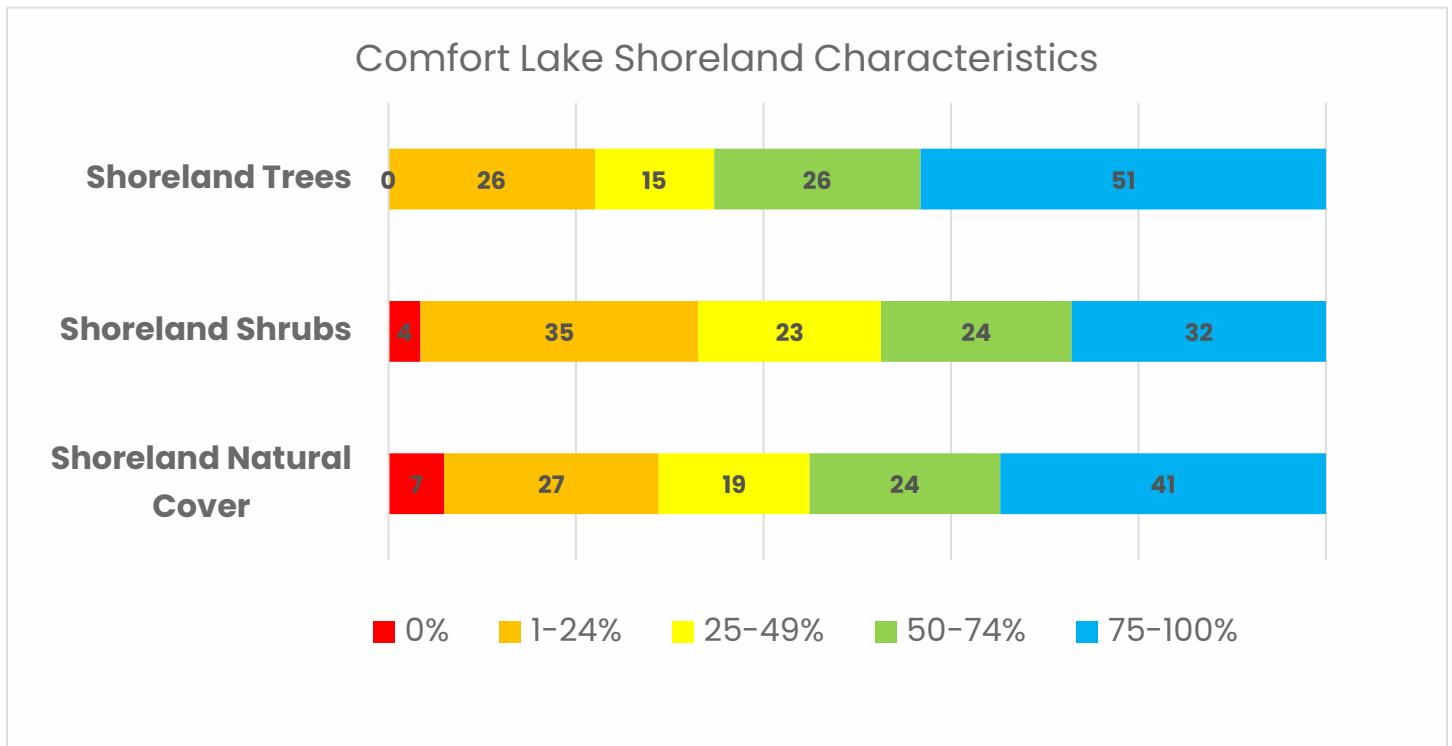
FIGURE 19 – COMFORT LAKE SHORELAND CHARACTERISTICS

The shoreland zone extends from the shoreline upslope, as can be viewed in figure 2. The shoreland zone of Comfort Lake scored “Moderate” with 21.74/33. Notable from the shoreland zone on Comfort Lake is the absence of any shrubs, or natural cover on a number of survey points. Areas with a complete lack of natural vegetation have an outsized impact on runoff and lake water quality.

- Plant a tree! – 11 points without shoreline trees or shrubs
- Don't go there? Don't mow there! – 18 points with less than 25% natural vegetation
- If a tree falls in the lake... leave it! – 92 points without overhanging woody habitat

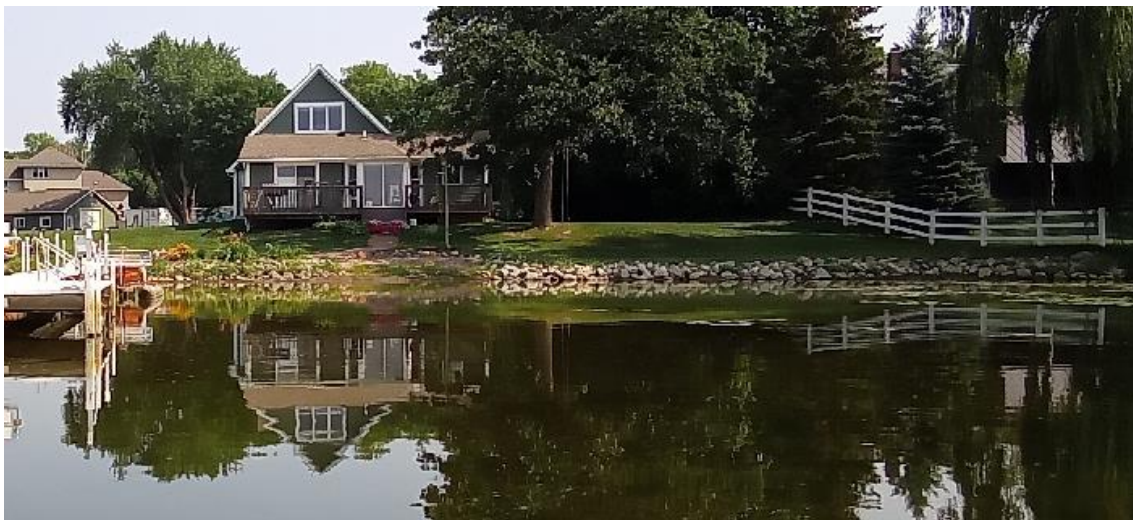
FIGURE 20 – COMFORT LAKE SHORELINE WITH 0% NATURAL COVER

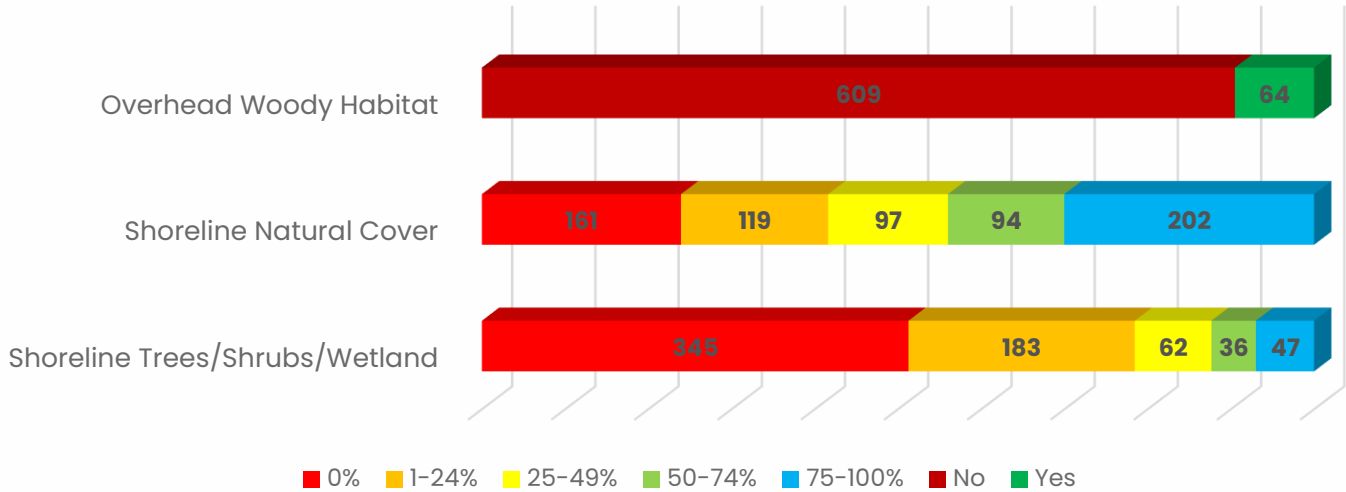
FIGURE 27- FOREST LAKE SHORELINE CHARACTERISTICS

More details on the characteristics of the shoreline can be viewed in figure 27. Notable in this figure is that there are 161 points that had 0% natural cover, and 345 sites with zero trees, shrubs, or wetland. These sites that have 0% canopy or natural cover are a high priority for addressing shoreline issues and are having a significant impact on water quality and shoreline habitat on Forest Lake. The lack of shoreline canopy can be seen clearly in figure 28 where each red point is a site with zero trees, shrubs, or wetland.

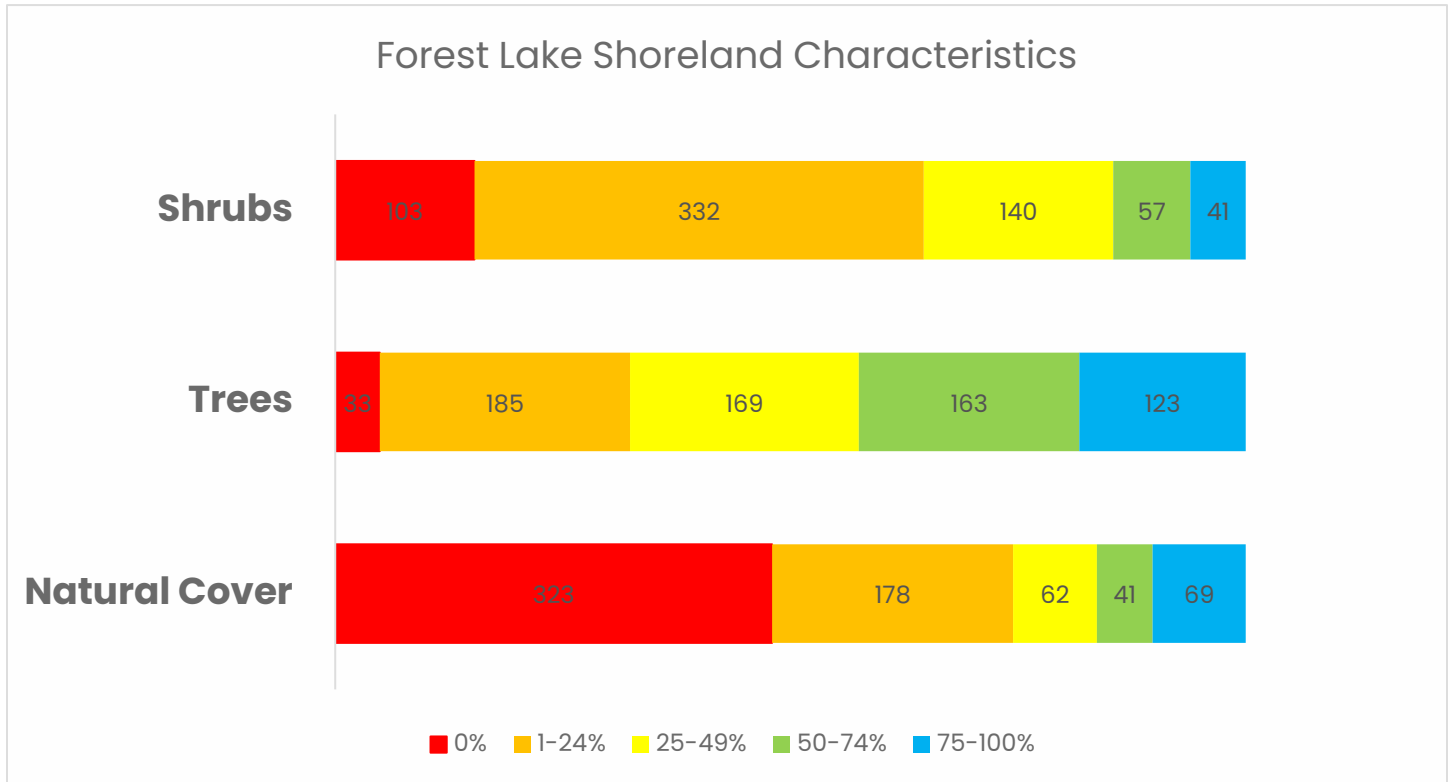
FIGURE 29 – FOREST SHORELAND CHARACTERISTICS

The shoreland zone of Forest Lake scored 13.87/33, or Very Low. While a higher score than the shoreline zone, there was still a lack of natural cover on 323 points. More details of the shoreland characteristics can be viewed in figure 29. The priority for targeting shoreland areas is improving the 33 points that lack canopy cover, and the 75% of points that have under 25% natural cover.

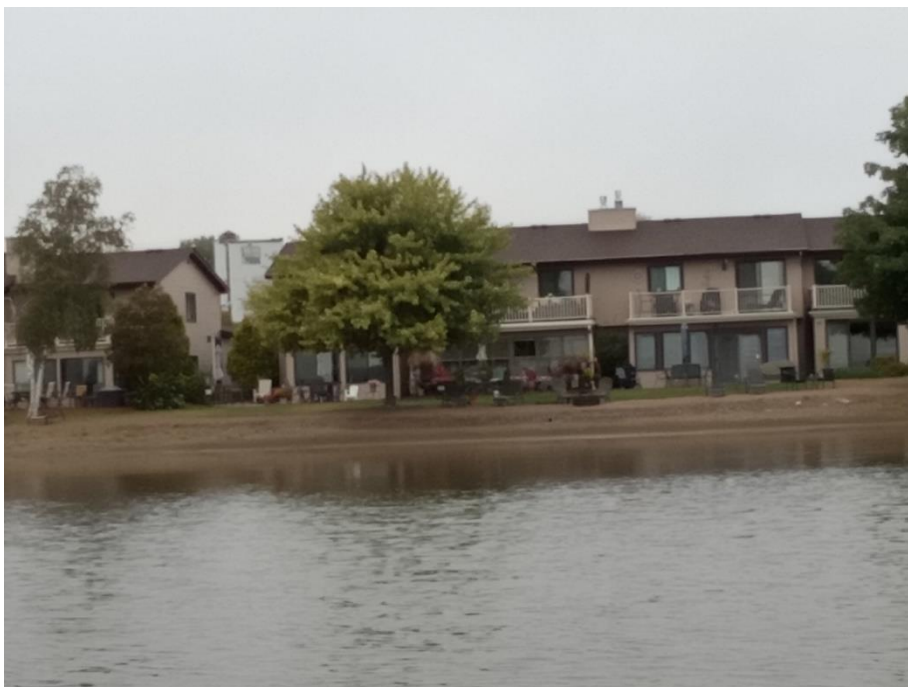
FIGURE 30 – CHARACTERISTIC FOREST LAKE SHORELINE WITH 0% NATURAL COVER AND SPARSE CANOPY.

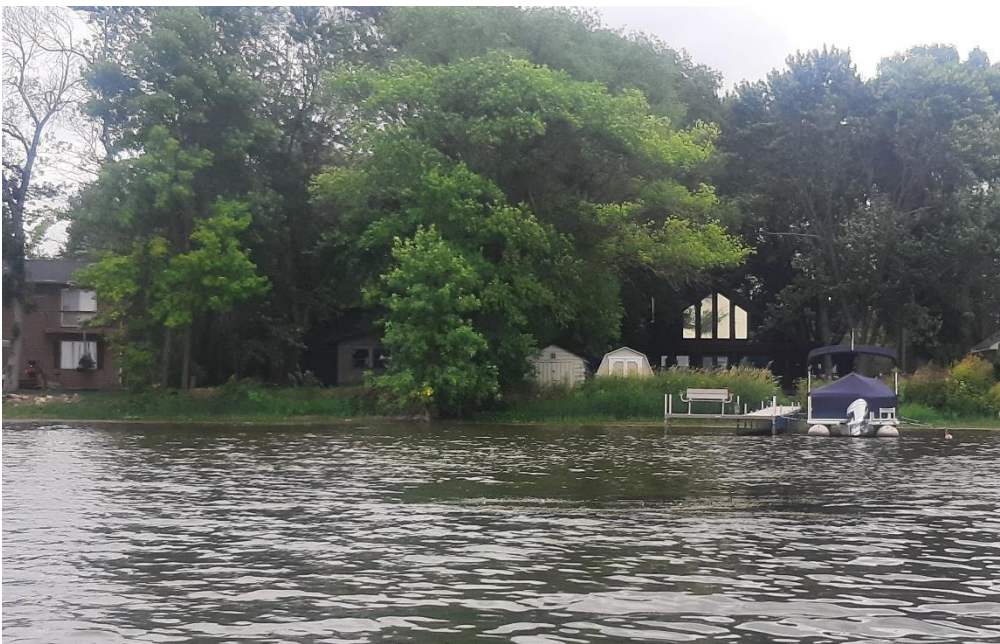
FIGURE 33 – FOREST LAKE SHORELINE WITH 100% NATURAL COVER

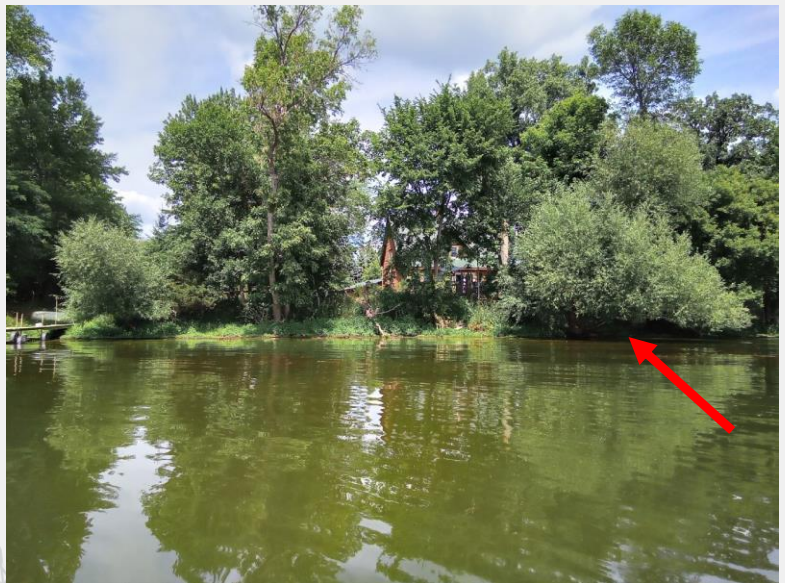
Bone Lake Example:
75-100% natural shoreline cover
75-100% shoreline trees or shrubs

Note the overhanging woody habitat

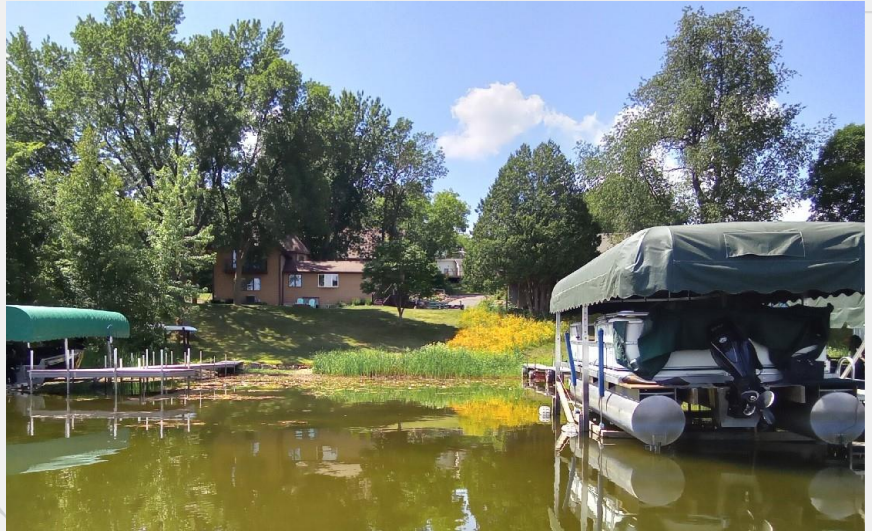
Bone Lake Example:
50-74% natural shoreline
cover
1-24% shoreline trees or
shrubs

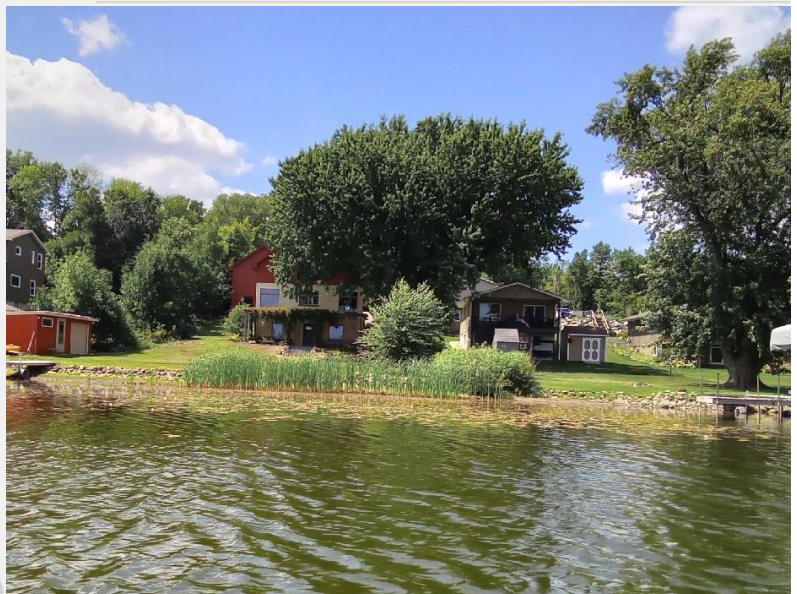
Bone Lake Example:
25-49% natural shoreline
cover
25-49% shoreline trees,
shrubs, or wetland

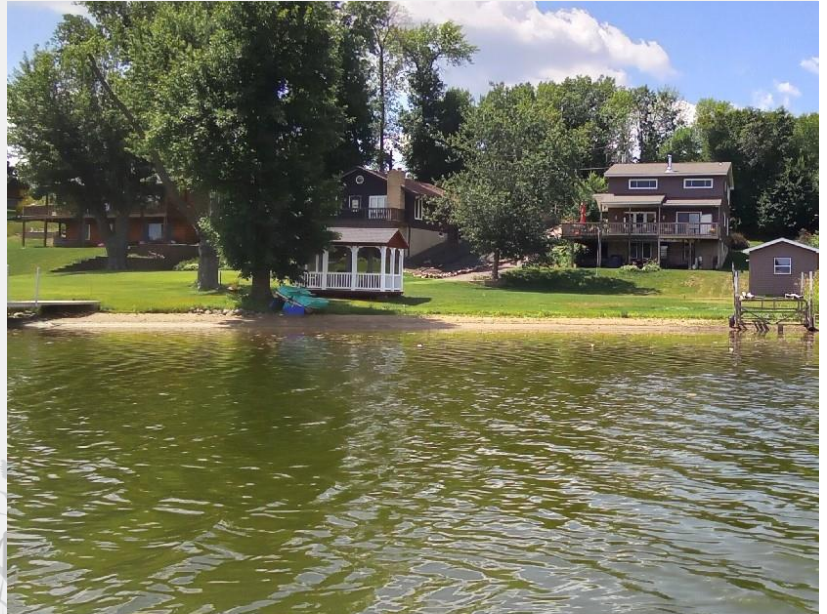
Bone Lake Example:
0% natural shoreline cover

1-24% shoreline trees, shrubs,
or wetland
