Protecting Your Water Resources

BARCHENGER PROPERTY

Shoreline Water Quality Buffer & Erosion Control

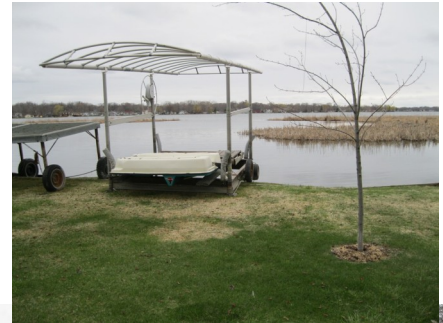
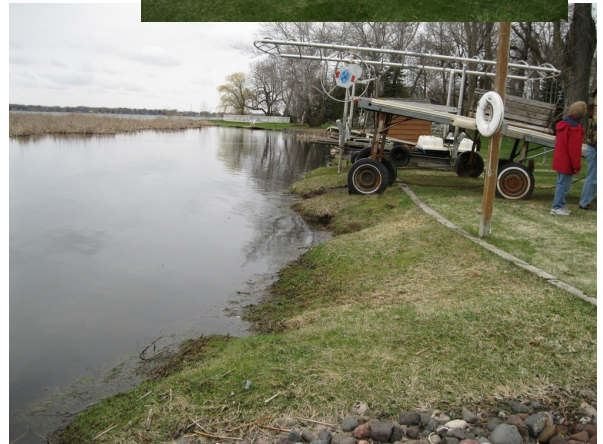
Before:
April 2011

The Barchenger property lies on the northwest shore of Forest Lake (Lake 1). The site was dominated by mown turf grass down to the existing shoreline resulting in:

- Direct conveyance of nutrients and pollution from the property was going directly into the lake untreated, contributing to increased algae and unwanted vegetation blooms in the lake.
- Limited near shore plant diversity
- Limited wildlife habitat
- Erosion of the shoreline

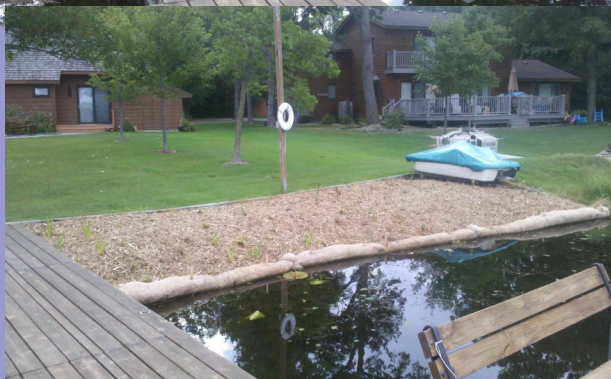
After:
September 2011

Mown turf grass was replaced with a water quality upland buffer planting using a variety of native plants and mulch along lakeshore designed to intercept and treat stormwater runoff from the yard prior to getting into the lake. To control shoreline erosion a system of bio-logs and erosion control fabric was used along with the buffer planting. The project consisted in the establishment of 600 sq. ft. of new buffer, 90 linear feet of shoreline protection.

310 native grasses and flowers were planted. The native plantings and vegetated shoreline protection provide multiple benefits, including;
