JORDAN — Shoreline Restoration

Protecting Your Water Resources

PROJECT SPECS

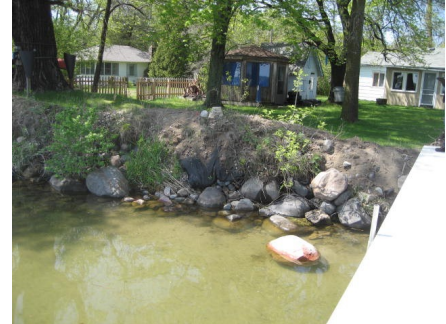
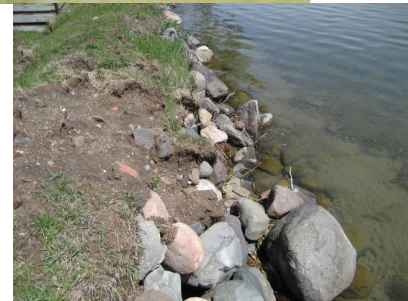
**Before
Spring 2013**

The Jordan property lies on the north shore of Forest Lake, Lake 1. Ongoing ice and wave action at the shoreline had resulted in a large, eroding ice ridge. Mowing of turf grass close to the edge of the shoreline was also resulting in increased shoreline instability. Issues identified by the District during the initial site visit included:

- Active shoreline erosion, undercutting of the shore
- Actively eroding, large ice ridge
- Mowing of turf grass to the lake edge
- Limited plant diversity
- Limited wildlife habitat.
