KEMPLIN RESIDENCE—Shoreline Restoration

Protecting Your Water Resources

PROJECT SPECS

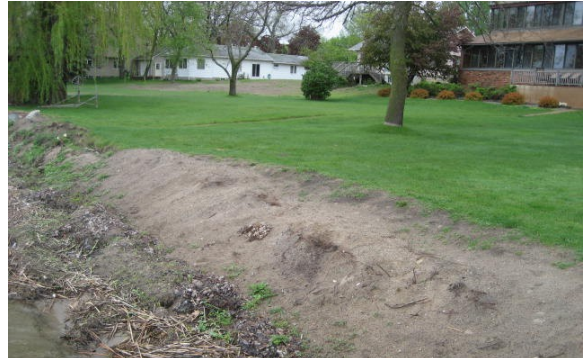
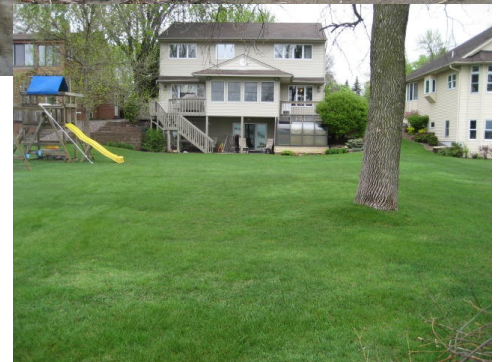
**Before
Fall of 2011**

The Kemplin property lies on the north shore of Forest Lake (lake 1). In addition to an eroding shoreline, the site was dominated by turf grass. As a result, there was:

- Active shoreline erosion due to limited root structure to withstand wave/ice action.
- Direct conveyance of nutrients and pollution from the property into the lake, increasing algae and unwanted vegetation blooms.
- Limited plant diversity
- Limited wildlife habitat

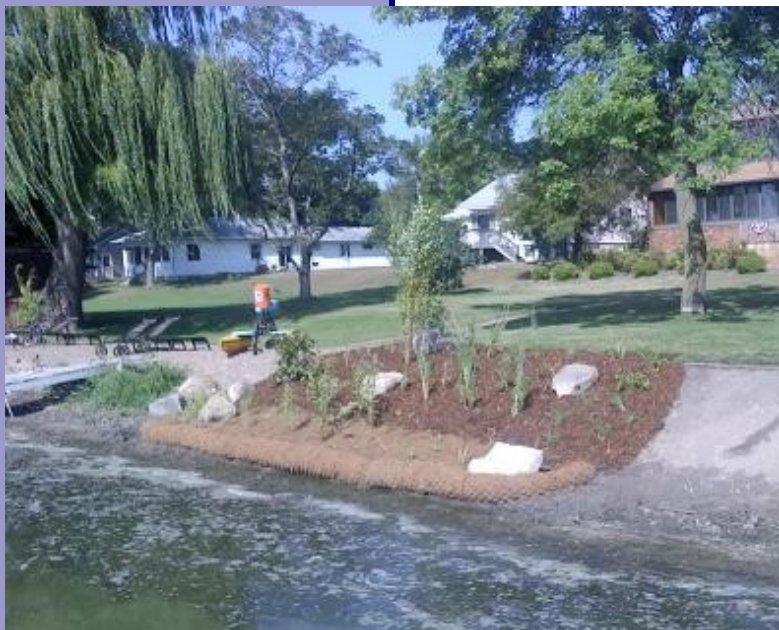
August, 2012

Shoreline erosion was stabilized with native plantings and bio-logs designed for the site taking into account wave height and potential for ice action. Turf grass was replaced with a variety of native plantings along the lakeshore. Approximately 155 native grasses, flowers, shrubs, and aquatic plants were planted. The buffer and native plantings have many benefits, including;

- Stopping soil from washing into the lake.
- Stormwater is slowed and retained as it flows toward the lake increasing infiltration and decreasing input of nutrients and pollutants to Forest Lake.
- Plant diversity is dramatically increased and the increase in root structure protects the shoreline from erosion due to runoff and wave/ice action.
- Fish and wildlife habitat is increased.
